Heath Town Baths and Library

HEATH TOWN BATHS & LIBRARY Structural Condition Survey

November 2011

This report forms part of a Feasibility Study for the adaptive re-use of Heath Town Baths & Library to a Sports Academy on behalf of the Tessa Sanderson Foundation Academy.

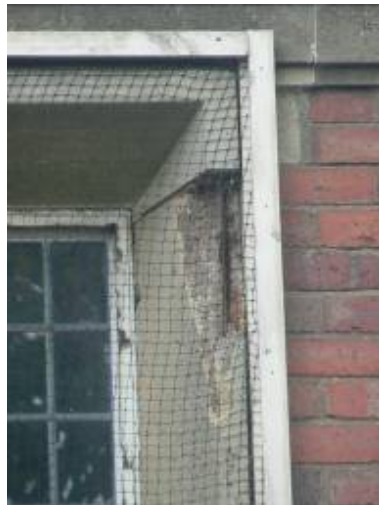
Photograph No. 5

The upper parapet requires repointing. The first floor window (WF10), is suffering from noticeable areas of spalling, especially to the right hand reveal where the reinforcement bar is now showing, as shown on photograph No. 5.

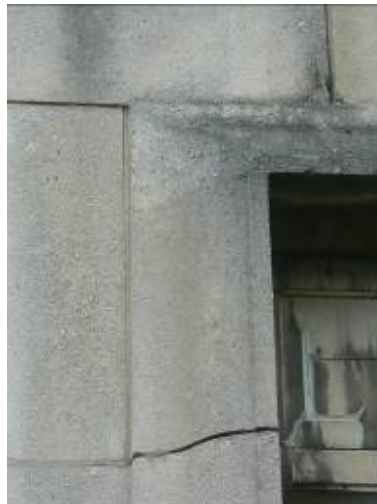
Photograph No. 9

The feature door surround has a failure to the architrave section to the left hand southern side, as shown on photograph No. 9.

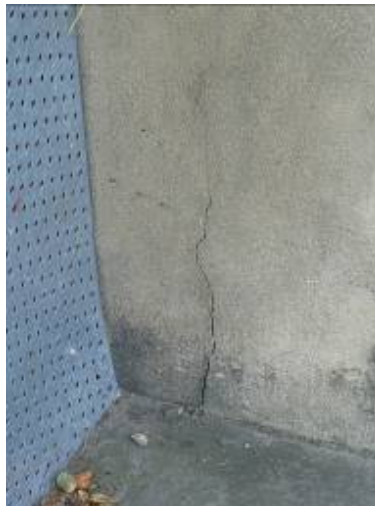
Photograph No. 11

On the inside of the reveals, there is an open joint between the individual blocks and to the bottom corner of the northern reveal, there is one vertical crack which requires repair, as shown on photograph No. 11.

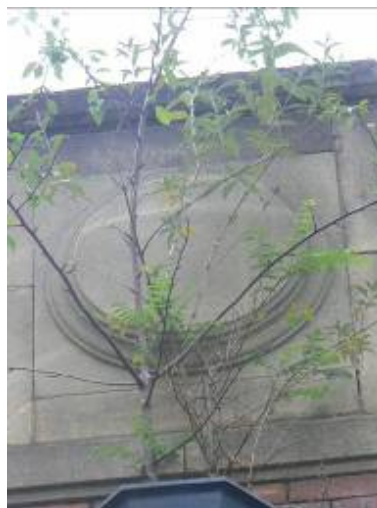
Photograph No. 16

Between the two arches there is a central downpipe and some of the fixings to this are broken. It can also be seen that there is now a small tree growing out of the top of the hopper and it would therefore, be recommended that this downpipe is taken off, repaired and re-fixed. A view of the small tree is shown on photograph No. 16.

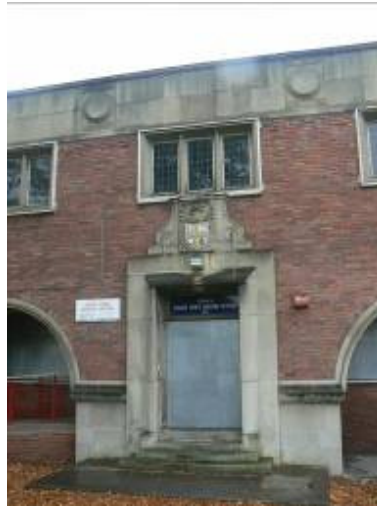
Photograph No. 17

The central entrance door, this is shown on photograph No. 17.

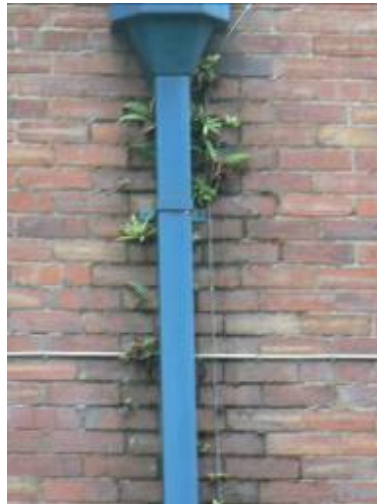
Photograph No. 22

To the central downpipe between the arches, this has a large amount of vegetation behind, which would indicate that the water is not discharging properly, as shown on photograph No. 22. This requires the downpipe to be removed, the brickwork repointed, the downpipe overhauling and re-fixing.

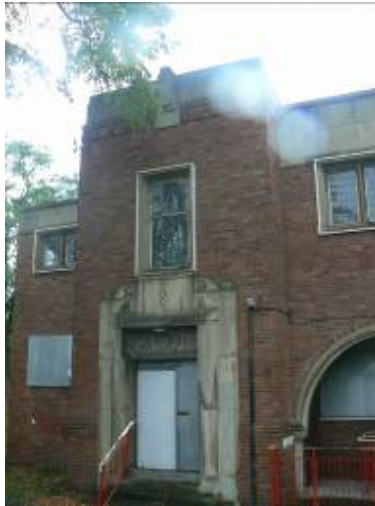
Photograph No. 25

The southern library entrance tower is shown on photograph No. 25.

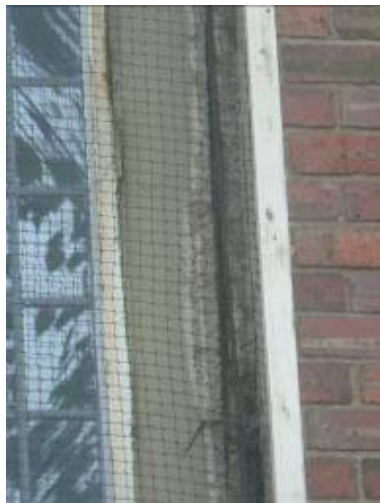
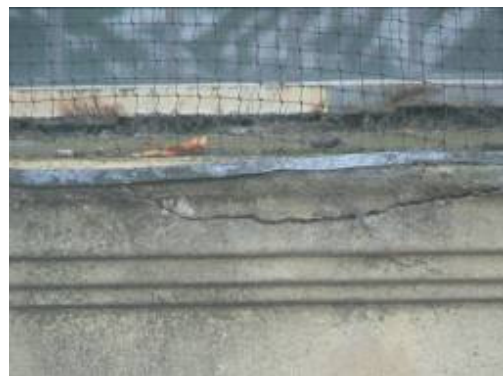
Photograph No. 26

The window surround to WF3 is in a poor condition, especially the cill and right hand reveal, which is shown on photographs numbered 26 and 27.

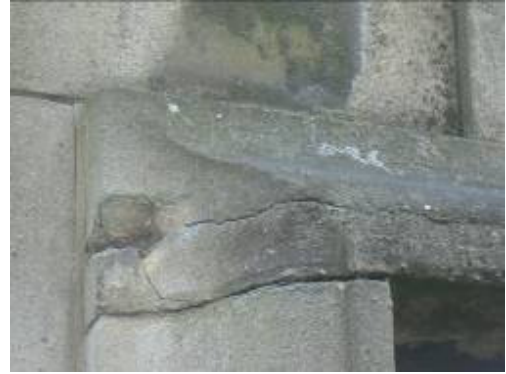
Photograph No. 29

To the lintol over the ground floor door, the concrete has spalled and there are exposed reinforcing bars showing and this crack extends all the way across to the southern end where this section of reconstituted stone is also coming away, and this is shown on photographs numbered 28 and 29.

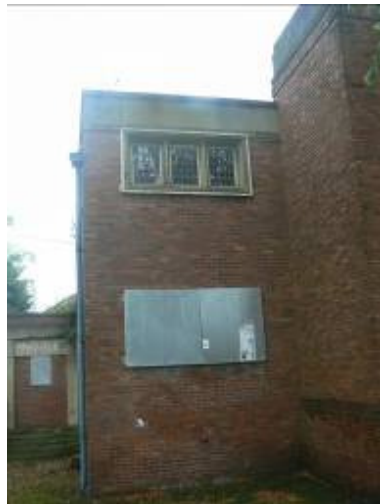
Photograph No. 30

The southern end of the building is shown on photograph No. 30 and here the parapet requires repointing and it can also be seen that to the top corner, there is vegetation growing, and this is shown on photograph No. 31.

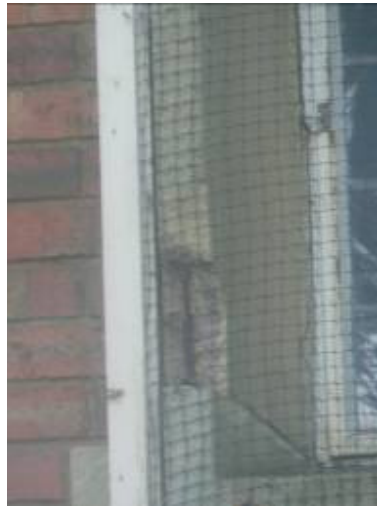
Photograph No. 32

To the first floor window, WF02, the southern reveal has spalled, as shown on photograph No. 32.

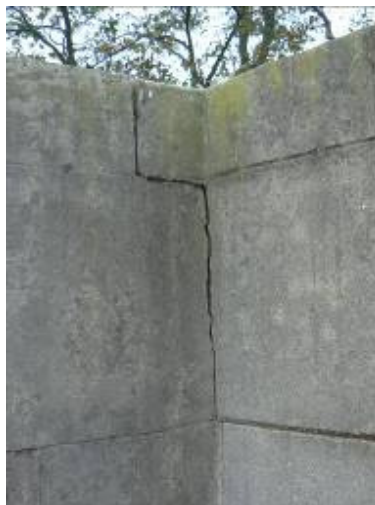
Photograph No. 106

On the north-eastern corner there is localised displacement, as shown on photograph No. 106.

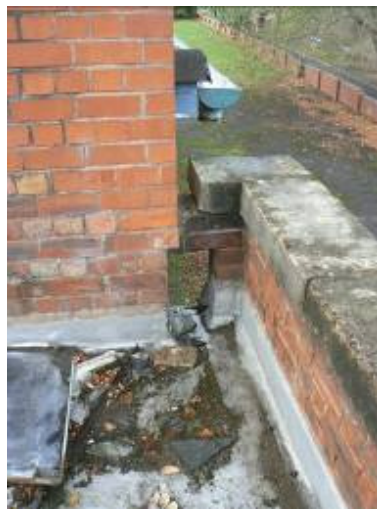
Photograph No. 138

On the western side of the parapet, a small section of coping to the drainage outlet is missing and generally this area requires re-forming, as shown on photograph No. 138.

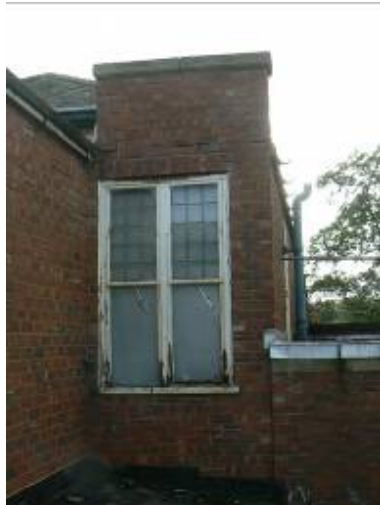
Photograph No. 142

On the southern return, the parapet wall is leaning to the south and this has fractured at its base, and it would be recommended that the top eight courses are re-set. This area and the failure lines are shown on photographs numbered 142 and 143.

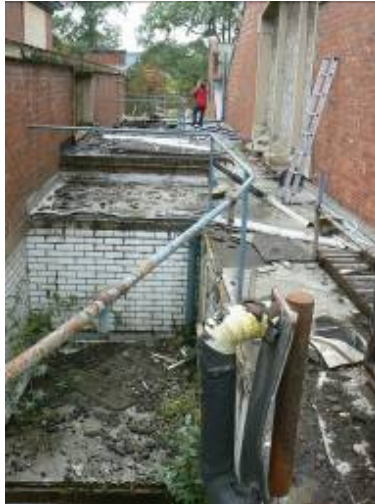
Photograph No. 150

In the central area, behind the main swimming pool hall, this area of roof is shown on photograph No. 150.

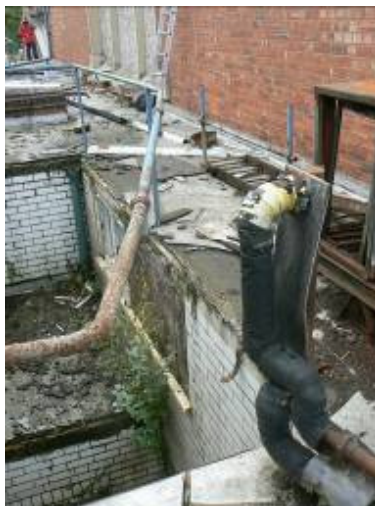
Photograph No. 151

To the first lightwell area, the handrail has been adjusted to suit the plant, but this does leave a large hole and will need to be adjusted as currently it is considered to be un-satisfactory with regard to Health and Safety, as shown on photograph No. 151.

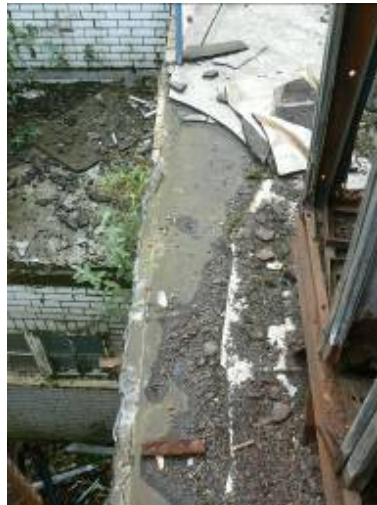
Photograph No. 152

As with the remainder of the roof, the asphalt on the edge is coming away, as shown on photograph No. 152.

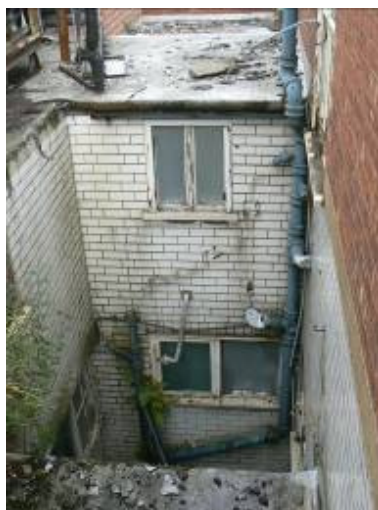
Photograph No. 53

To the lightwell, this is faced with a glazed white brick and it can be seen that the condition of the windows is quite poor. There is a lower flat roof and the front edge again is damaged, and there is also a large amount of vegetative growth, especially around the soil and vent pipe, and this is all shown as a general view on photograph No. 153 and the vegetative growth on photograph No. 154.

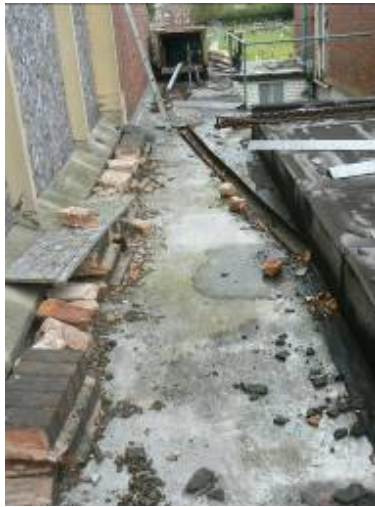
Photograph No. 157

The central area of the flat roof has a lot of debris present, but no sign of any major leakage and a general view is shown on photograph No. 157.

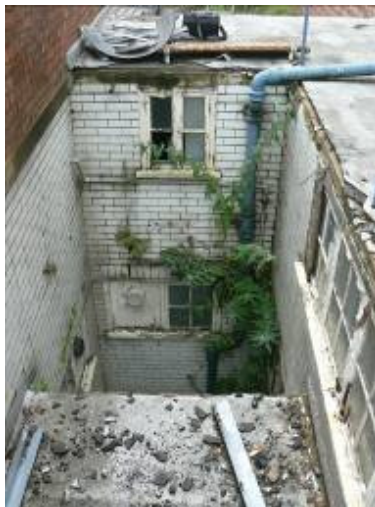
Photograph No. 158

To the southern lightwell, the handrail is quite basic and the edge of the slab has been vandalised with the asphalt now coming away. Within the lightwell itself, there is a lot of vegetative growth and the windows are in a poor condition, and a general view is shown on photograph No. 158.

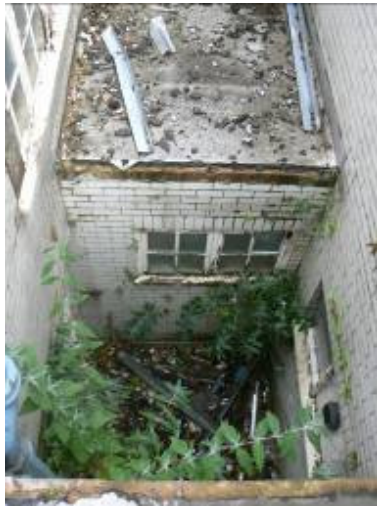
Photograph No. 159

It is noted that there is a lot of debris at the bottom of the lightwell and also the roof half way down has damage at the edge, and this is all shown on photograph No. 159.

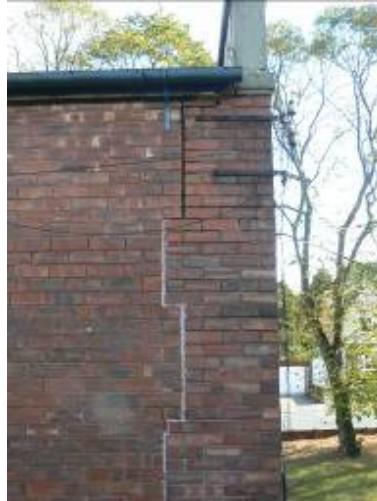
Photograph No.170

Moving along where the brickwork changes, this joint has been crudely filled with mastic sealant and the upper section is open and this will require repointing. It can also be seen that at the junction with the upper parapet, there is slight displacement and damage to the eaves band, and all the above is shown on photograph No. 170.

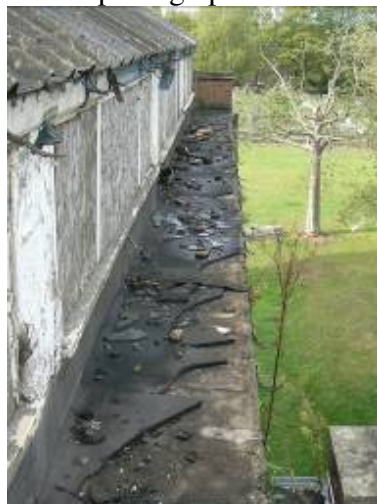
Photograph No. 175

The asphalt all the way along the edge of the swimming pool building is in a poor condition and a view looking to the west is shown on photograph No. 175.

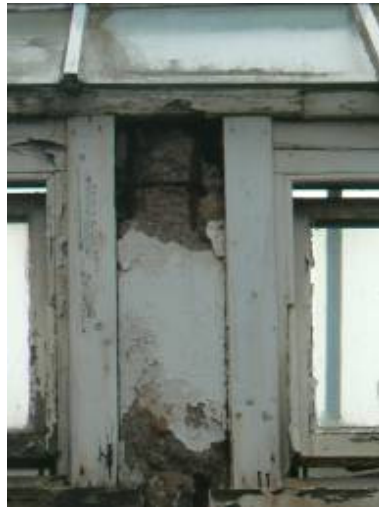
Photograph No. 179

At the first frame position, the concrete is in a poor condition with the reinforcement showing, as shown on photograph No. 179.

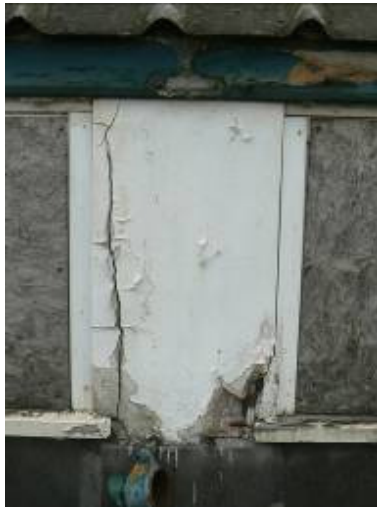
Photograph No. 185

To the lower level upstand and again starting at the eastern side, the first frame has exposed and spalling concrete, as shown on photograph No. 185 and there is a similar situation to the remainder of the frames and a photograph of each is shown on photographs numbered 186 to 190 inclusive.

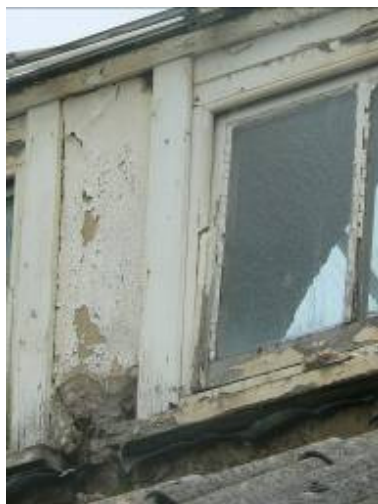
Photograph No. 203

From what could be seen, the upper lantern is in a similar condition to that noted on the northern side, in that the timber framework to the glazing is in a poor condition. To the main concrete frames, there is again noticeable damage with exposed sections of reinforcement and starting at the eastern side, the first frame has exposed reinforcement bar at both the top and the bottom, as shown on photograph No. 200. The remaining five are in a similar condition, as typically shown on photographs numbered 201, 202 and 203.

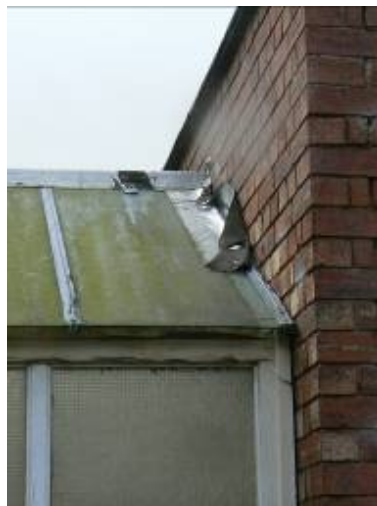
Photograph No. 206

The flashing with the service tower at the western face is in a poor condition, as shown on photograph No. 206.

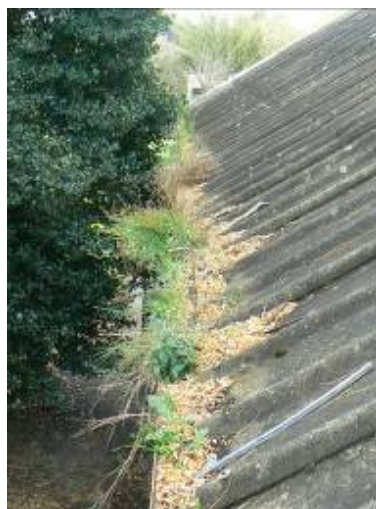
Photograph No. 212

As noted previously, the gutter is completely full of debris and vegetation, as shown be seen on photograph No. 212.

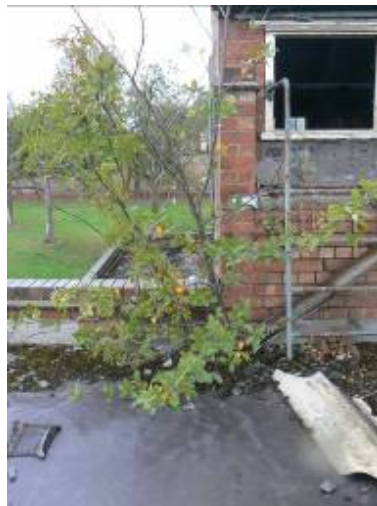
Photograph No. 217

At the junction with the Swimming Pool building, there is now a small tree growing, as shown on photograph No. 217.

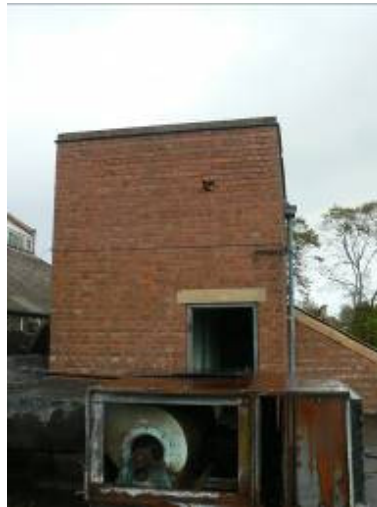
Photograph No. 222

The service tower is shown on photograph No. 222 and the brickwork here is in a reasonable condition with just repointing works being required.

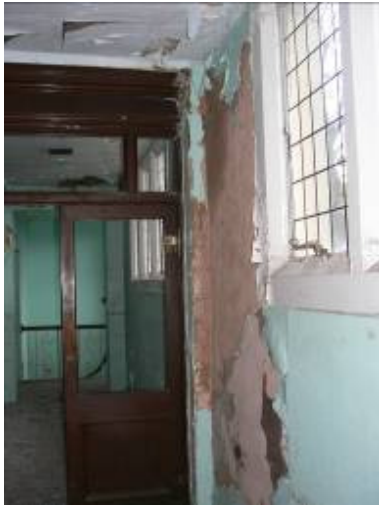
Photograph No. 226

Room F3 – This is the main eastern corridor and the eastern wall is in a poor state of repair with both the northern and southern ends having large areas of plaster delaminated, finishes coming away and damp penetration. This is all shown on photographs numbered 226 and 227 respectively.

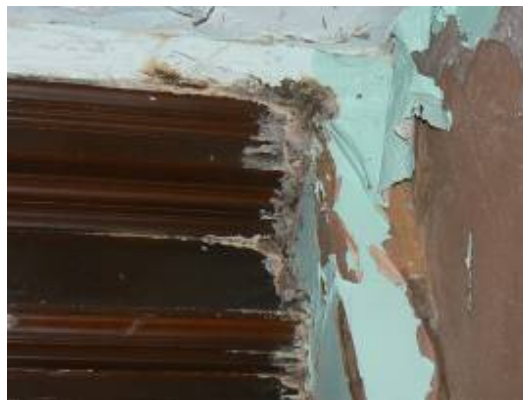
Photograph No. 228

These positions correspond with the external rainwater pipes which have already been noted as leaking. The walls show no sign of major structural cracking, the main issues being the damp penetration. What is noticeable is that in the large areas of damp, there is a significant amount of spores from the rot, which will need to be further investigated to ascertain whether this is dry or wet rot, and typical examples are shown on photographs numbered 228 to 230.

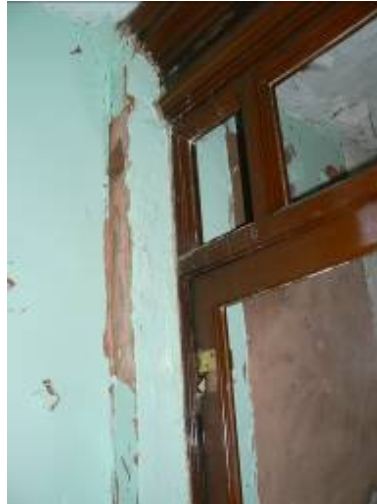
Photograph No. 231

Room F4 – At the southern end boundary doors at the junction with F3, the damp staining can be seen to also be coming through the pier on this side, as shown on photograph No. 231.

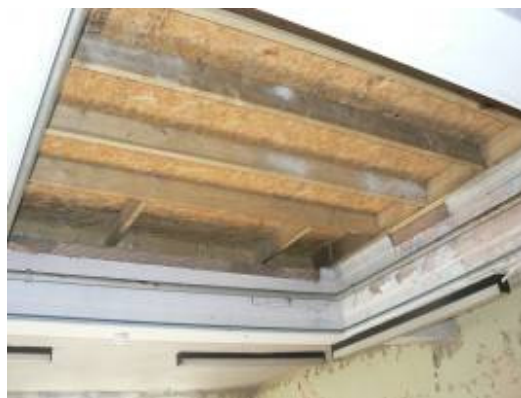
Photograph No. 241

Room F11 – This is the southern room which has a flat ceiling with a lantern to the centre which has been removed and infilled with timber joists and chipboard, as shown on photograph No. 241.

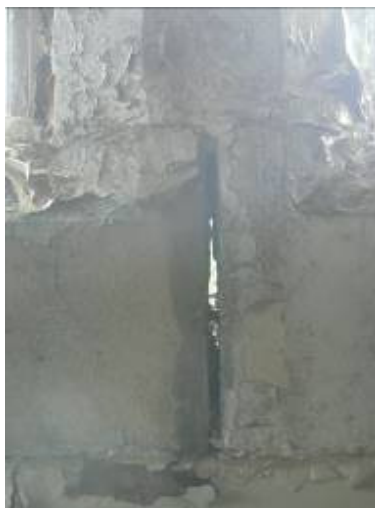
Photograph No. 243

On the southern wall, the main window is heavily painted over and where the cill joins it can be seen where daylight is visible, as shown on photograph No. 243.

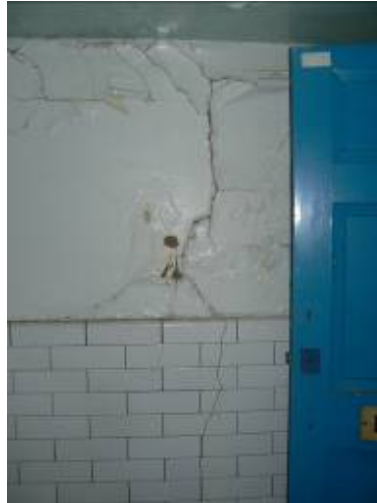
Photograph No. 46

In the lobby area there is a crack which then extends down through the tiles, as shown on photograph No. 246. This is not considered to be major structural movement and can be cut out and repaired.

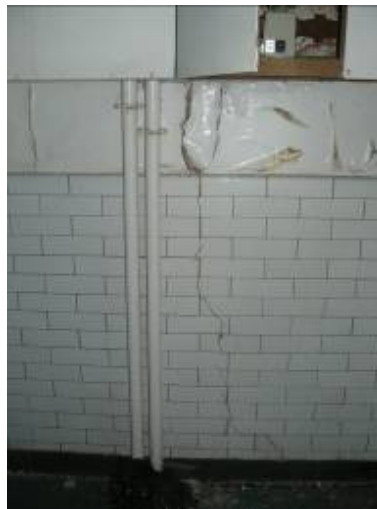
Photograph No. 248

Room UG4 – This is the male toilet at the northern end and there has been a lot of water ingress into this room and on the western wall there is a near vertical crack which extends through the tiles, as shown on photograph No. 248.

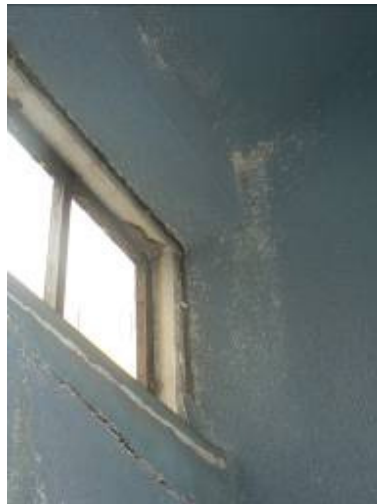
Photograph No. 254

In the end section there is a similar situation with the finishes coming away. It can also be seen that around the window, the frame has moved away from the eaves beam slightly and there is also previous repairs to the finishes where there is now a smooth render, all as can be depicted on photograph No. 254.

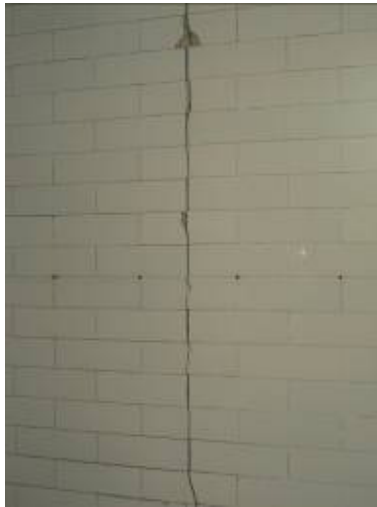
Photograph No. 255

Room UG6 – This is a staircase leading down towards the basement and on the northern wall there is a noticeable vertical crack, as shown on photograph No. 255.

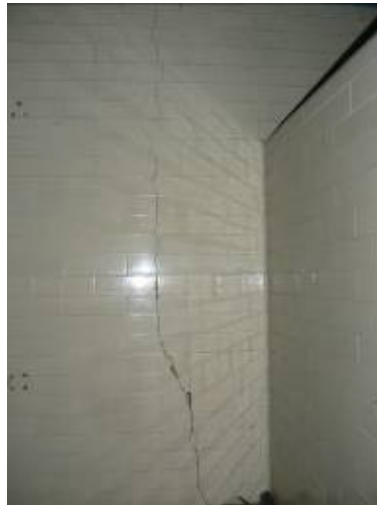
Photograph No. 257

Room UG 7 – On the western wall there is a vertical crack, as shown on photograph No. 257.

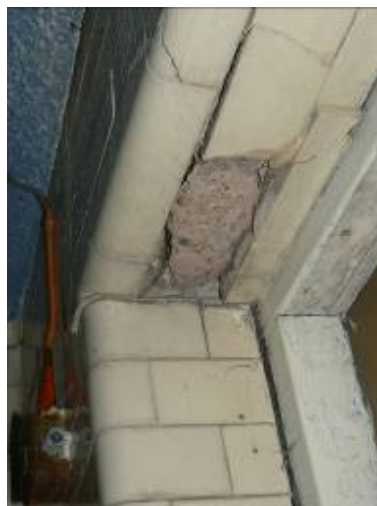
Photograph No. 258

Room UG8 – This is a toilet area and in the main section, it can be seen that to window WU10, the tile is coming away on the soffit, on the underside of the lintol and the concrete is spalling behind, as shown on photograph No. 258.

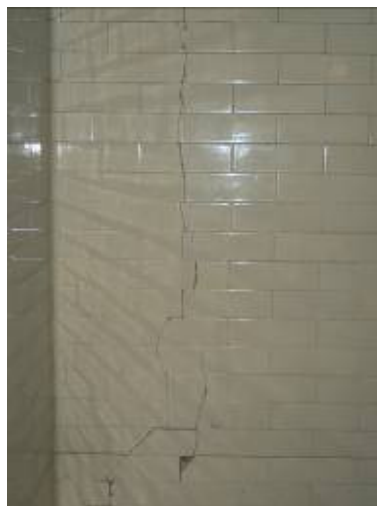
Photograph No. 260

Room UG10 – This has a central vertical crack in the wall, as shown on photograph No. 260.

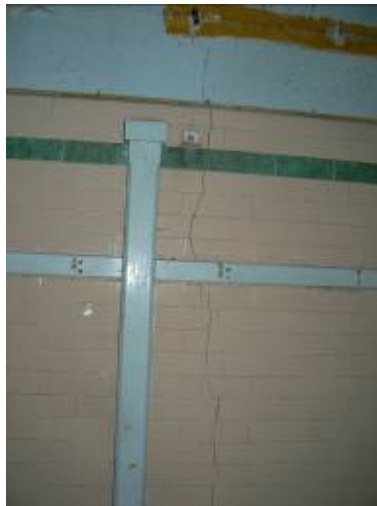
Photograph No. 280

On the western wall, the finishes have been affected by the damp ingress coming in which is generally at flashing positions above. There is one vertical crack towards the northern side, as shown on photograph No. 280. However, this is not considered to be structurally serious.

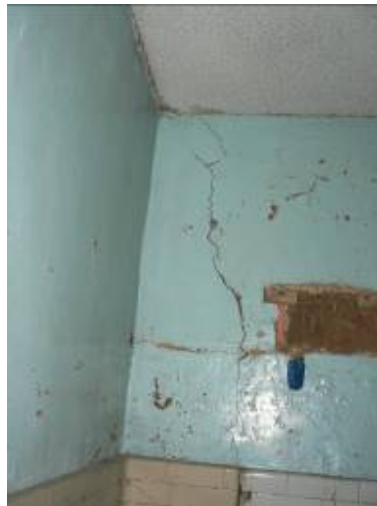
Photograph No. 282

On the eastern wall there were previously W.C.'s, and there is slight cracking on the northern part of the eastern wall, as shown on photograph No. 282.

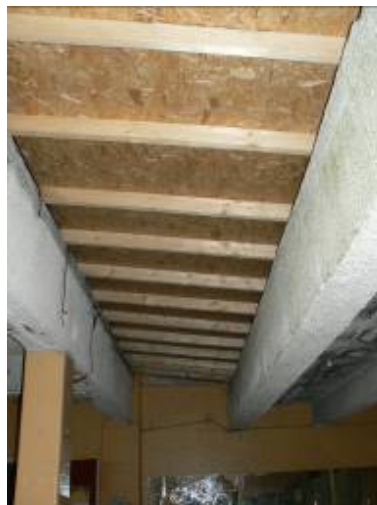
Photograph No. 288

Between G14 and G15, there is a small mono pitched area which again has softwood joists and chipboard over, as shown on photograph No. 288, and this seems to be working satisfactorily.

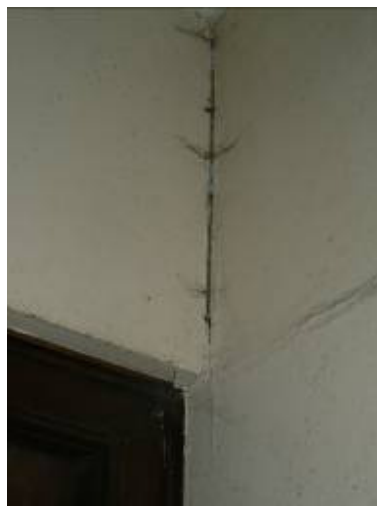
Photograph No. 291

Room G20 – This is the front entrance lobby which has slight streaking on the southern wall and this again is indicative of water ingress. There is also a slight split at the south wall to east wall junction, as shown on photograph No. 291.

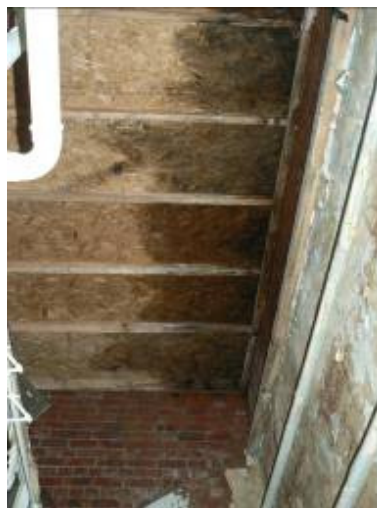
Photograph No. 298

Room G28 – This originally had a glazed lantern over the top which has been removed and softwood joists and chipboard with felt put in instead, as shown on photograph No. 298.

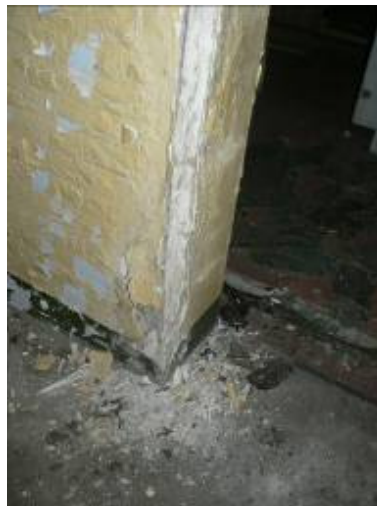
Photograph No. 309

To the doorway leading through to G42, this is quite badly damaged to the reveal, as shown on photograph No. 309.

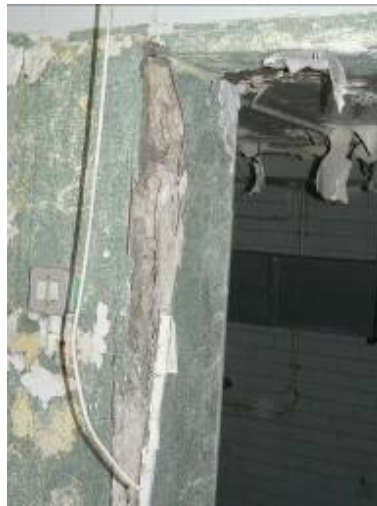
Photograph No. 316

On the first part of the northern wall, the western side is saturated. However, there was no significant cracking. Around the first truss bearing there has been previous water ingress, but there was no sign of any failure to the truss. The doorway leading down into G48, the plaster has come away from the wall, as shown on photograph No. 316. There are also a lot of salts washed through from the leaking valley above.

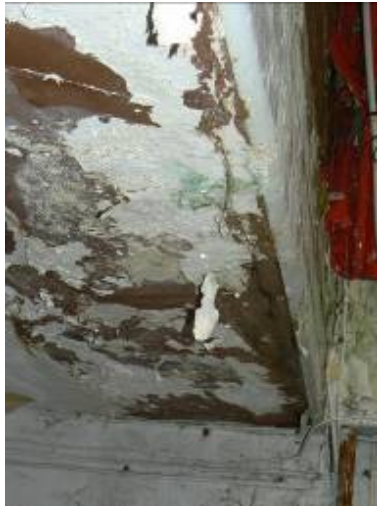
Photograph No. 317

The remainder of the room showed no major damage, apart from a loss of decoration. However, the concern is in the north-east corner where water is ingressing and the plaster around the beams is starting to show signs of cracking, as shown on photograph No. 317.

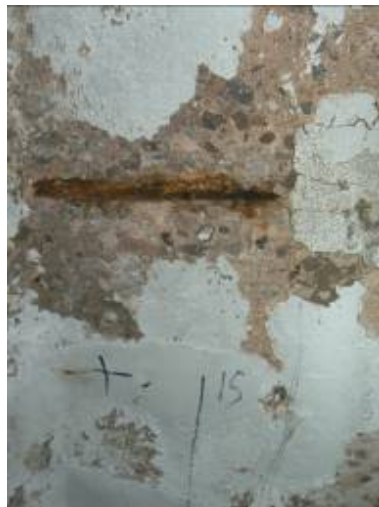
Photograph No. 339

Generally, this is in a similar condition to the northern side in that there are localised areas of exposed concrete to both the ceiling and the pool wall, and this is typically shown on photographs numbered 339 and 340.

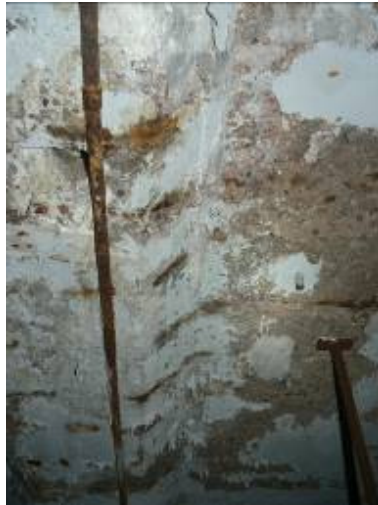
Photograph No. 341

At the downstand for the drainage channel, there is again nominal cover to the reinforcement steel and there is a large amount now exposed, as shown on photograph No. 341.

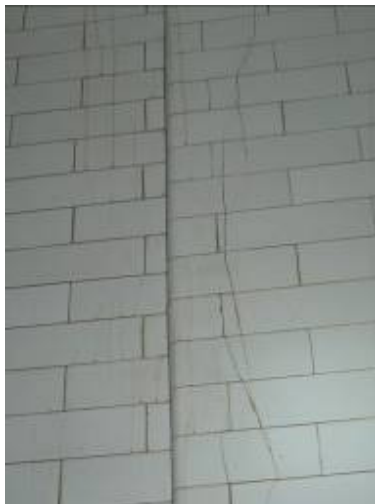
Photograph No. 380

On the eastern wall there is a slight crack down the edge of the column and this is to the main pool supporting structure, as shown on photograph No. 380.
