Black Country Blue Network

Summative Evaluation

Report to Wolverhampton City Council

March 2019

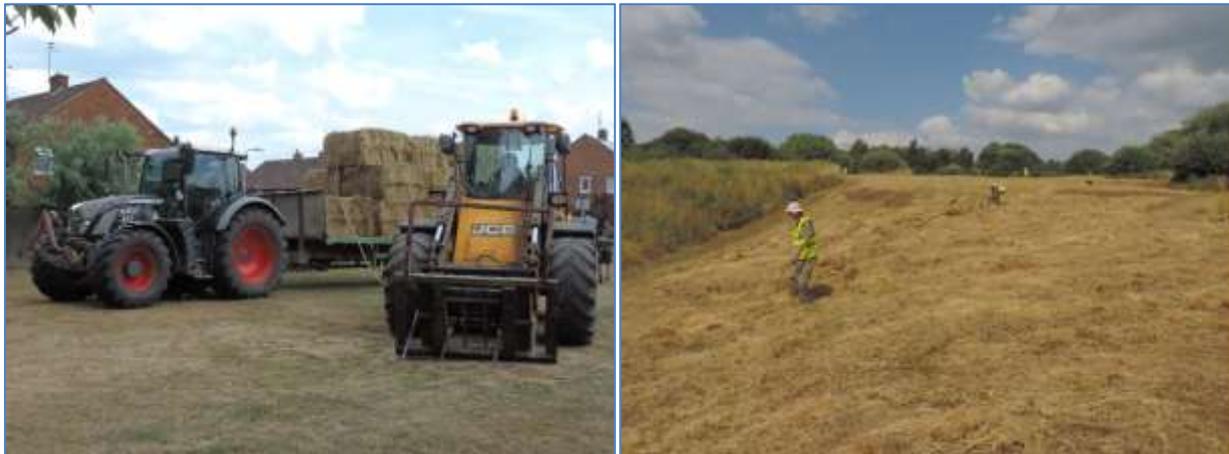
The work undertaken at Smestow Valley commenced with meadow creation, undertaken in July 2018, with some works to improve pedestrian access along and to the disused railway line. Hay was collected from meadows at Castle Vale, Birmingham, which had in turn been created by strewing hay from Eades Meadow National Nature Reserve and other sites in south of the Black Country. We were able to inspect the hay and it contained a large seed-load of species such as sweet vernal grass, black knapweed and hay rattle. The hay was cut and baled on one day and delivered the following day when it was immediately spread by team of individuals, largely volunteers from the Wildlife Trust.

Figure 4 Delivery of freshly cut hay in 'super bales' (L) and volunteers spreading the hay at Smestow Valley (R)

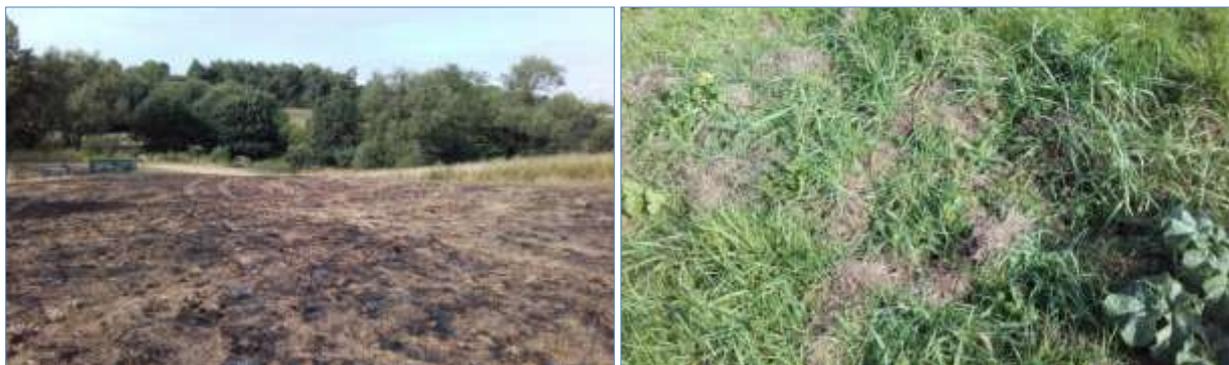
Figure 5 Burnt hay-strewn area(L) and recovering sward (R)

Due to the prolonged drought and high summer temperatures the hay strewn meadow creation material became highly combustible. Unfortunately, some of the meadows were deliberately set on fire. The rapid response of the fire service and local volunteers ensured that the fires were confined just to the hay strewn meadow areas and did not go deep into the soils beneath. As a consequence of the reduction in competition this has enabled the meadow sward to rejuvenate such that by mid-October an approximately 80% coverage had been achieved.

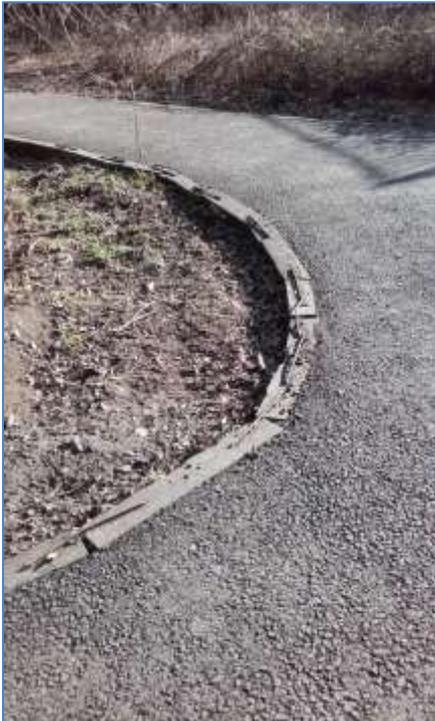
Figure 6 Detail of path construction.

On the western side of the site, from the disused railway across to Castlecroft Primary School and Windmill Crescent new path works are currently being implemented. The southern section is characterized by a heavy-duty sleeper and stone path, comprised of reclaimed Azobe sleepers. These are very durable, high quality timbers that are in keeping with this rural setting. The northern section is a lighter duty stoned path with timber edging. This was less advanced than the sleeper path and had in places had its edging pushed over. But this should not be a problem in the future once the paths have been stoned up and the soft landscape reinstated to the sides.

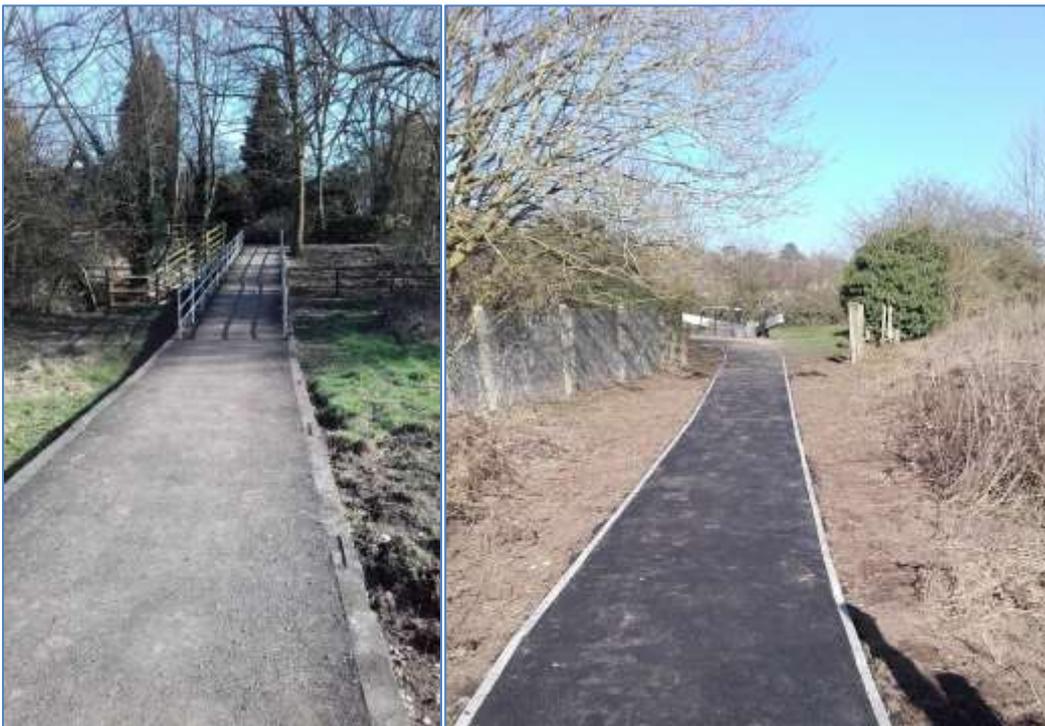
Figure 7 Upgraded paths

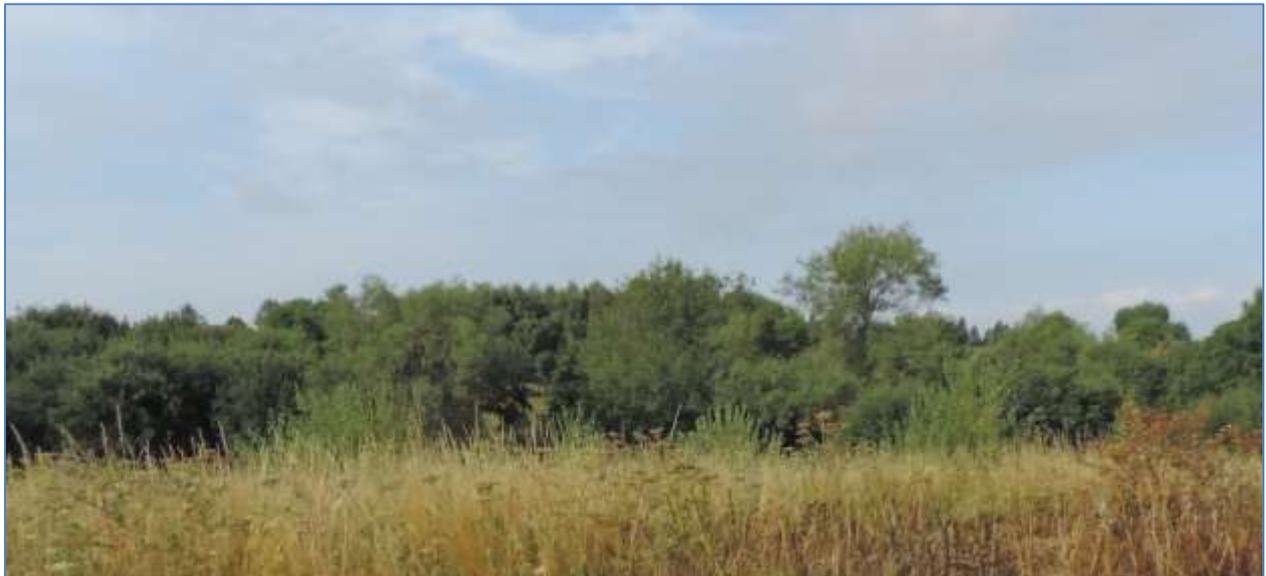
The other element of improving the status of habitats at Smestow Valley is ground flora enhancement of approximately 2.5 hectares of woodland to the north-west of the meadow areas. The planting has now been completed.

Figure 8 - A view of the woodland planned for ground flora enhancement from one of the meadows

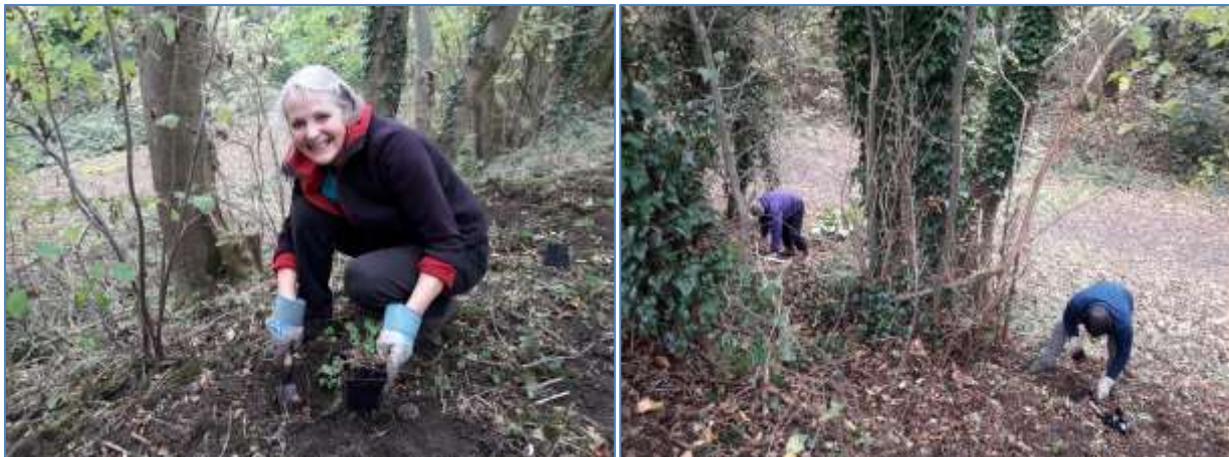
Figure 9 - Volunteers planting wildflowers in the woodland

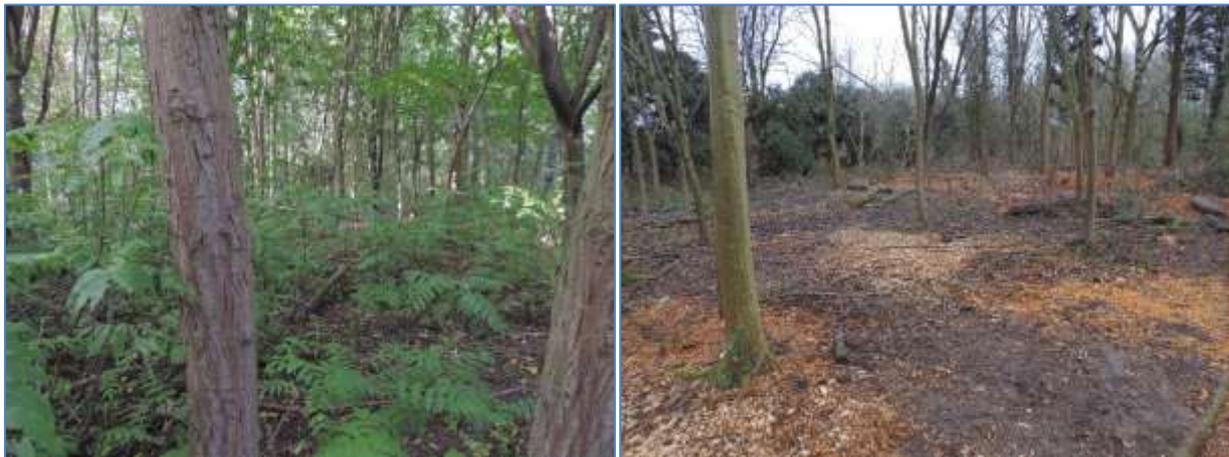
Figure 10 - WEC woodland before and after thinning, note extensive *Rhus typhina*

The woodland at the WEC is a combination of planted native woodland and areas used as tree nursery/storage areas that were subsequently left unmanaged and have developed into woodland. Some of these areas, particularly the woodland on the slopes at the southernmost end of the site were very overcrowded and in need of thinning. The area was also densely colonised by the North American species *Rhus typhina* which suckers vigorously. This southern area has been heavily, but sensitively thinned and the *Rhus* controlled. this should bring numerous benefits in terms of improving the structural diversity of the woodland and allowing more light to reach the woodland floor. This should bring benefits in terms of both woodland flora and fauna. This has also made the woodlands considerably more attractive to visitors and paths have been created through the area (see later). Planting of appropriate native species is planned and will be carried out before the end of March.

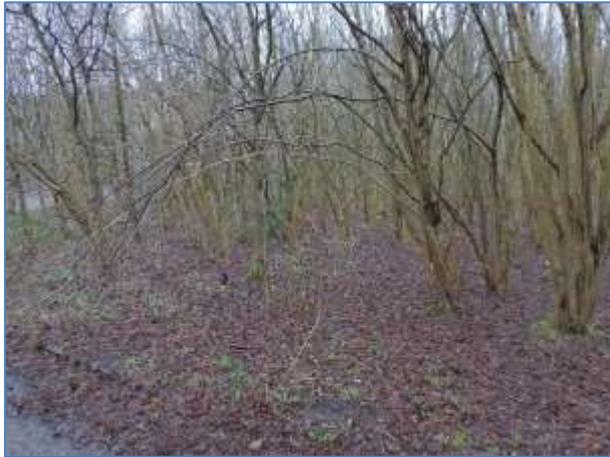
Less intensive management is being undertaken on the woodland in the northern part of the WEC, including some selective coppicing. This will take place in March, the stools have already been marked with blue paint.

Figure 11 - previously coppiced stools marked up for recoppicing

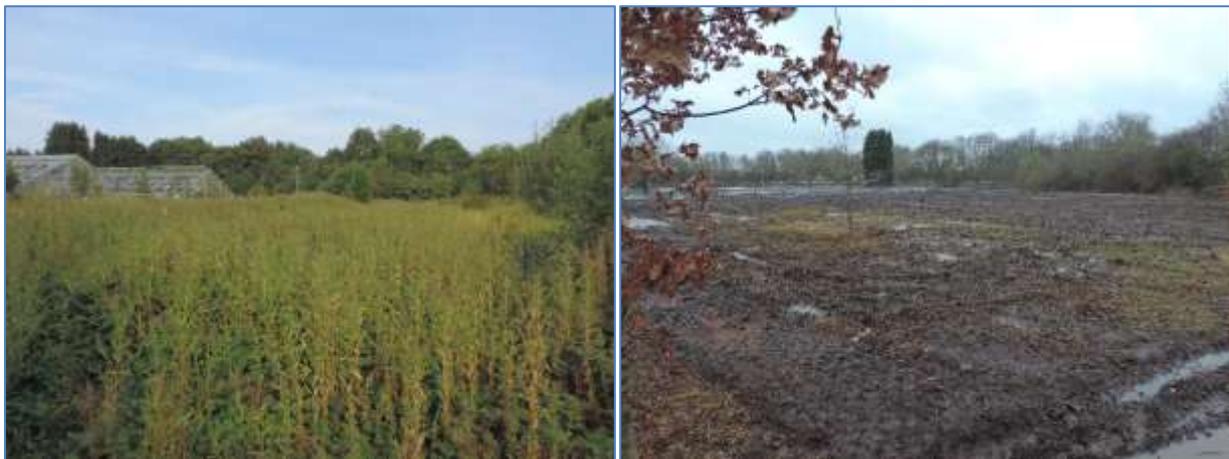
Figure 12 - Tall herb area north of compound was completely covered by tall herb and the uneven ground has been remodelled.

Across the WEC were several areas of rough grassland and tall herb. Some of these areas were very uneven and have been completely cleared and levelled ahead of reseeded, Figure 12.

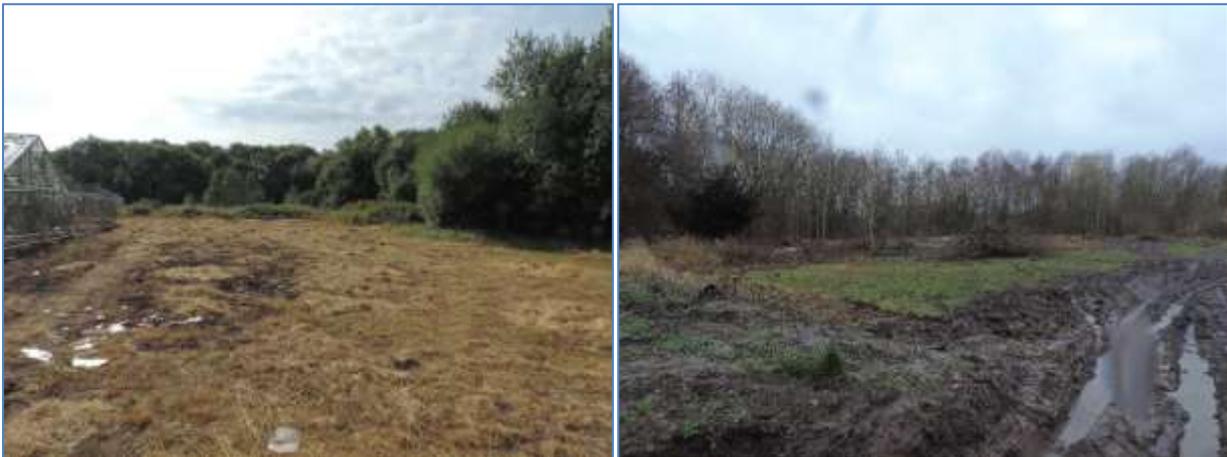
Figure 13 - The same two areas as in the previous figure. The tall herb and uneven ground have been completely cleared (left) but the rough grassland has been largely retained.

The area in Figure 13 was cut and cleared in summer 2018, although a small part of the area was burnt later. Although much of this area has been retained, the removal of the banks (in the background of the first image and in the foreground of the second) and the need to take machinery across the ground in wet conditions means that part of it now needs to be regraded and reseeded.

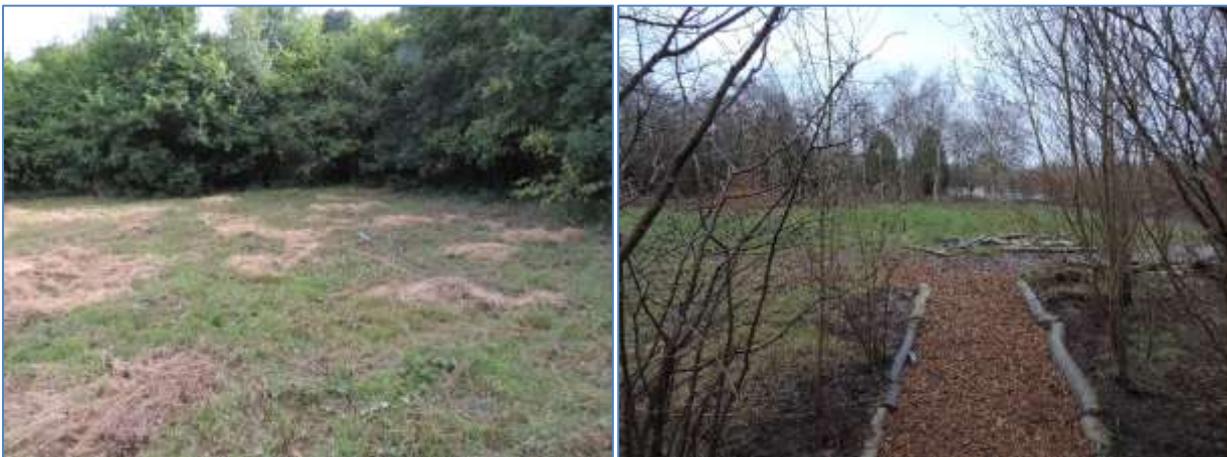
Figure 14 - Grassland area managed by mowing in summer 2018, still intact (middle distance) in 2019

In contrast, the grassland area in Figure 14 was cut and cleared in summer 2018 and remains in good condition.

The work being carried out in very wet conditions has clearly not helped in maximising the amount of existing grassland retained, however if more consideration had been given to marking out access routes before moving machinery across the site it is likely that the need for extensive reseeding/regrading could have been reduced, speeding recovery of the habitats.

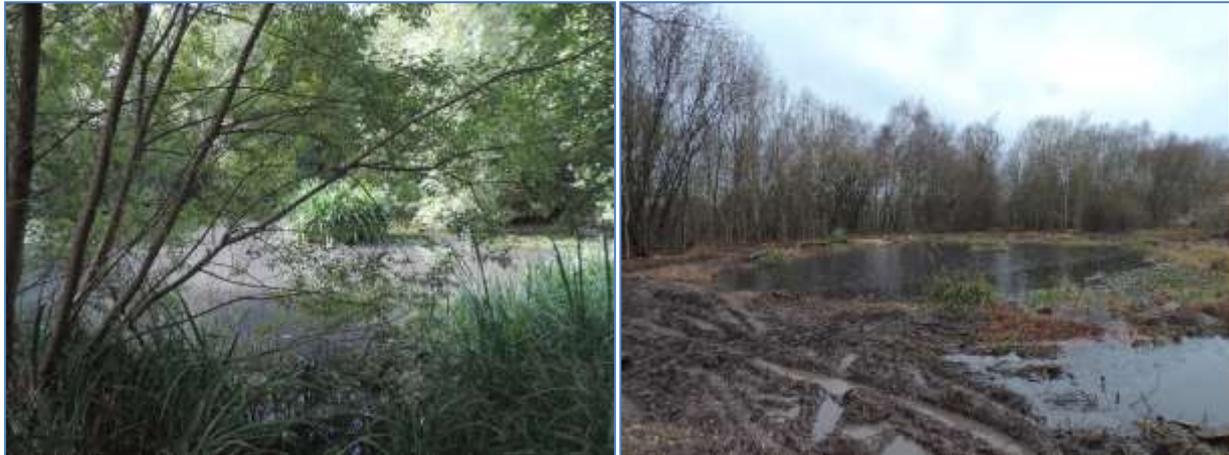
Figure 15 - the pond before and after removal of surrounding trees and shrubs

A significant pond, measured at over three metres deep, lies in the southern part of the site between the woodland and grassland areas. The pond had become so overgrown that its true extent was not apparent. The pond has been completely opened up and the surrounding areas are to be restored as grassland. A small area of boardwalk remains to be installed.

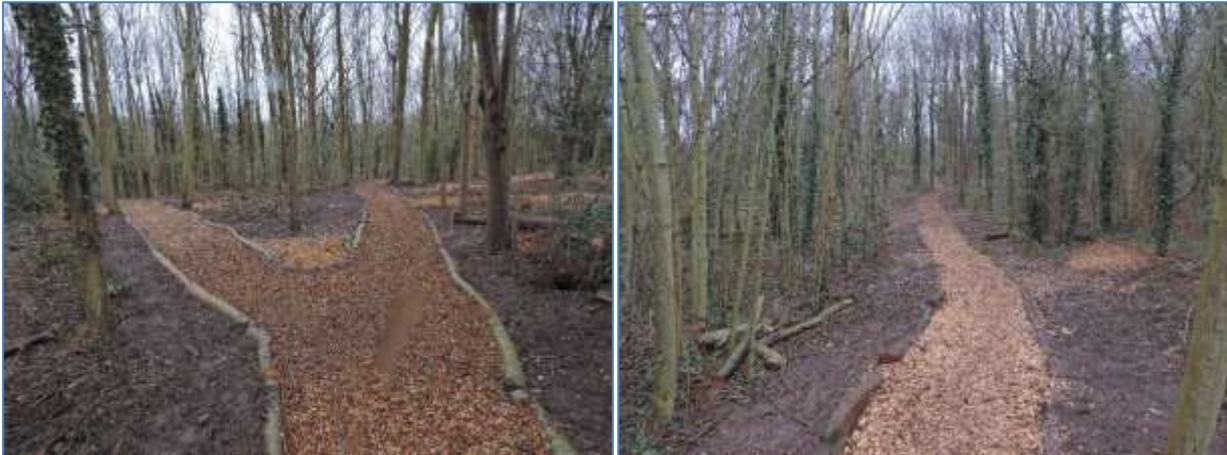
The new paths have been made using timber cut during the thinning works and surfaced using woodchip made from the brash. The paths look attractive but may not be particularly durable, especially as there has not been any permeable membrane used under the chip. This means that the paths are likely to require topping up with more woodchip from time to time.

Figure 16 - new paths within the woodland areas

- New woodchip paths – monitor to see whether some of the loose logs are removed; the loose chippings may get kicked out; if they do or they sag down in situ then it may be necessary to top them up.

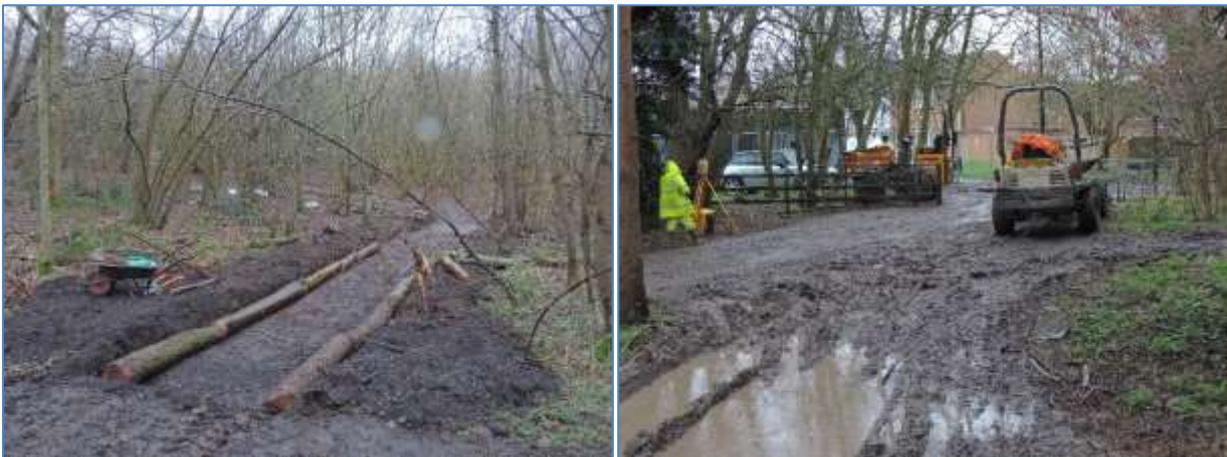
Figure 17 - work in progress to create new access from the disused railway line

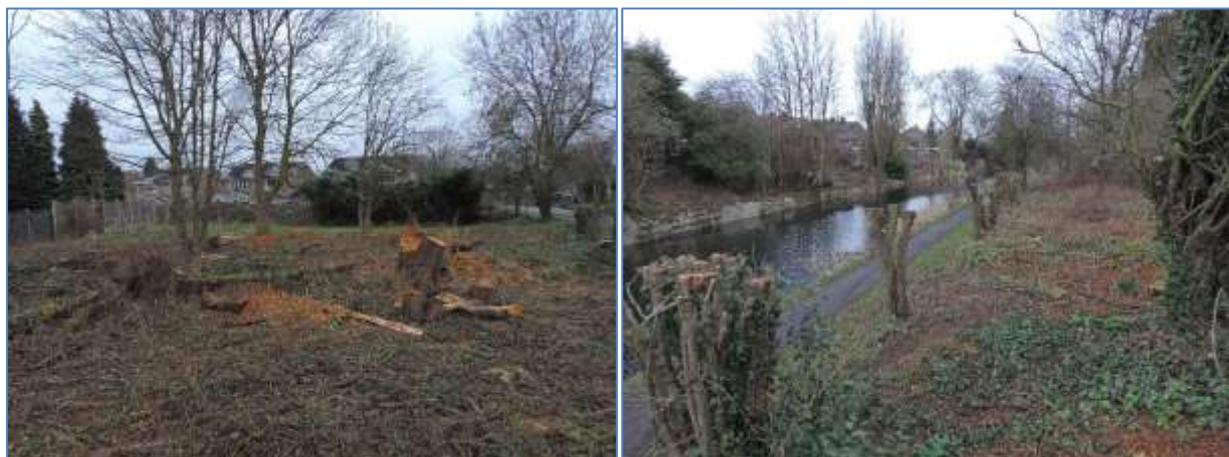
The open space area will be planted with native wildflowers and bulbs. The woodland has been heavily thinned and the overgrown hawthorns, which possibly mark an old boundary hedge, have been pollarded. A great deal of rubbish has been removed from these areas.

Figure 21 - woodland thinning(left) and pollarded hawthorns

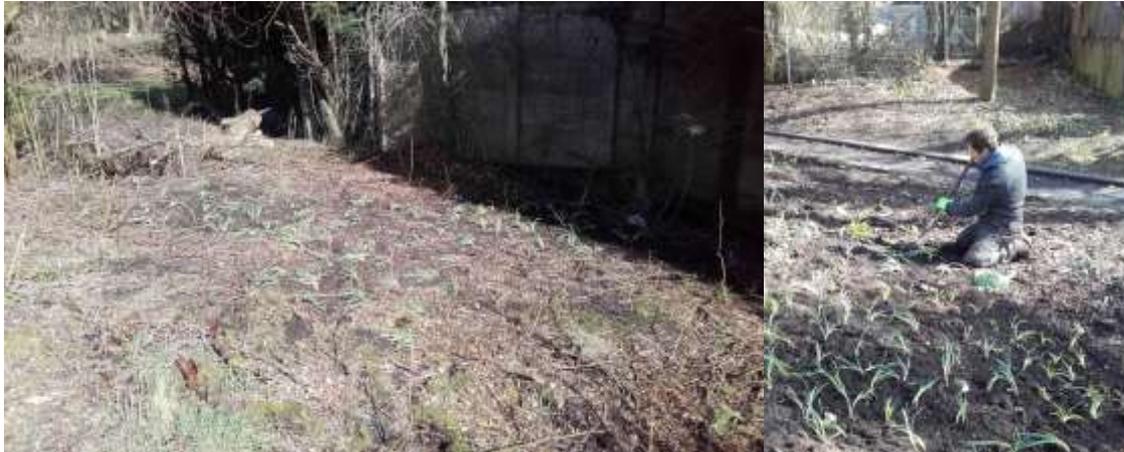
Underplanting with native trees and fruit trees and wildflower introduction, with several thousand wildflower bulbs is taking place during March. This should significantly improve the structure of the

Figure 22 – wild daffodil planting (left) and planting in progress

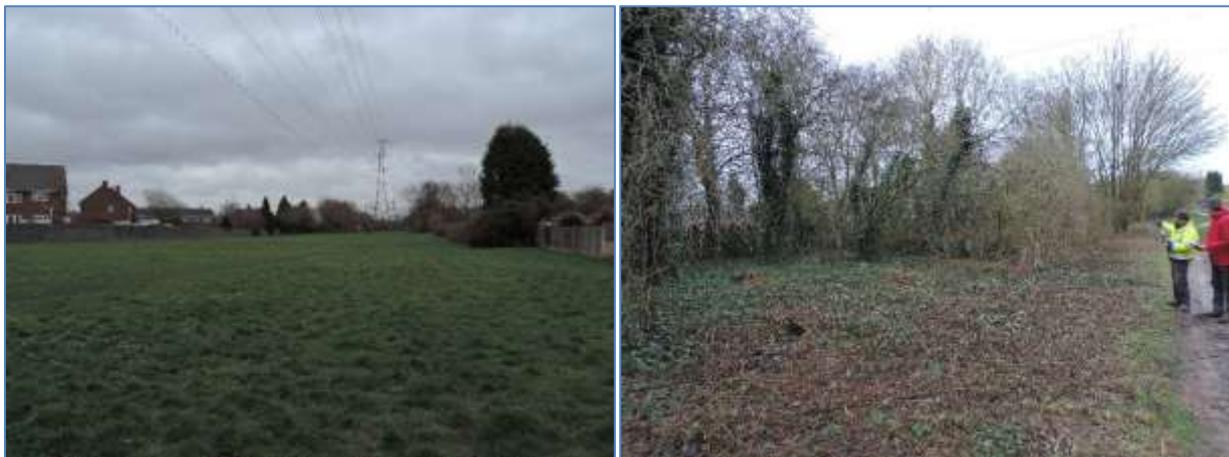
Currently this area is managed as gang-mown amenity grassland although its size and location make it of little value for sports and recreation. Some traditional fruit tree species will be planted together with native bulbs. Restoration as a wildflower rich meadow area will bring local ecological benefits whilst also creating an important ‘gateway’ into the proposed Local Nature Reserve. In addition some woodland management and enhancements is in progress adjacent to the canal.

Figure 23 - Olinthus Avenue: open space for orchard planting and meadow creation (left) and woodland management near canal

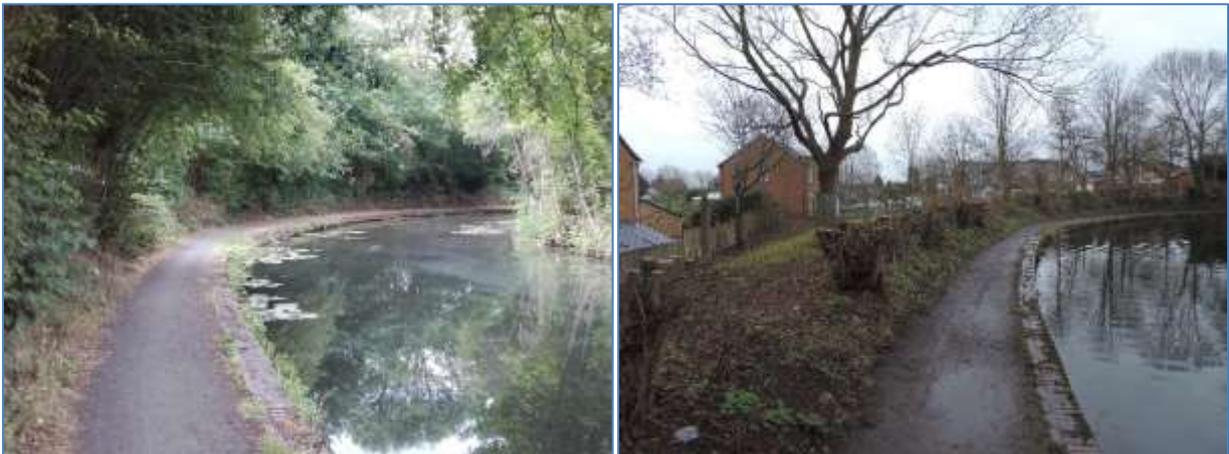
Originally it was planned to convert an adjacent area of amenity grassland to meadow with a footpath link to the canal, however the link was unpopular with nearby residents and was omitted. A reduced proposal has seen the overgrown hedge cut back to be followed by underplanting with wildflowers and bulbs. The northern half of the open space is to be scarified and seeded with an appropriate wildflower meadow mix.

Figure 24 - The hedgerow at Bluebell Crescent before and after management works

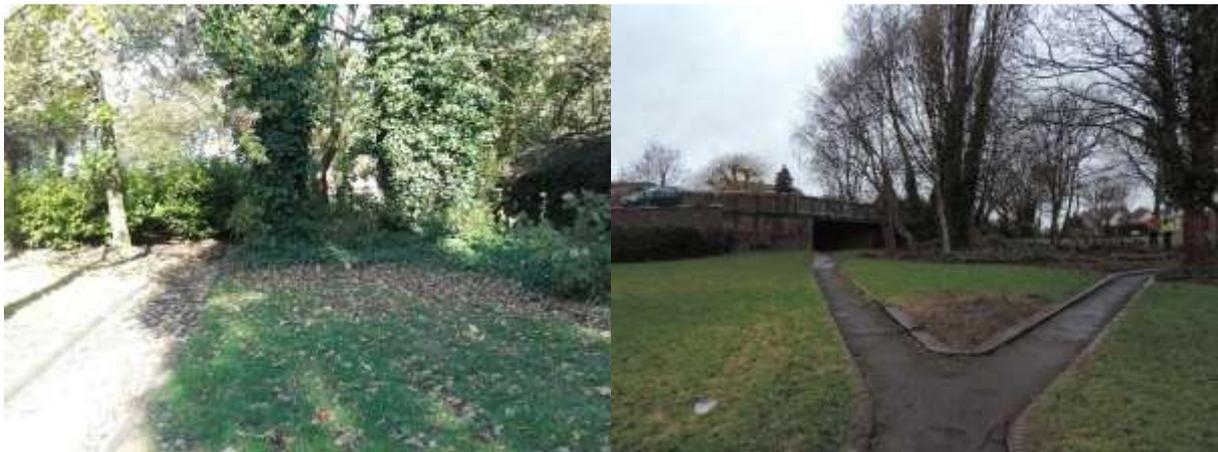
This area currently comprises a small area of tree planting and amenity grassland near the edge of Wednesfield town centre. Tree works and the establishment of a small area of wildflower meadow is will provide another attractive 'gateway' into the LNR. Trees and shrubs have been removed to open up the canal landscape setting and make it more user-friendly; new works include some native hedge planting, fruit trees, bulbs, as well as the meadow.

Figure 25 - Area 9 before and after the removal of a diseased tree and works to open up the area for bulb planting

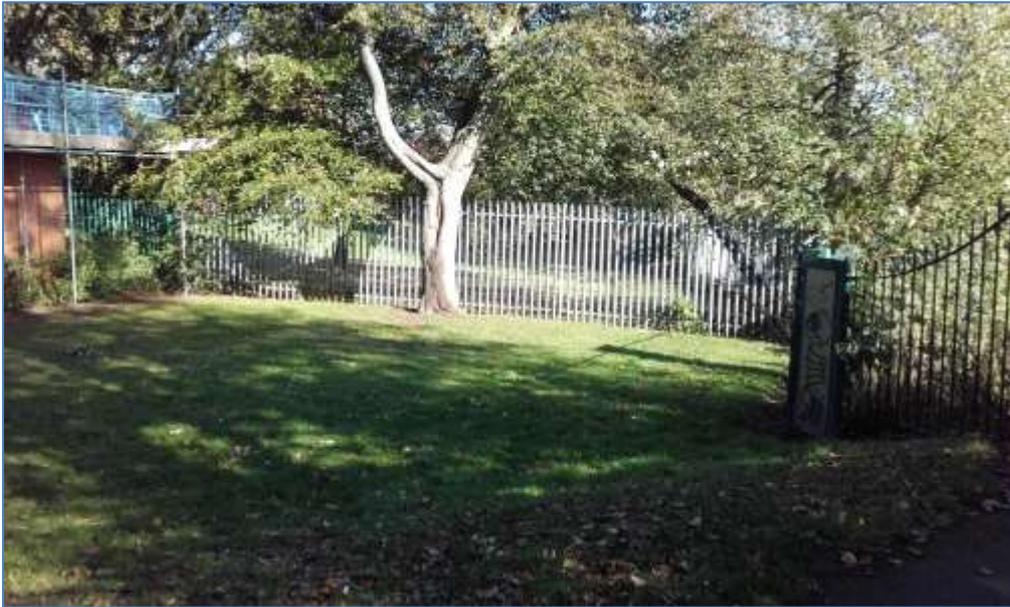
This is a relatively small area accessed via a footbridge crossing the canal and linking the park with Wednesfield town centre. It was proposed to undertake meadow restoration on relatively small areas of poor amenity grassland somewhat isolated from the main part of the park. Part of this area was too heavily shaded for successful meadow establishment and instead has been selected for native tree and hedgerow planting, meadow creation, and bulb planting with woodland ground flora.

Figure 26 - Part of the land within Wednesbury Park to be developed as wildflower meadow.

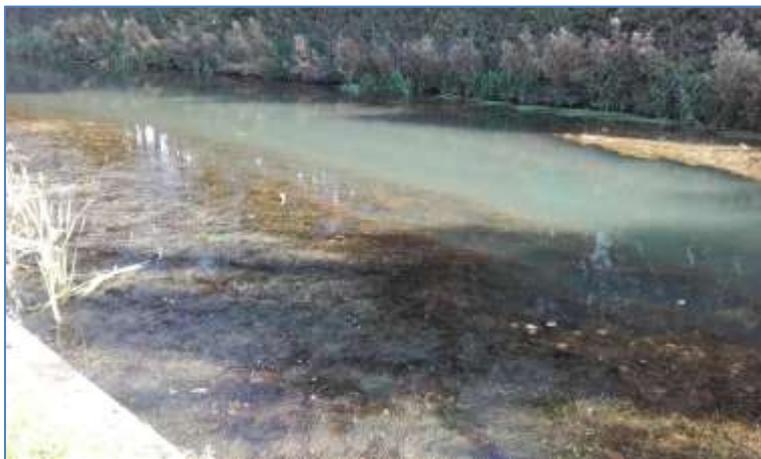
The Canal and River Trust's ecologist had identified that increasing the water depth accompanied by marginal habitat improvements could greatly increase the value of this stretch of canal, notably for water voles as well as aquatic and terrestrial invertebrates, fish and water plants. At present the depth of the canal is sufficient for navigation (1.3 to 1.4m) and there is a relatively low level of boat movement, which means dredging is not an operational priority and would not be carried out without the support of the project. However, in many places the navigable channel is relatively narrow and much of the canal is shallow and clogged with vegetation.

Figure 27 - South western end of canal after raking out of the central section but before dredging

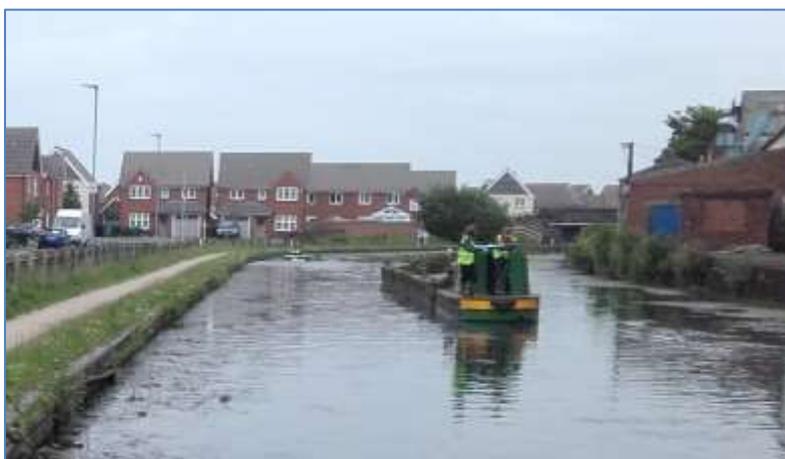
In order to control invasive aquatic weed species and aid boat navigation the central channel was raked clear by the Canal & River Trust. This operation was successful in June 2018, and the central channel has remained clear through to October when it was last inspected.

Figure 28 - Raking and collecting in progress

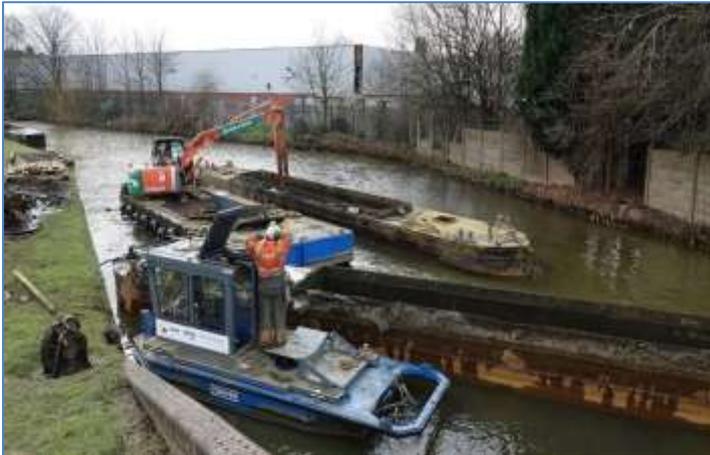
The dredging and marginal planting works, together with the erection of the ERDF signage took place in December/January 2019.

Figure 29 - Dredging in progress.

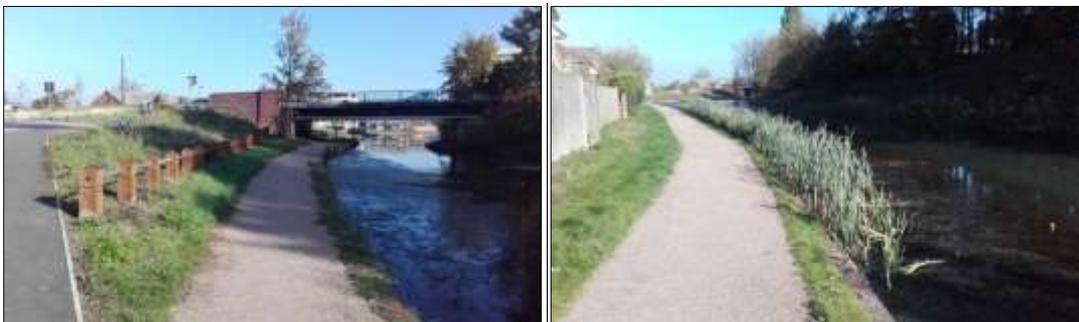
Figure 31 Gravel dressed towpath surfacing (May 2018)

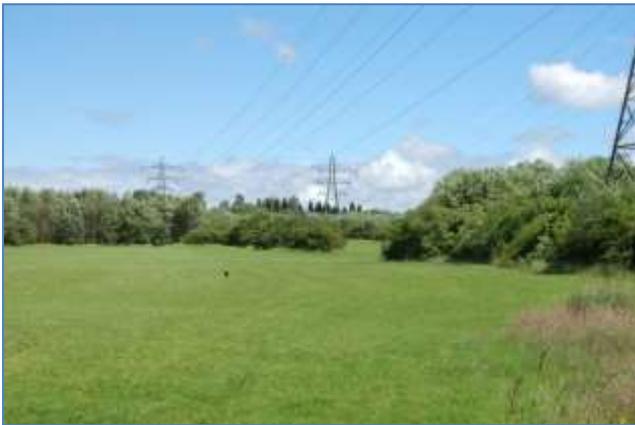
Figure 32 Cavendish Road Area 12 - gang mown amenity grassland in 2016

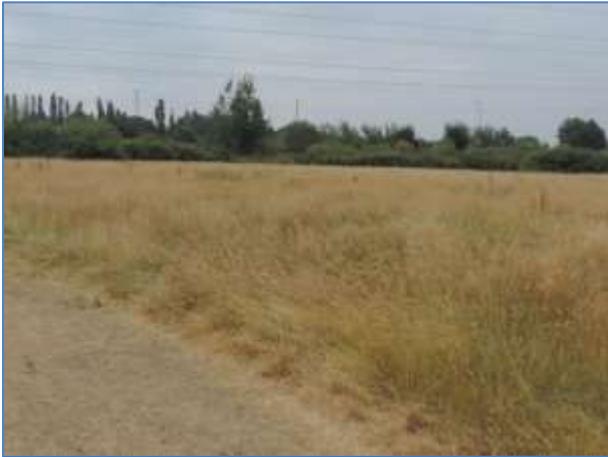
Figure 34 When visited on 12 July 2018 the drought meant most of the meadows had already gone to seed.

This less spectacular show of wildflowers in 2018 may be because of several reasons:

- The extreme dry, hot weather is likely to be the chief cause, further exacerbated by a number of local fires which affected relatively small areas around the periphery of the meadow where flowers would have been most visible to visitors.
- Some species (such as Bee Orchids) usually die after flowering, and it may be a number of years before the next generation becomes evident.
- There were issues with clearing the grass growth from the meadow in 2017. This could suppress meadow flora almost as much as excessive mowing.

None of these should be seen as a cause for concern, provided that the new cut and remove regime fully implemented in 2018 is sustained. This is essential in order to realise the greatest benefit from the new management regime.

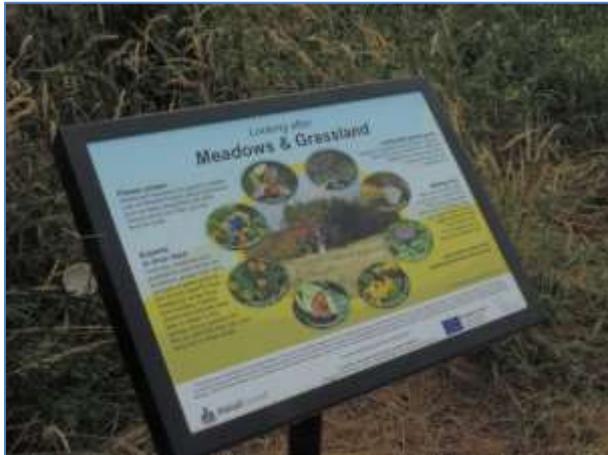
Figure 36 Interpretation sign for meadow management

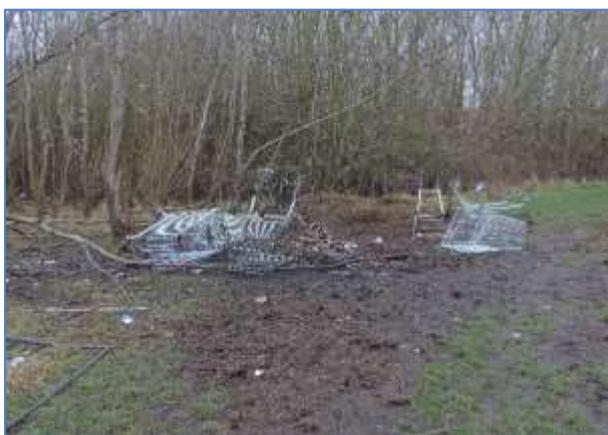
When visited in February 2019 the Cavendish Road and Reedswood Lane Entrance meadow areas remain much as they had when previously visited. It was too early to see or determine whether the floristic diversity has been increased as a result of the amended land management regime, but this can only be accurately assessed later in the growing season. A number of shopping trolleys had been abandoned on the edge of the meadow area. These have been reported internally to the council so they can be removed by the fly tipping team.

Figure 37 - abandoned shopping trolleys

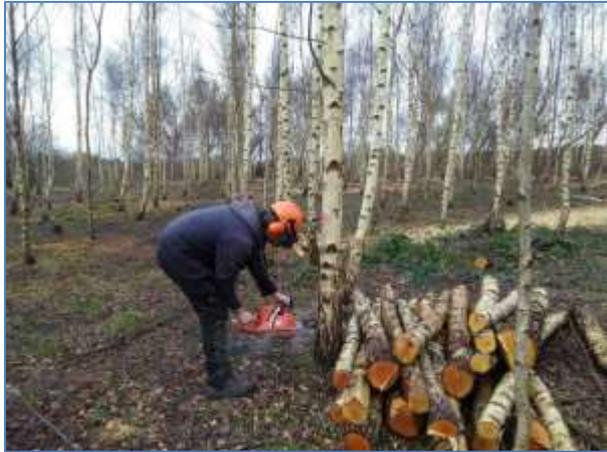
The woodland area being improved as part of the project is one of the many new areas of woodland established around the turn of the Millennium as part of the Black Country Urban Forest (BCUF). Some twenty years after planting, the trees were approaching maturity and the site had the appearance of established woodland. In common with many of the BCUF sites the woodland was in urgent need of thinning to reduce crowding of the trees and new glades and coppice coupes were created to increase the amount of light reaching the ground layer and increase structural diversity. There was also an

opportunity to plant additional understorey species to further improve the structural diversity of the woodland. Essentially such work will help the woodland in transitioning to a more natural and varied structure, which should bring benefits for its biodiversity by increasing the range of micro-habitats present.

Figure 38 Woodland glade creation in winter 2017

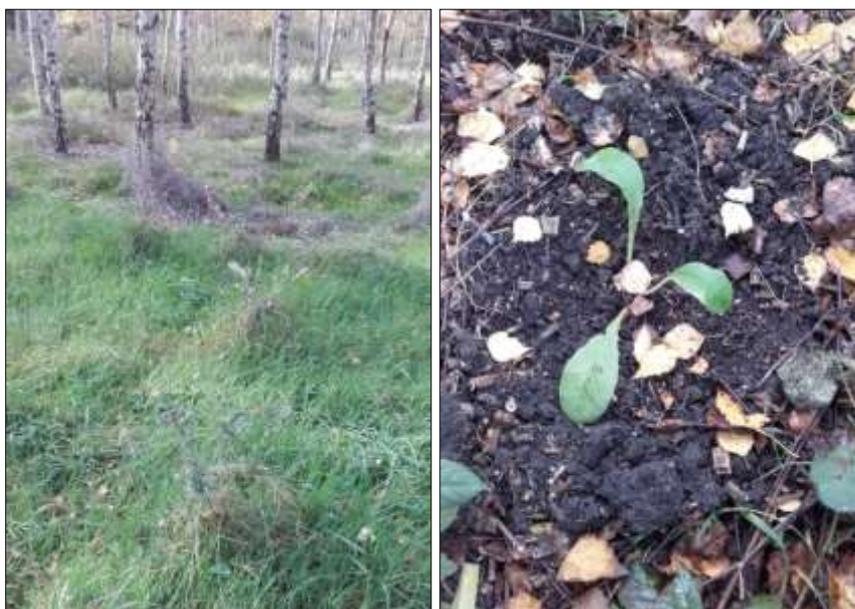
The large birch plantation area within the park continues to develop well. The thinned birch trees have allowed light to reach the woodland floor such that the native tree and shrub planting stations are generally developing well. The increase in light has however meant that the grassland areas have also grown rapidly such that in places they are effectively competing for nutrients and water. Whilst the native planting has survived, this competition for resources may have reduced their growth rates. Future management should monitor this situation and cut back the grass during the next growing season or consider replacing it with bark mulch. In some locations sycamore and maple natural regeneration was also in evidence. Although currently small it would be recommended that these be removed in due course before they start to out-compete the native planting. The coppiced hazels have rapidly re-grown from their bases to form multi-stemmed rich green foliage. During October primrose plug planting has been implemented on the woodland edges which should provide visual and ecological interest next spring.

Figure 39 Saplings suppressed by rank grass (L) and Primrose planting in October 2018 (R)

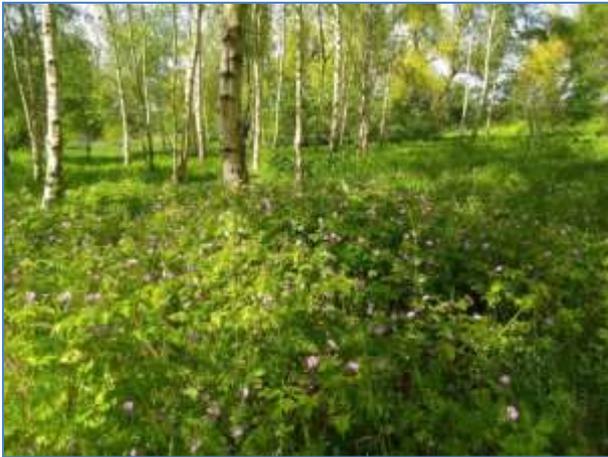
Work was carried out on three neighbouring areas of planting, divided by two broad 'rides' and surrounded by a circular path/ride inside a boundary hedge which has effectively overgrown to become a further component of the woodland. It is immediately apparent that the management work carried out has considerably opened up the woodland, although as no major clear felling was involved there has been no significant impact on the landscape value of the woodland.

Figure 40 Flush of spring flowers following thinning of the birch plantation

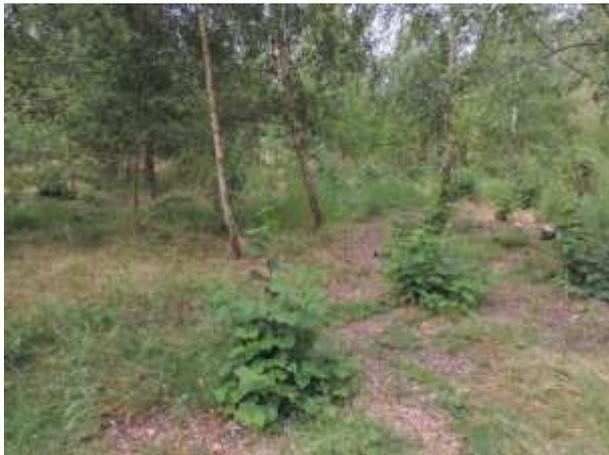
Figure 41 Healthy regrowth of coppiced hazel.

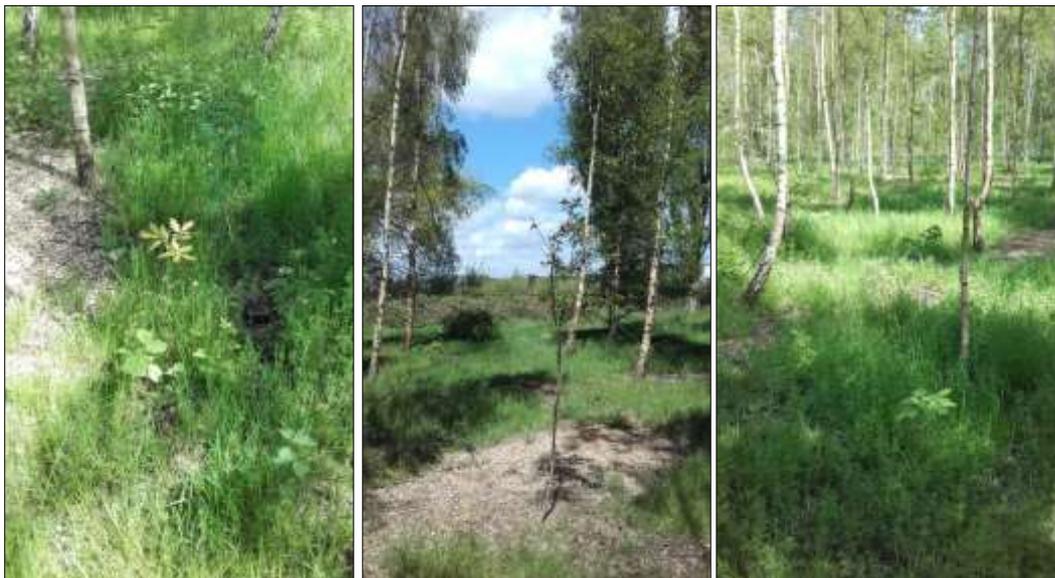
Figure 42 Thinned birch plantation with new tree sapling and understorey planting (May 2018)

Felling of birch trees to open up the canopy had been done sensitively; felling technique good with well-cut low stumps together with stump treatment to prevent re-growth; uncertain whether some of the understorey tree and shrub vegetation is natural regeneration or has been planted due to random pattern, closeness of some of the plants, and the presence of non-native species e.g. horse chestnut. No vandalism; visually the area looks light and welcoming, more natural, with low-key young planting standing a good chance of establishing to maturity.

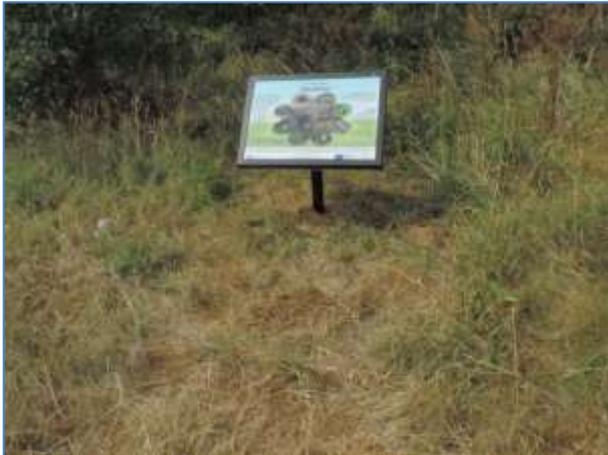
Figure 43 Signage for woodland management in a recently created glade

Visitors seemed to be less aware of these habitat works, presumably as the woodland is not one of the busiest parts of the park. The signage present around the woodland area was well positioned and should help encourage more visitors in future.

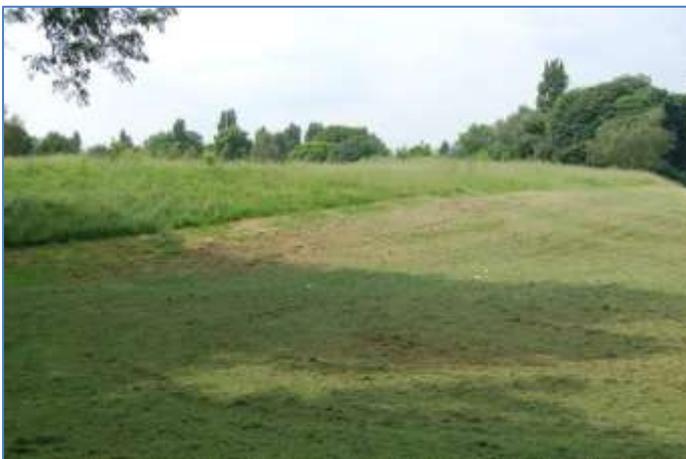
One conservation priority for Walsall is to increase the amount of heathland within the borough, following major loss of this habitat over the 19th and 20th centuries. A raised area of spoil of apparently low fertility in Reedswood Park was identified as a potential heathland creation area.

Figure 44 Before heathland creation works

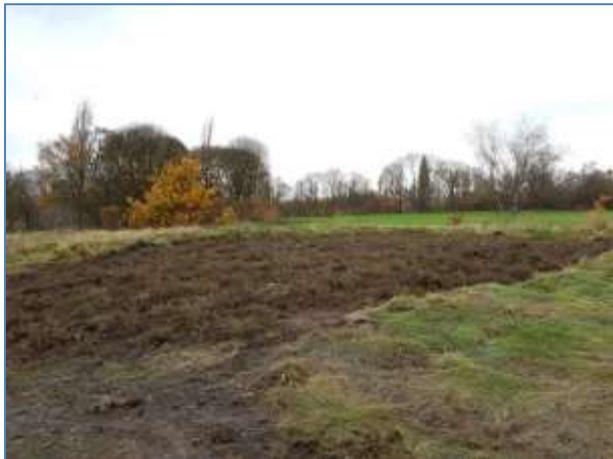
Topsoil stripping and strewing of cut heather was undertaken in the winter of 2017, with three irregular patches being covered in freshly-cropped heather to a depth of about 10cm.

Figure 45 Immediately after spreading of heather

Site preparation appeared good; heather/heathland brash strewing evenly spread; quality of brash appeared satisfactory; no vandalism. On visiting the site in the summer of 2018, it was apparent that although a reasonable amount of the heather remained on site, there were no signs of heather regeneration and minimal signs of the establishment of other species.

By July the heathland creation areas remain in evidence. During the drought it was observed that some of the area and adjacent scrub were deliberately set on fire, and whilst some of the shrubs have been killed, the heathland brash appears to have largely survived. In amongst the numerous plantains, docks, and thistles there was the occasional ox-eye daisy and red campion in evidence. No heathland species seem to have come through as of October 2018.

As of February 2019, no further burning has taken place. The two plots have changed little over the winter period as one might expect. The brash remains visible together with extensive areas of bare ground so if there is viable seed and the ground conditions are suitable then new seedlings should hopefully begin to establish this spring. Where young vegetation is coming through it contains typical pioneer species such as thistle, plantains, coarse grasses and the like. These will need to be monitored to ensure that they do not become over-dominant and swamp the heather and heathland species. If necessary, hand weeding or spot spraying may be required over the coming growing season. If insufficient quantities of heather and heathland species establish then consideration should be given to over-seeding or additional hay strewing

The failed attempt to establish heathland at Reedswood Park illustrates the value of simple soil testing in situations where there may be a question of the suitability of an area for establishment of new habitats.

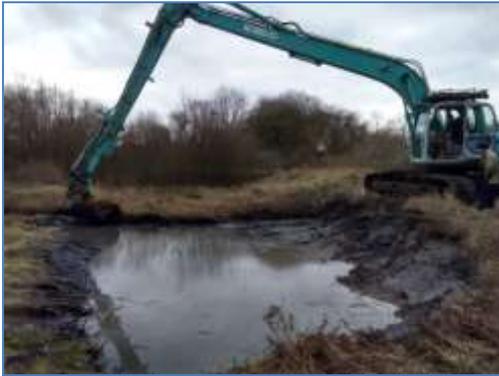
The Victory Pools comprise a fairly large pool at the western end of the park, and a smaller network of three linked pools. Prior to the project the pools were badly overgrown by reedmace and other species with relatively little open water remaining. There were also issues with rubbish such as dumped shopping trolleys. All the pools were dredged over the winter 2017/18.

Figure 46 Dredging of Victory Pools

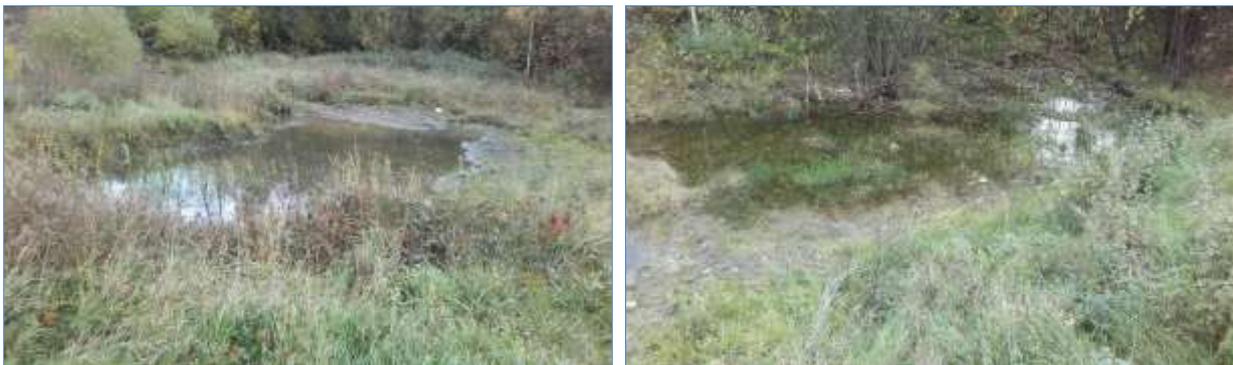
The western pool has been excavated effectively with a shelving bank profile, irregular, natural-looking bank outline and deeper water towards the centre, complete with a rocky 'island' that should enhance its ecological value; rough grassland and scrub habitats retained nearby provide good cover; excavated material spread appropriately around the pool periphery and part graded into the adjacent topography. The eastern 'natural' pools are much smaller and significantly shallower, which provides a slightly different habitat to the western pool. Whilst it was holding water in May 2018, due to its limited depth, this may have a tendency to dry out in the summer. No vandalism or fly-tipping was evident although at the eastern pond some vegetable waste had been tipped into it.

Figure 47 Eastern Victory Pools in October 2018

In mid-July 2018 the pools were visited, and it was clear that dredging had been effective in greatly increasing the extent of open water. Dredgings had been moved at least seven metres from the pools, and there does not seem to be any risk of them being washed back into the pools. Large numbers of common newts were observed in the smaller pools together with frogspawn and frog tadpoles. It was apparent that both pools had greatly benefited from the dredging work. It is unlikely that the smaller pools would have had sufficient water for amphibian breeding without the dredging work.
