Black Country Blue Network

Summative Evaluation

Report to Wolverhampton City Council

March 2019

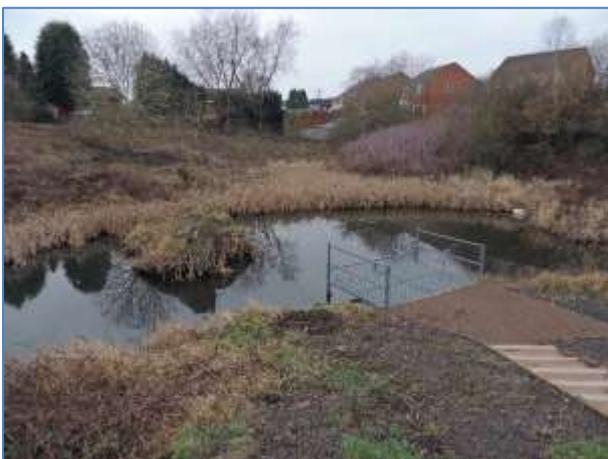
Figure 49 - new platform at Victory Pools

The only concern relating to this work is that the pools will inevitably be recolonised by aquatic/emergent vegetation and it will be beneficial for them to be monitored in the long term and further clearance

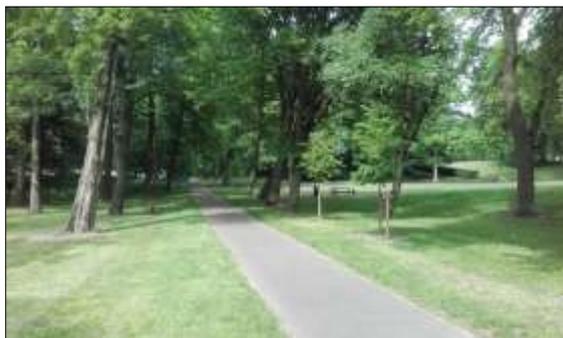
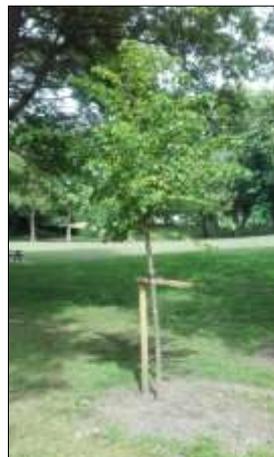
The ten lime trees (65 litre heavy standard *Tilia cordata* Winter Orange) appeared to be of good quality stock with straight leaders, clear stems, and well-developed crowns. No assessment could be made of their root systems, the tree pit preparation works, or how well the trees were planted although none of them appeared to be showing signs of stress. All had been double staked complete with cross bar and rubber tie. No air or irrigation tubes had been included, nor some kind of mulch around the base which may hinder their successful establishment. Whilst none of the trees had been vandalised some of the tree stakes had been removed and taken away, and some of the tree ties had been broken or removed completely. Given the location of this tree avenue, along one of the principal paths within the park, it would be recommended that the stakes and ties be replaced both to provide the necessary support to the tree and for their visual appeal.

Figure 50 Reedswood Park Avenue Tree Planting (May 2018)

In October 2018 the earlier unwanted removal of some of the tree stakes and damaged ties have all been rectified. Only one tree had a timber cross piece between two stakes that had been prized off the stake at one end (although still firmly attached at the other). If this could be resolved swiftly then that would demonstrate good stewardship.

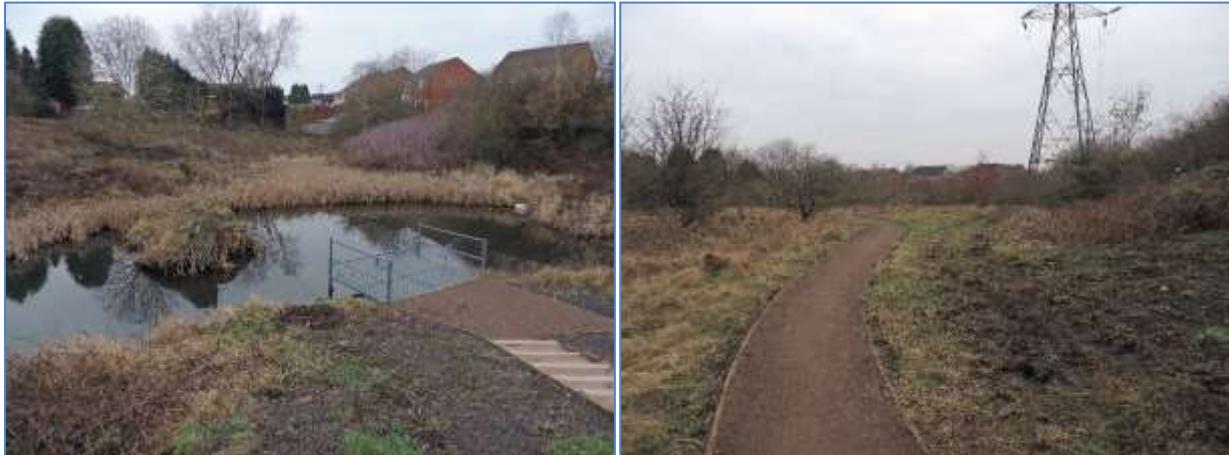
Access works at Reedswood Park have been limited to the area around Victory Pools in the western part of the site. These have comprised the provision of a dipping platform and surfaced paths, including a tarmacked portion where the path gradient is quite steep. There was also some vegetation management

to improve access along nearby paths. These were nearing practical completion when inspected on 28 February 2019, with the installation of a handrail, the final element, in progress.

Figure 51 - New dipping platform (left) and surface path at Victory Pools.

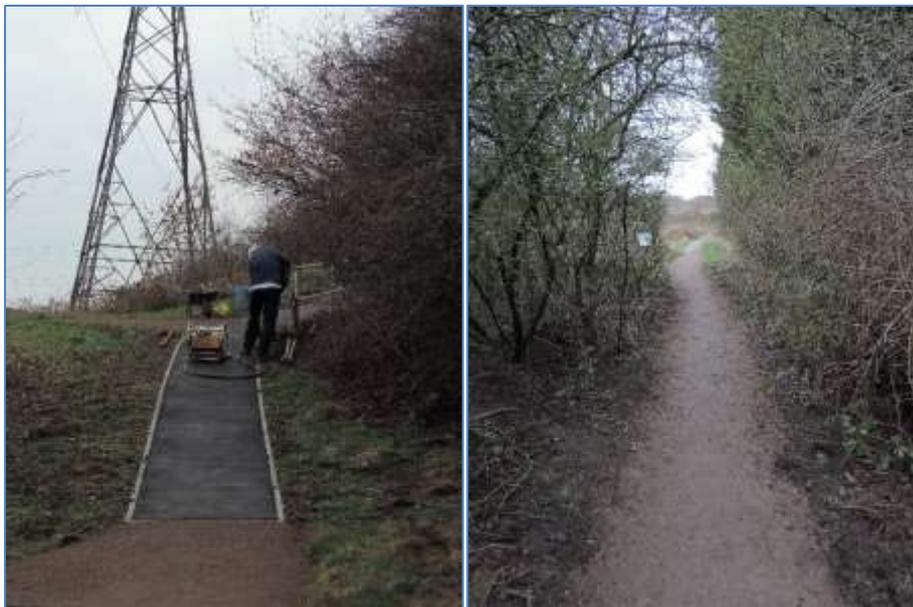
Figure 52 - Tarmacked section and handrail installation (left) and vegetation managed along path.

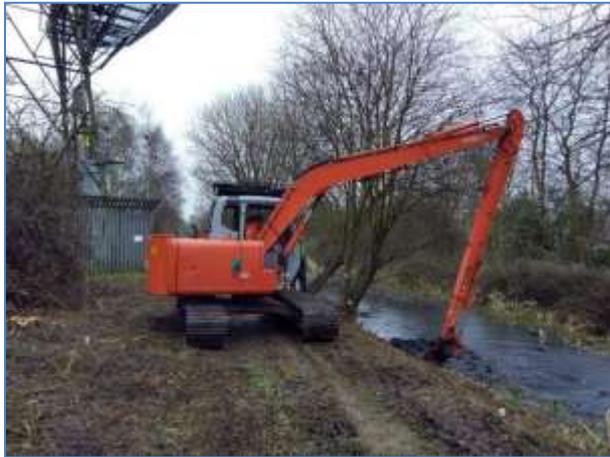
Whilst none of the canal dredging or footpath improvement works were evaluated prior to our beginning this work it was clearly evident from the non-dredged areas that the disused canal would have been completely clogged with dense marginal vegetation, and the adjacent shrubs and scrub would have been dense and unkempt features giving an enclosed and psychologically threatening towpath setting. To enable the back-actor access to undertake the dredging the bank-side vegetation has been trimmed back to provide a much more open and appealing environment. The spot dredged areas were clearly evident and have been effective in restoring open water to the canal; they are of limited extent in relation to the total length of the branch canal, but they should still have increased ecological benefits. The excavated material has been sensitively deposited in linear strips to the rear of the towpath verge next to the retained areas of shrubs and scrub.

Figure 53 Dredging at the Anson Branch Canal

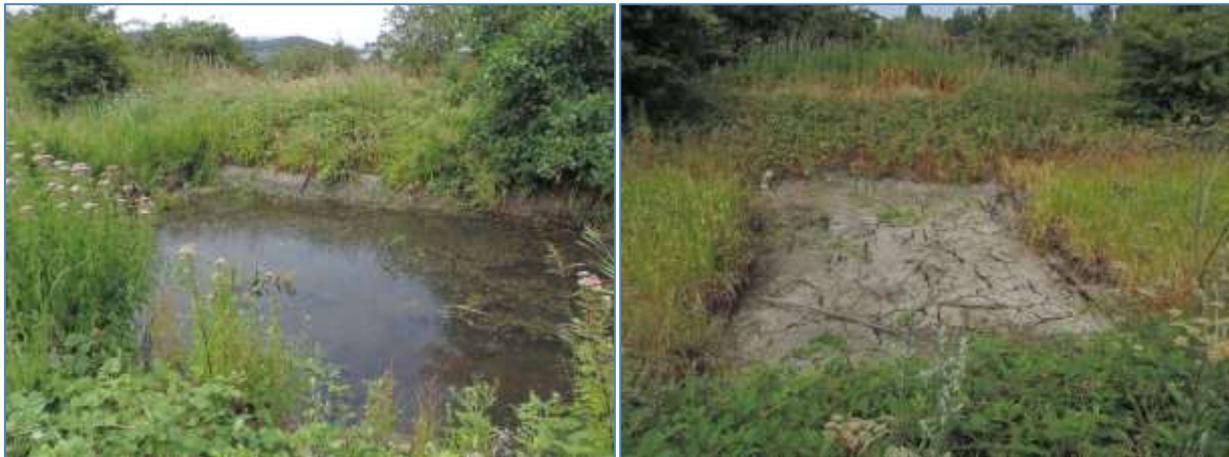
Figure 56 Pool with approximately 400mm water depth and dry pool showing the range of conditions created by the dredging works.

A revisit later in the summer showed that despite extended drought most of the dredged areas were still holding reasonable depths of water (estimated at 100 to 400mm). One of the areas had dried out completely – this is not a concern as a range of conditions is likely to support a wider range of species, as some require seasonal water bodies. It was clear that the dredging had a significant beneficial impact on habitat quality.

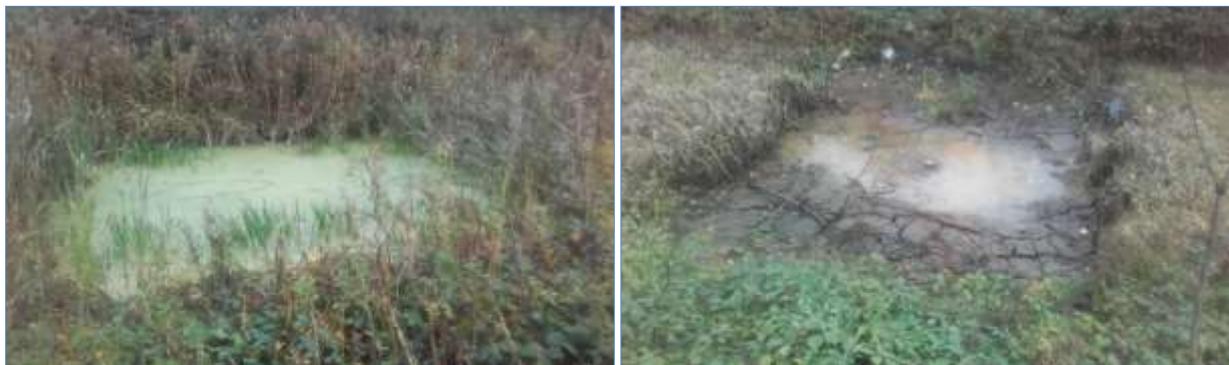
Figure 57 Spot dredged areas in October 2018. The pool on the right is the one above that was totally dry during the drought.

The works were inspected again in October. Due to the immature tree thinning and scrub removal next to the towpath last winter it was encouraging to see that the route beside the canal remains relatively open and welcoming. The brash has been sensitively laid to one side to form dead hedge features. There is an interpretative sign near the main entrance which is in good condition (although beginning to be partially obscured by regenerating shrub growth). The relatively large dredged section of canal on the opposite side from the sign remains largely free from aquatic vegetation re-growth which was encouraging, although chickweed is developing a blanket cover. Further to the south-west the various spot dredged sections remain evident, but their small size and relatively shallow depth has meant that some dried or partially dried out during the drought and they are becoming re-colonized by marginal vegetation.

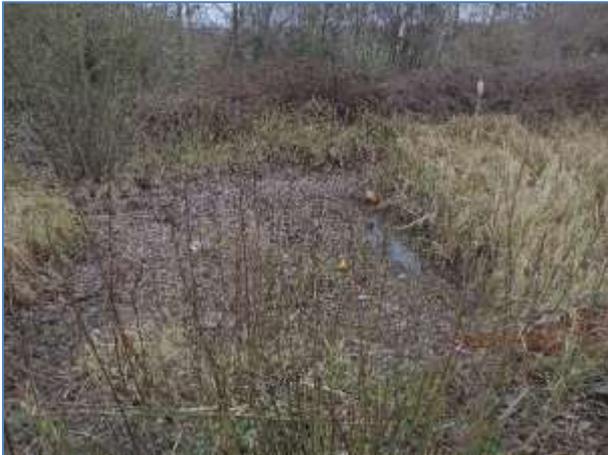
Figure 58 - In February a single dredged area was not fully covered in water.

When visited in February 2019 it was apparent all but one of the dredged areas was full of water, despite the very dry February. One area was not completely full but it was noted that this was over a bridge and that this has probably affected the local hydrology. Permanent signage was in place including acknowledgement of ERDF funding.

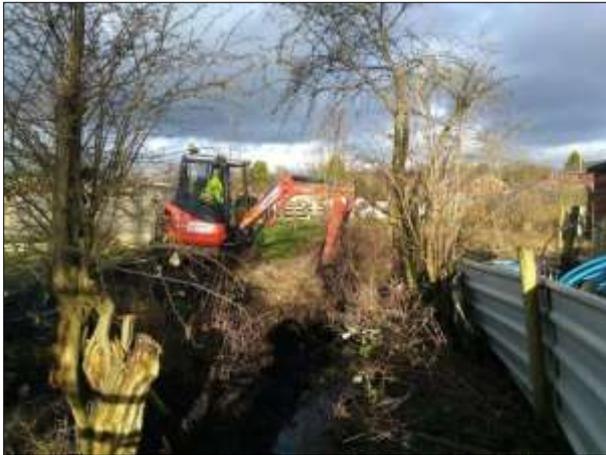
Figure 59 Ditch dredging in progress

It is understood that prior to the works the ditches and watercourses were almost obscured by tall, dense, rank bank-side vegetation. The restoration of these features has allowed light to reach down into the steep sided cuttings and the water-bodies; improve water flows; reduce flooding; and improve their biodiversity value. Numerous patches of frog spawn were evident in May. The excavated material had for the time being been crudely spread onto the allotment banks which looked unsightly. But this was rectified during the summer of 2018.

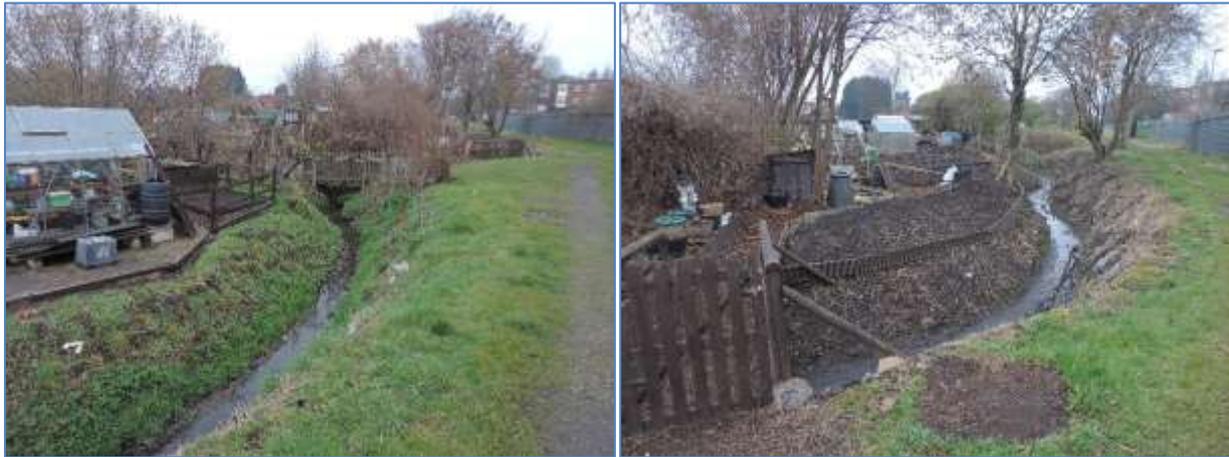
When visited in February 2019, the site was looking in excellent condition with some waste material that had been removed from the streams now having been taken off-site. It was clear that the streams are being well maintained by the allotment association. We also noted frogs present in the stream showing continued use by amphibians.

Figure 61 - The dredged watercourses in February 2019

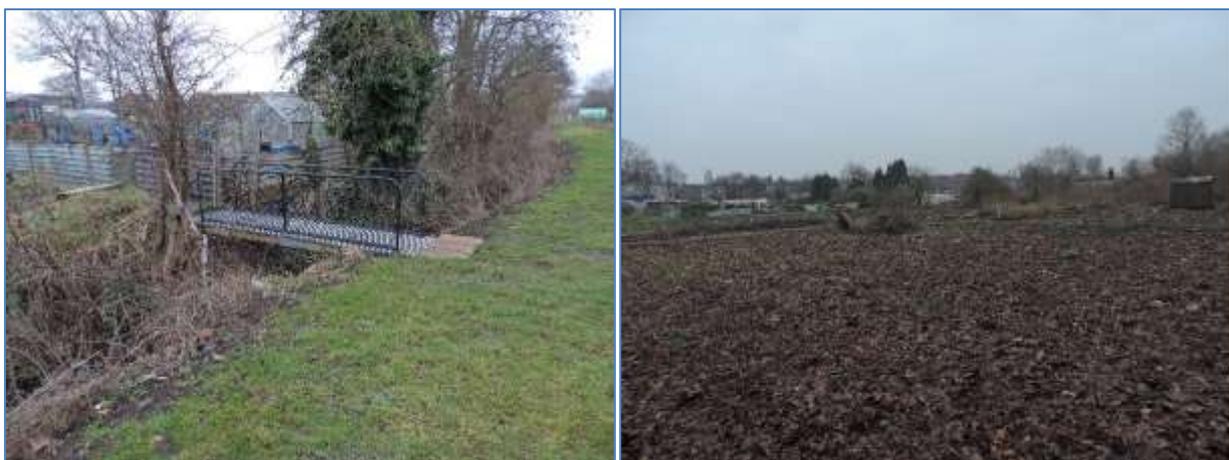
- New bridges across the stream.
- Creating a new wildlife/picnic area
- Commencing refurbishment of a sensory garden.

Figure 62 -Added value - bridge installed over the stream (left) and area cleared for new allotments and nature area

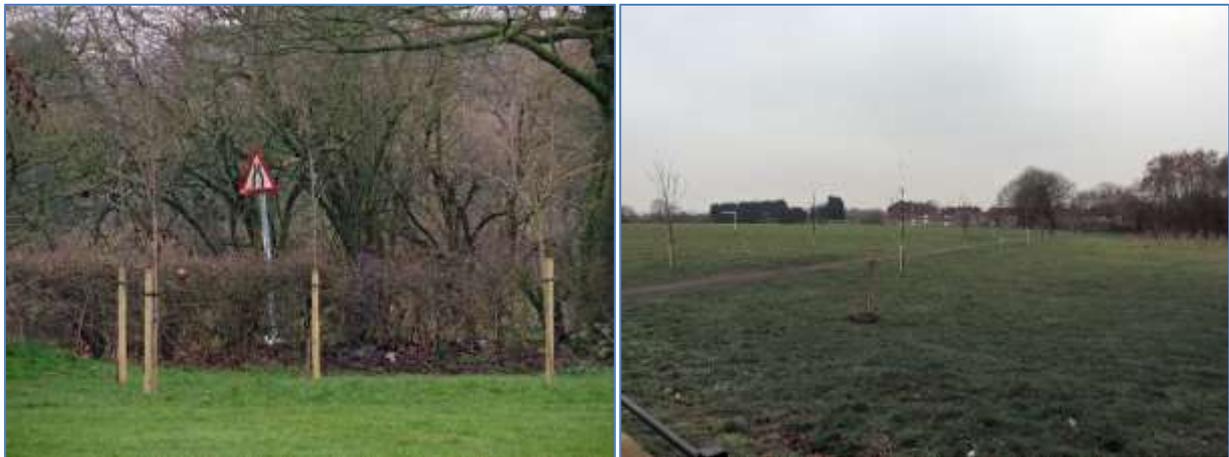
Figure 65 Specimen trees (left) and new avenue

The planting has been done to a high standard with the woodland and orchard trees being staked and mulched, Figure 64. The shrub planting has been planted as unsupported whips, there is a slight concern that these could be vulnerable to damage by gang mowing. It would be beneficial to add marker posts around these areas. Vandalism has been minimal, although one specimen Magnolia has been snapped in half and should be replaced, Figure 66. The Orchard area does not have any official access other than from the park, although there are two informal entry points where the low retaining wall to the north has been broken down and it could be beneficial to turn one of these desire lines into an official access.

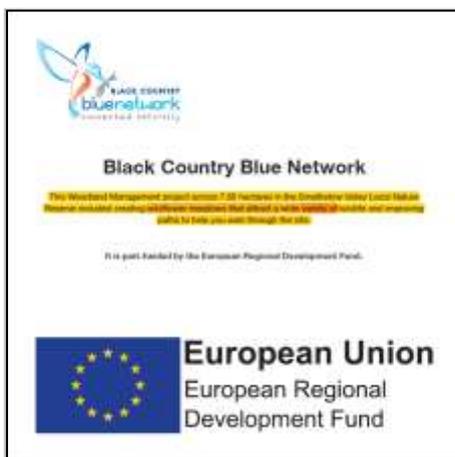
Figure 70 | Design for funding acknowledgement plaque

A design has been agreed for funding acknowledgement plaques to be placed at each of the project sites. These follow a consistent design with site-specific text being inserted as appropriate. The plaques include the project logo and ERDF logo as required.

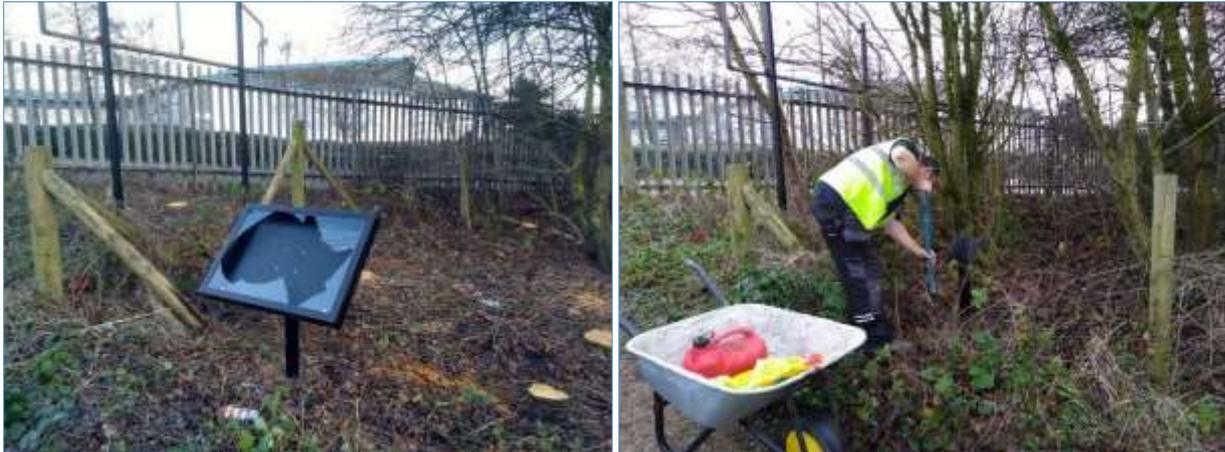
Figure 71 Installation of lectern and subsequent damage (winter 2017)

Fifteen interpretation signs had been installed but were not present in May 2018. During the previous winter all had been vandalised (some removed from site altogether, some uprooted, and some in situ but badly damaged). Walsall MBC acted swiftly and removed the uprooted and in situ damaged signs such that by May 2018 only the lecterns were present. It is unclear why such a level of vandalism should have arisen. Such signs should under normal conditions have been acceptable although from a design perspective the fixing of a relatively large sign onto a single upright (rather than two) might give the appearance of being less robust.

Following discussions between Walsall Council and the suppliers of the signage and lecterns replacement with a much more robust design of lectern was agreed. The council has a stock of replacement boards which can be fitted to the lecterns if they are subject to major vandalism. We have advised the insertion of a protective layer of polycarbonate if any signs have to be replaced.

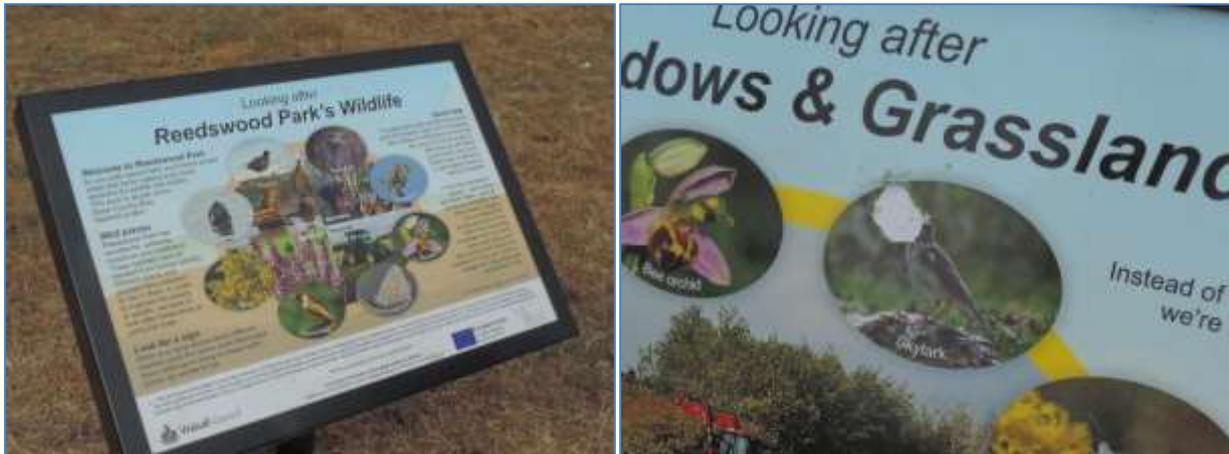
Figure 73 Replacement lectern and signage at Reedswood Park (L) and minor vandalism (R)

By July previously vandalised signs have all been replaced with clear, sturdier boards and lecterns. Although some of these signs have been the subject of minor vandalism, they appear to be much better suited to their situation and are all in acceptable condition. Only two seemed to be 'failing' in that the main Bentley Lane entrance sign has slipped down in the frame to expose a gap and tape along the top; and the sign at the end of Birchover Road had been partially marker pen graffitied on. Although not visible some of the signs could be partially rotated around the central circular support post. This lack of sturdiness may 'encourage' further vandalism unless the post can be set rigid.

As of February 2019, the interpretation signs remain in situ and have not been removed or heavily vandalised. There are a number however where the interpretation boards have either been scratched, defaced, pushed so that they have become concave within the frame or such that they have become loose and dropped down within the frame. One of the top rear portions of a sign lectern had been partly damaged where someone had tried to leverage off the lid. In terms of the interpretation panels consideration should be given to either replace them on a regular basis so that the material stays fresh and in good condition; or making the panels more robust e.g. by including a stiffer backing board and/or adding packers and adding a clear front fascia layer that would be scratch and knife resistant as well as easily cleaned of graffiti. It would also be prudent to reconfigure and clean the slightly damaged panel frame so that this sign looks well maintained. For future reference a slightly different, more robust frame and lid detail might be beneficial to help prevent them from being vandalised.

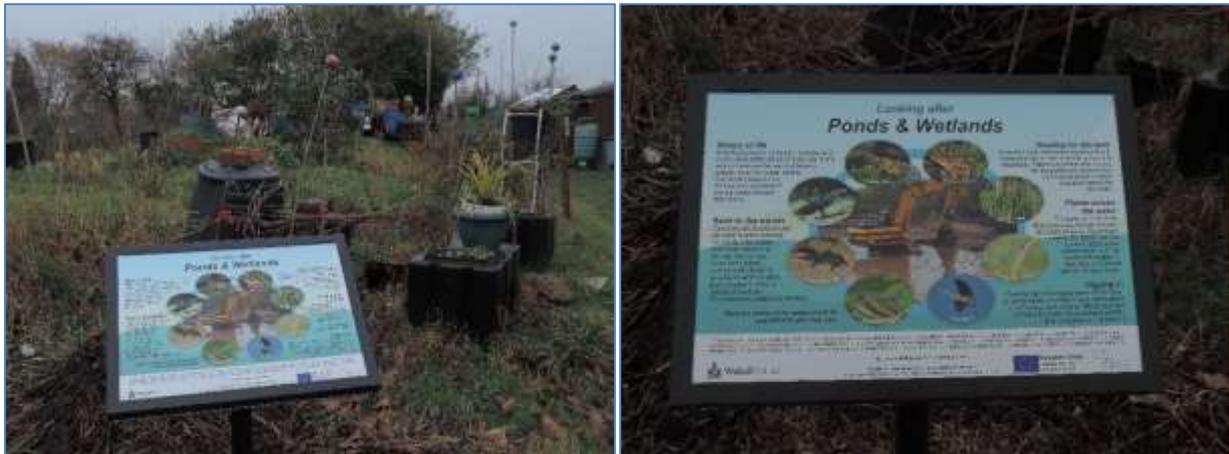
Figure 75 - Signage at Lane Avenue Allotments

A single sign of the 'Ponds and Wetlands' theme has been installed at Lane Avenue Allotments close to the point where the stream enters a culvert and leaves the site. This is very close to the entrance and has a good level of visibility. A ladder sign had not yet been installed, but see Anson Branch Canal below.

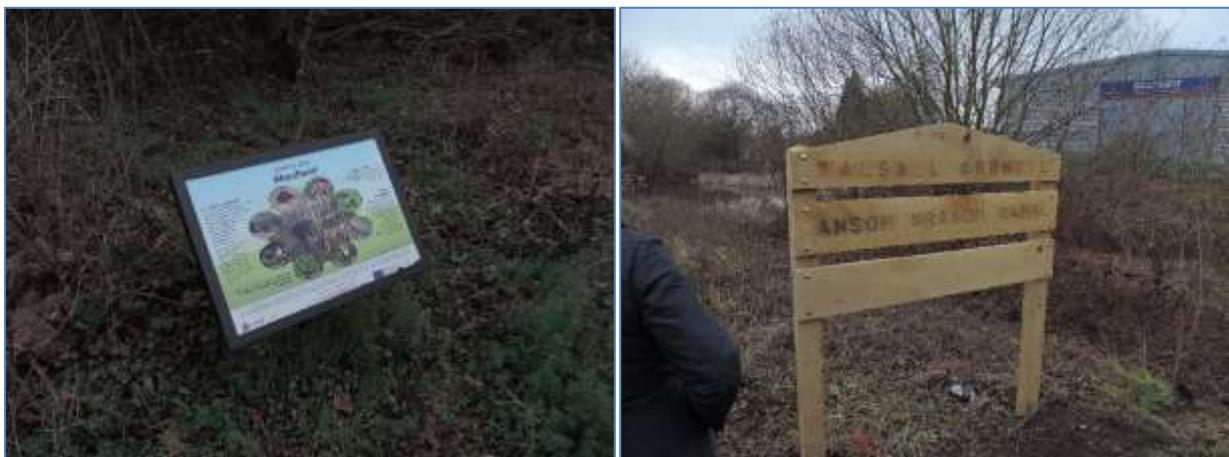
Figure 76 - Signage at Anson Brach Canal including the first of the 'ladder signs' to be installed

At the Anson Branch Canal a single interpretative sign consistent with the Reedswood park signs has been installed. This is a woodland sign and is placed near a small area of woodland at the site. One of the 'wetland' signs would have been more appropriate, it may be possible to change the board to a spare wetland sign in future.

On the date of the site visit a ladder sign had been newly installed but the funded by ERDF signage had not yet been placed on the lower board. Similar signs were being installed at Reedswood Park and Lane Avenue allotments as part of the same programme of work.

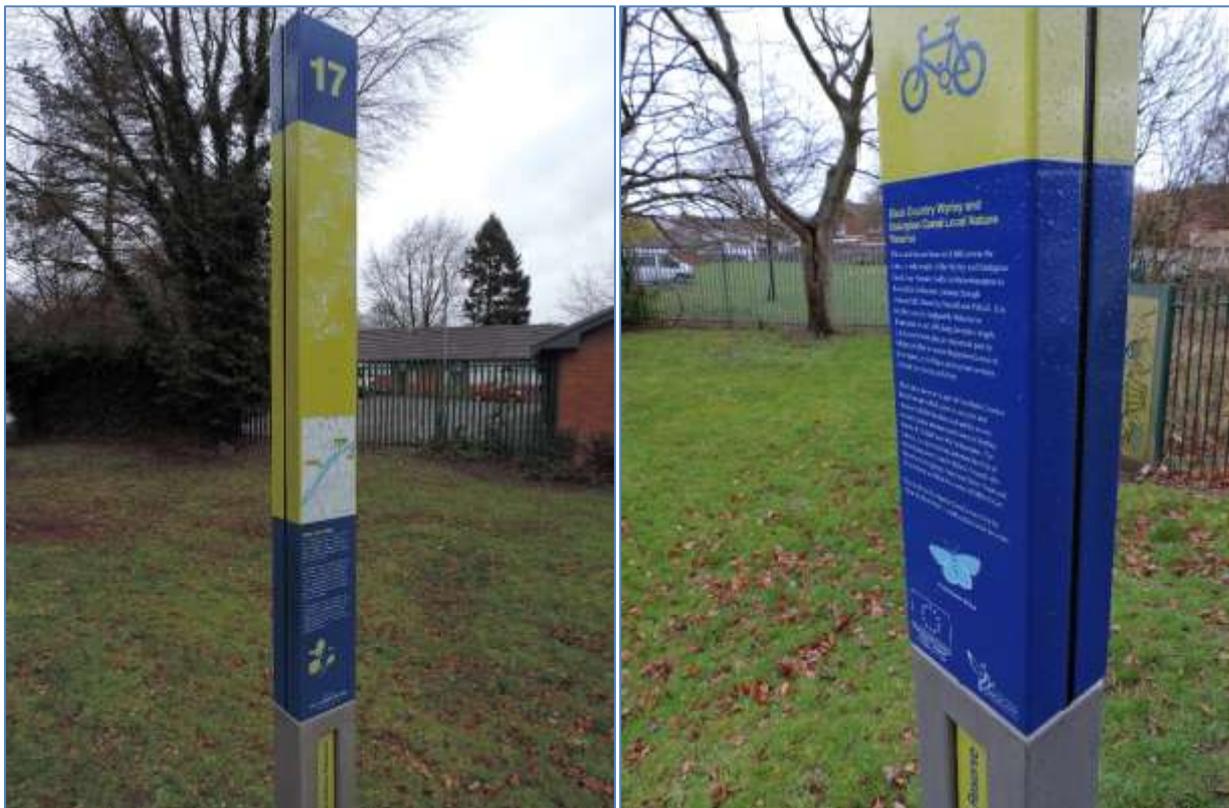
Figure 77 - Example of one of the tall direction posts at site 7, land within Wednesfield Park

The interpretation signs were installed in mid-November 2018. This mainly comprised location markers in tall (Figure 77) and low (Figure 78) designs along the length of the canal.

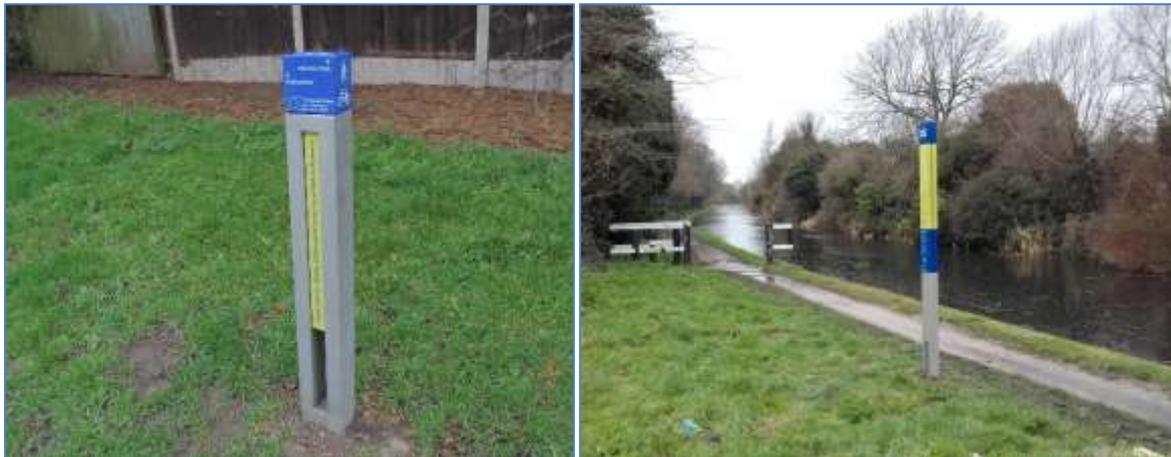
Figure 78 - small format sign at site 12 (left) and tall sign at site 16

The signs are of steel construction with a vitreous enamelled finish. It appears that one sign has received minor damage and lost a section of enamel.

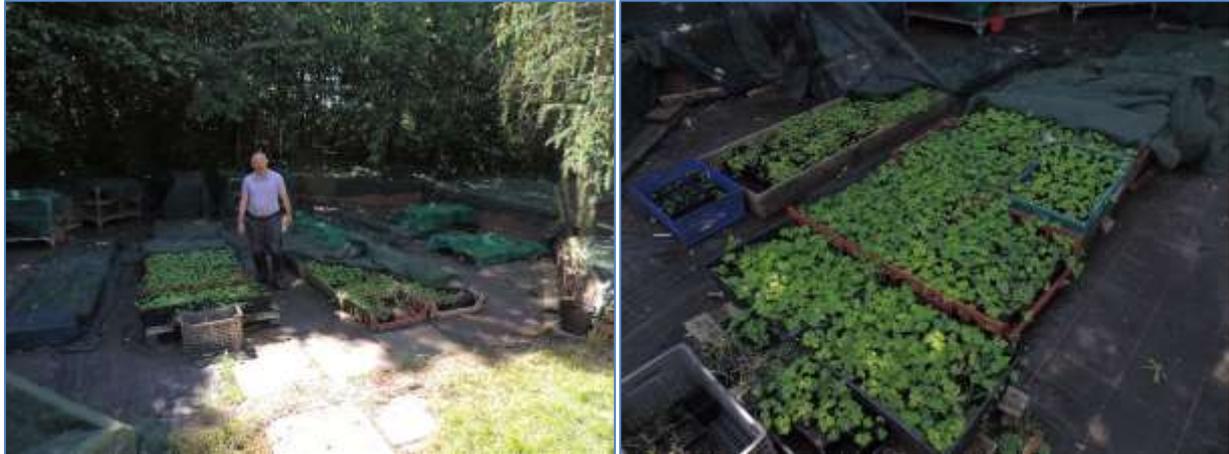
Figure 85 The main area for growing plants as plugs (left) and woodland ground layer species are grown under shade netting

Growing Local Flora is an initiative by the Wildlife Trust for Birmingham and the Black Country. It produces plants for the project from locally collected seed and propagates wild plants. Local provenance plants and seed are not available from another supplier. The aim was to provide plants and seeds of local provenance to ensure the project is supplied with materials of the highest ecological quality.

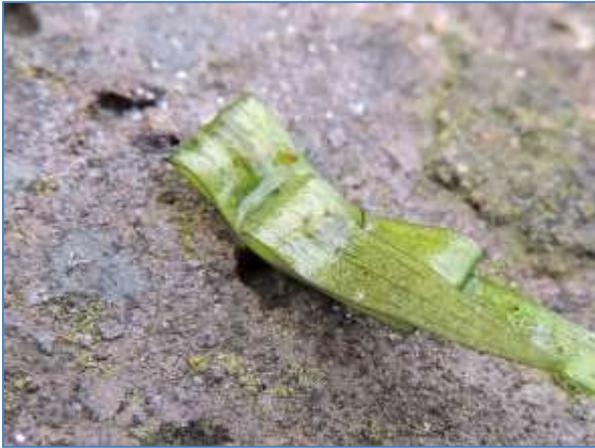
Figure 88 Leaf folded to contain common newt egg

Considering how badly silted the ponds had been before work was undertaken it was remarkable that common newts had occupied the open water so rapidly, with clear evidence of breeding on the Anson Branch – a pondweed leaf folded to protect eggs laid inside the loops. There was also evidence of frog breeding (tadpoles) at the allotments and Reedswood Park.
