Heath Town Baths and Library

HEATH TOWN BATHS & LIBRARY Structural Condition Survey

November 2011

This report forms part of a Feasibility Study for the adaptive re-use of Heath Town Baths & Library to a Sports Academy on behalf of the Tessa Sanderson Foundation Academy.

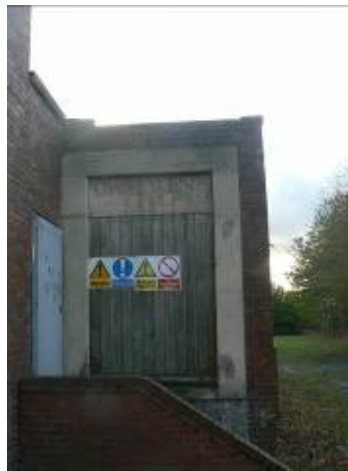
Photograph No. 1

Starting at the northern end is the single storey section which was the original entrance to the Children's Bath, as shown on photograph No. 1.

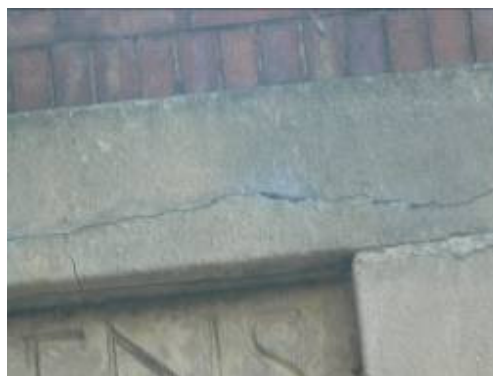
Photograph No. 2

The surround is in a poor condition with significant cracking and spalling to the lintel, as shown on photograph No. 2, and there is also spalling to the bottom left hand side of the reveal where the cracking extends up to the doorhead.

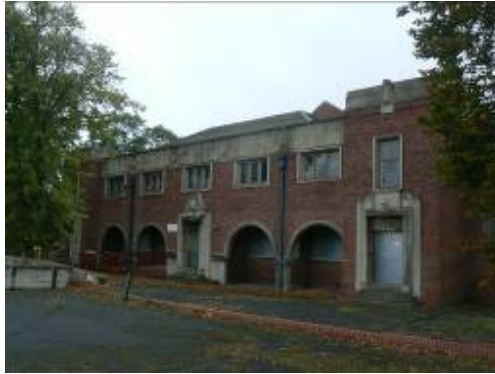
Photograph No. 3

Moving to the main front elevation, this is shown on photograph No. 3, and the northern side is shown in detail on photograph No. 4.

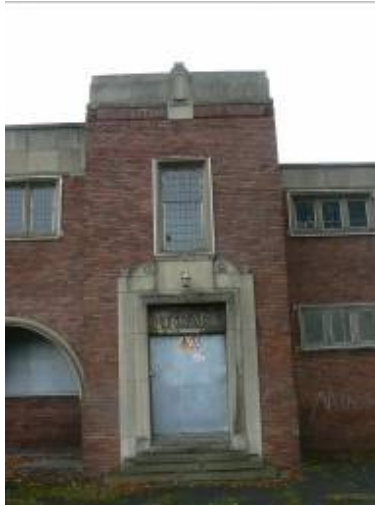
Photograph No. 6

To the North Tower Library entrance, this is shown on photograph No. 6.

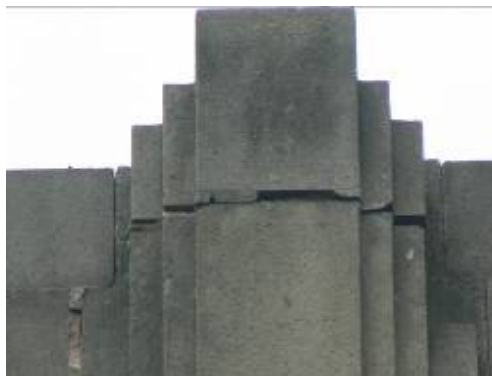
Photograph No. 7

The parapet corbel detail is noticeably open jointed, as shown on photograph No. 7, and will likely need to be re-set. This will be further inspected from the roof.

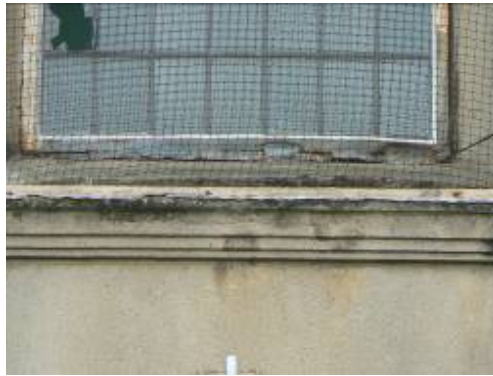
Photograph No. 8

To the first floor window (WF9), this shows no sign of major spalling to the upper section, although the junction of the window and the cill is slightly poor, as shown on photograph No. 8.

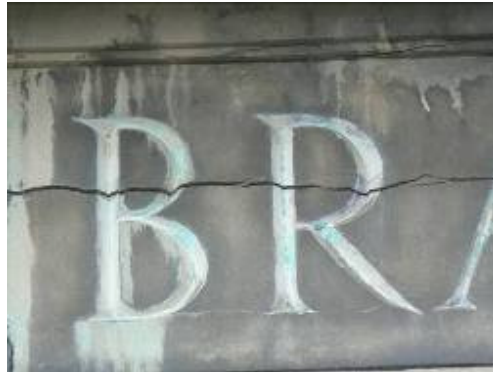
Photograph No. 10

Across the central plaque there is a horizontal crack which is likely to be due to corroding reinforcement, and this is shown on photograph No. 10.

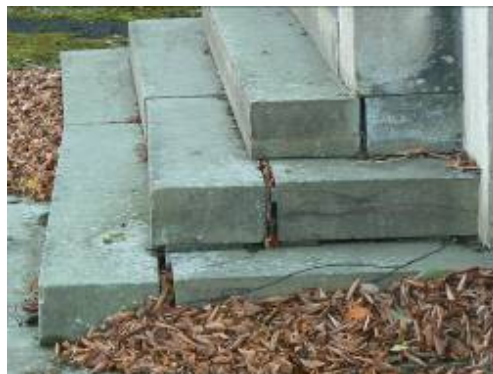
Photograph No. 12

The steps have become quite displaced, as shown on photograph No. 12, and it would be recommended that an allowance is made for these to be carefully taken up and re-set.

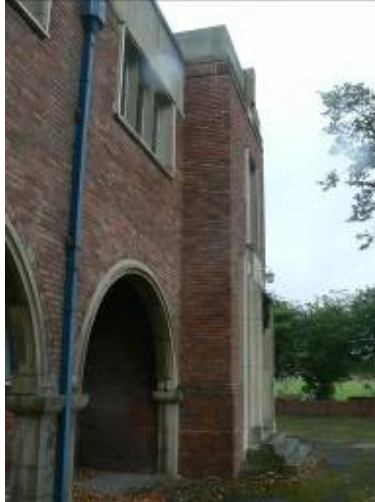
Photograph No. 13

On the small southern return to the entrance tower, as shown on photograph No. 13, the upper parapet joints are slightly open.

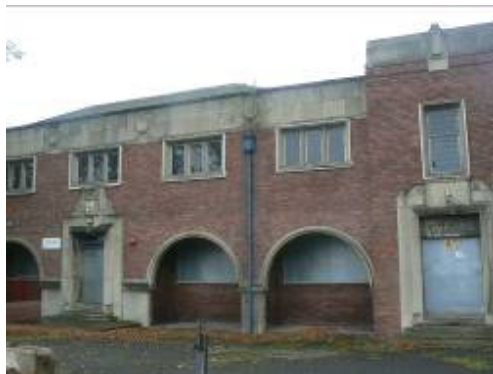
Photograph No. 14

The northern half of the main frontage is shown on photograph No. 14.

The parapet shows no sign of any major displacement, only slightly open joints which require repointing.

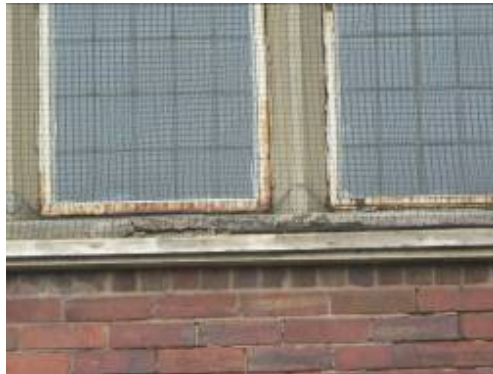
Photograph No. 15

At first floor level, the cill to window WF8 has exposed reinforcing bar and the concrete is spalled, as shown on photograph No. 15, and this cill will need to be replaced.

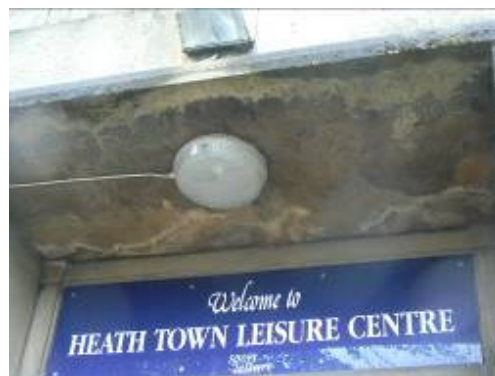
Photograph No. 18

To the ground floor door surround, there is a slight separation of the side panels on the southern elevation and to the underside of the lintol, there has been water penetration which is indicated by the staining present, as shown on photograph No. 18.

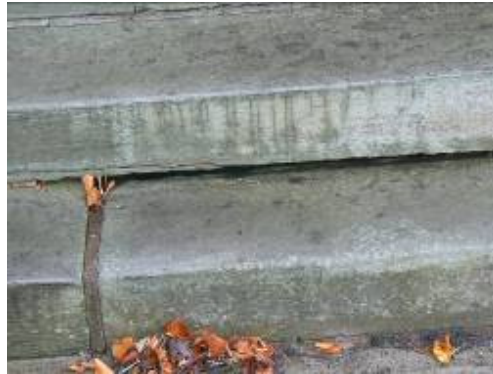
Photograph No. 19

To the steps it can be seen that there is a void under the lower step, as shown on photograph No 19, and this needs to be re-set.

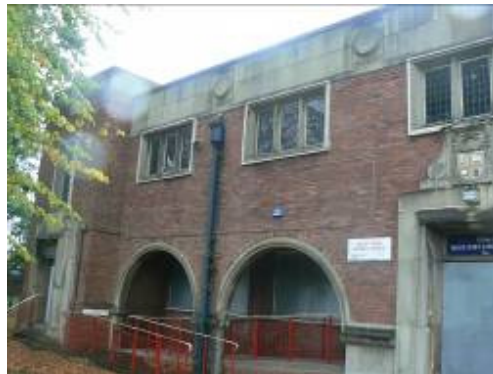
Photograph No. 20

The southern section of the central area is shown on photograph No. 20.

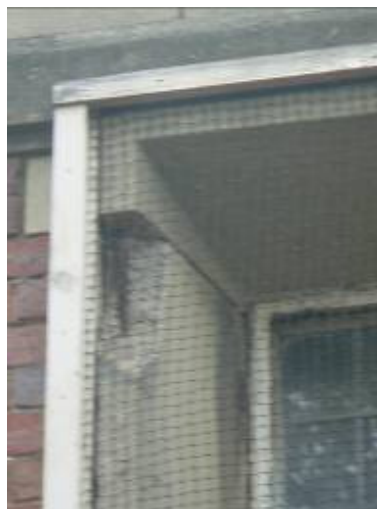
Photograph No. 21

The first floor window (WF5) has exposed reinforcement bars showing to the southern reveal, as shown on photograph No. 21.

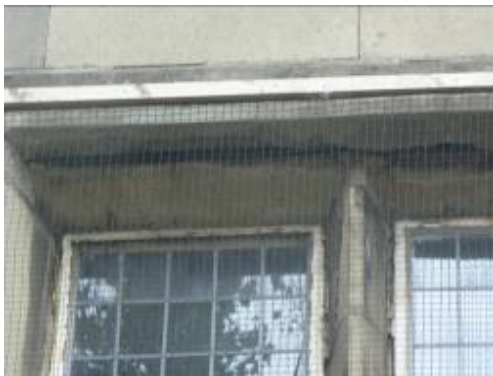
Photograph No. 23

Window WF4 is in a poor state of repair and it can be seen that the lintol section has exposed reinforcing bars and spalling stone, and also the cill shows a large amount of spalling stone, as shown on photographs numbered 23 and 24.

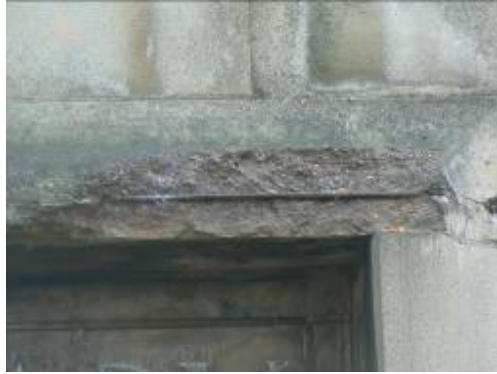
Photograph No. 28

To the lintol over the ground floor door, the concrete has spalled and there are exposed reinforcing bars showing and this crack extends all the way across to the southern end where this section of reconstituted stone is also coming away, and this is shown on photographs numbered 28 and 29.

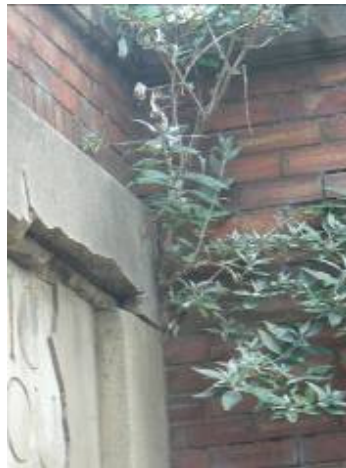
Photograph No. 33

To the southern extreme of the elevation, at the entrance to the original public wash house, the lintol is in a poor condition and there is vegetation growing out of the corner of this junction. It can also be seen that the face of the stone below has also been lost, and this is all shown on photograph No. 33.

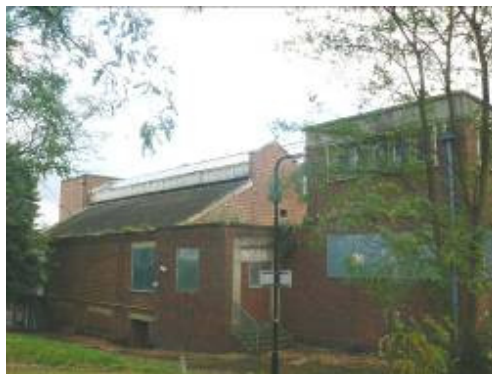
Photograph No. 34

A general view is shown on photograph No. 34.

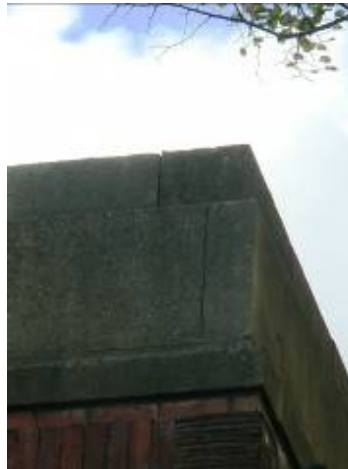
Photograph No. 35

Starting with the front staircase tower, this appears to be in a reasonable condition. There is slight cracking to the front edge of the parapet and this is shown on photograph No. 35, but the remainder of the brickwork is in a reasonable condition.

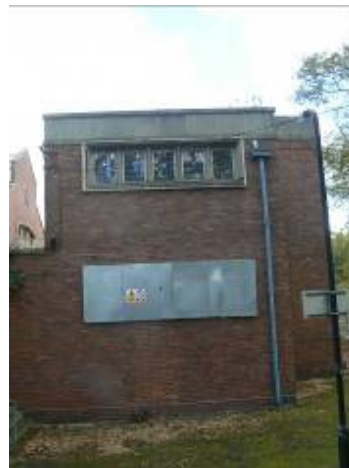
Photograph No. 36

To the next section, window WF01 is in a poor condition with the cill and the western reveal, showing exposed reinforcement. A general view of this section is shown on photograph No. 36 and the areas of damage on photographs numbered 37 and 38.

The parapet above here is slightly open jointed and would benefit from being repointed. The brickwork is in a reasonable condition and the ground floor window is completely boarded over and therefore, its condition could not be seen, as can be appreciated on photograph No. 36 above.

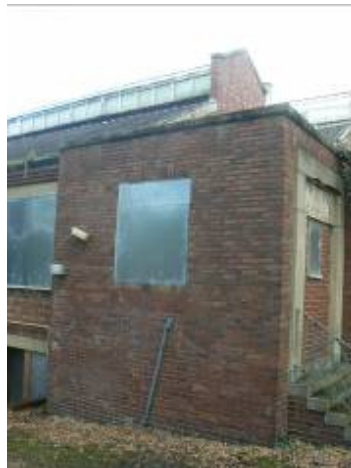
Photograph No. 39

To the western elevation of the public wash house entrance, as shown on photograph No. 39, there is a central crack indicating a failure of the lintol, where the flat arch has dropped, as shown on photograph No. 40. The coping above here is slightly open jointed which requires pointing and the lintols re-setting.

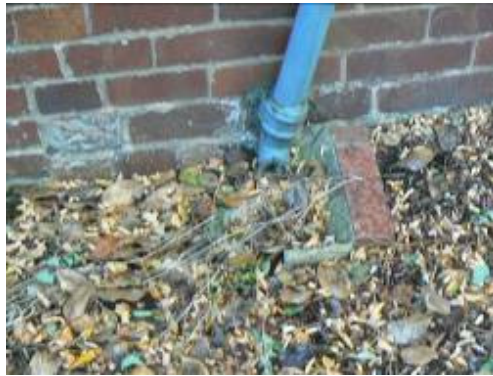
Photograph No. 41

The drainage gully at the base of the wall is in need of being cleared and it would be recommended that it is actually replaced and re-formed, as shown on photograph No. 41.

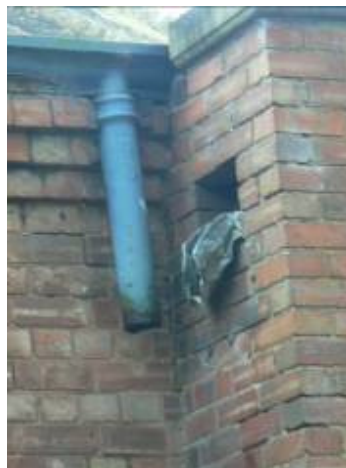
Photograph No. 42

On the small return section the downpipe is missing and therefore, the water from, not only the southern guttering but also the public washroom entrance hopper, is discharging down the wall, and this is shown on photograph No. 42.

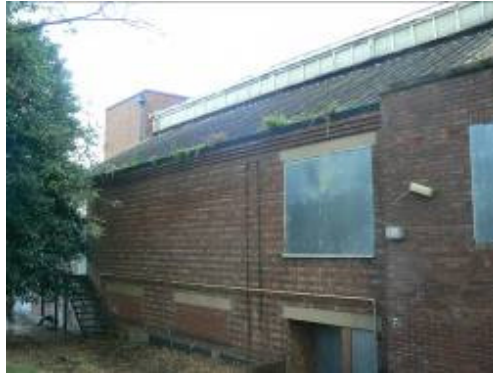
Photograph No. 43

The next area of the building is shown on photograph No. 43.

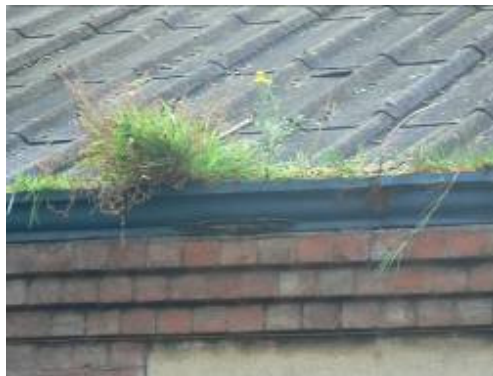
Photograph No. 44

The roof to this area will be covered in a later section of this report, but what is noticeable is that the guttering is completely filled with vegetation and is decoratively in a poor condition, as can be seen on photograph No. 44.

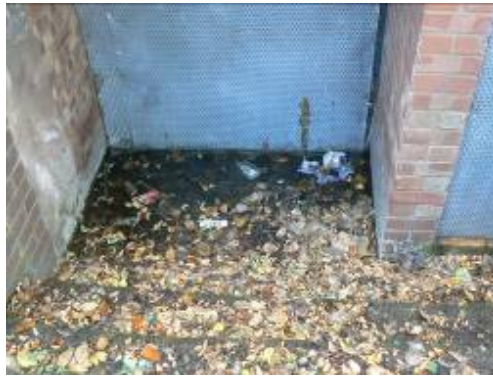
Photograph No. 45

To the lower service room door, this requires drainage at the base as at present, water collects, as shown on photograph No. 45.

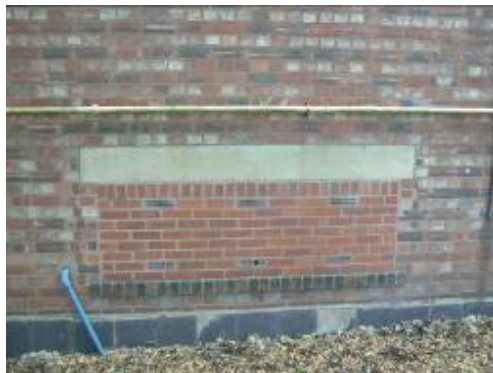
Photograph No. 46

There are then two openings which have been infilled with a non-matching brick but air bricks have been inserted, as shown on photograph No. 46.

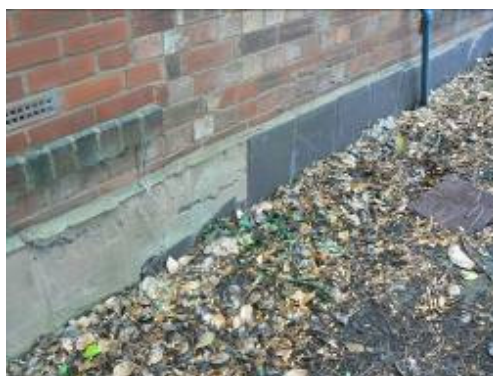
Photograph No. 47

What is noticeable is that an attempt to provide tanking has been introduced in the form of a render with slate to the outside, as shown on photograph No. 47. However, this is likely to be ineffective and it is evident that the slates are now coming away.

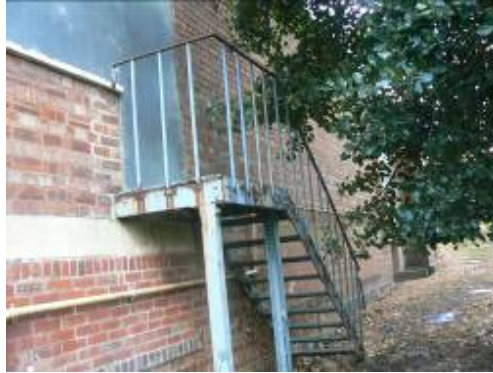
Photograph No. 48

At the southern end of this section of the building, there is a set of steel steps leading up to DG01. However, these are noticeably corroded and it would be recommended that an allowance is made for their replacement and they are shown on photograph No. 48.

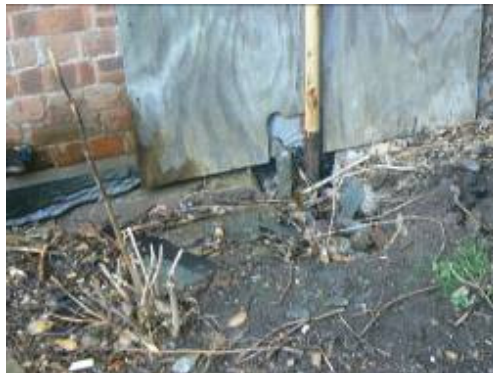
Photograph No. 49

On the end of this section of the building, the downpipe is missing completely and therefore, the water is discharging directly onto the ground. The gutter is in a poor condition and this area is generally saturated, as shown on photograph No. 49.

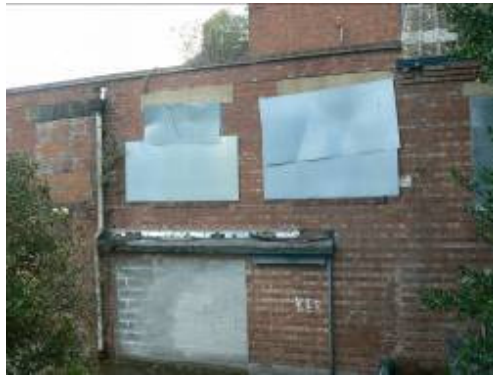
Photograph No. 50

The next section of the building is shown on photograph No. 50 and this shows that the upper windows have been completely boarded over and at the position of a large opening at the lower level where there was a sliding door, this has now been infilled with blockwork.

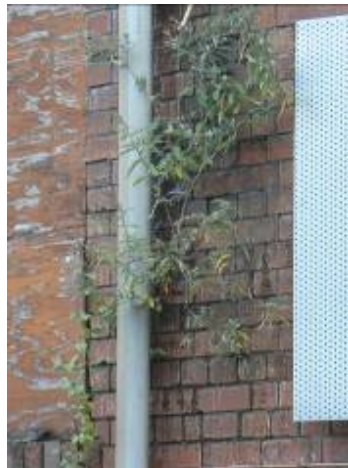
Photograph No. 51

At the downpipe at the edge of the sliding door, it is assumed that from the amount of vegetative growth present, this is leaking, as shown on photograph No. 51. The downpipe should be removed, the rainwater outlets made good and the brickwork repointed prior to re-fixing the downpipe.

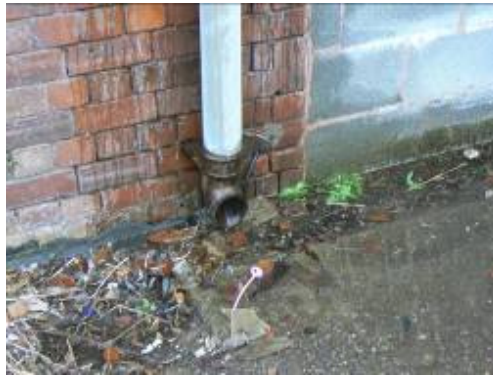
Photograph No. 52

At the base there is also a lot of standing water, indicating that the drainage is not working correctly and although a drainage survey has not been carried out, it would be recommended that an allowance is made for it to be replaced, as shown on photograph No. 52.

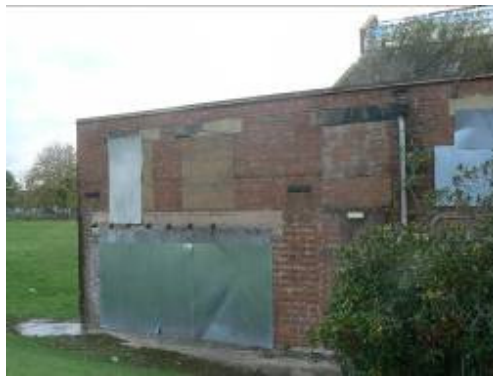
Photograph No. 53

At the western end the openings are all boarded up, as shown on photograph No. 53.

The lintols are in a poor condition with the eastern most one adjacent to the previous downpipe having exposed aggregate, the reinforcement showing to the central one and the concrete spalling off and to the western most, the reinforcement is clearly visible behind the boarding at the western end, and this can all be seen on photographs numbered 54 to 56 inclusive.

At the rear the three lintols are in a poor structural condition and an allowance should be made for these to be replaced. The condition of the windows could not be determined as they are all boarded over.

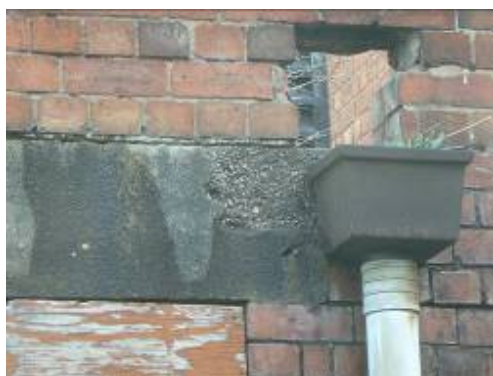
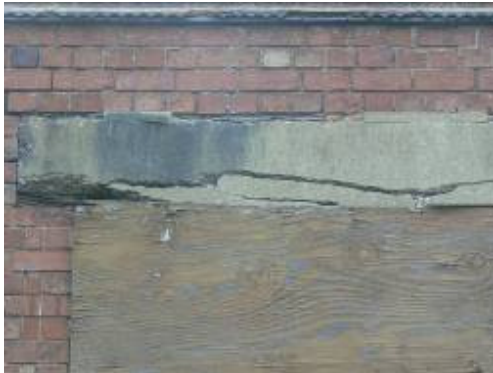
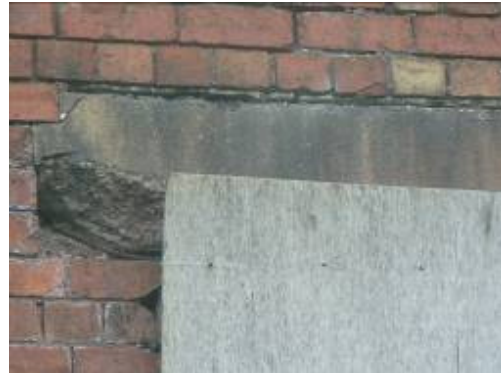
As with the front elevation, the main areas of defect are related to the reinforced concrete and reinforced reconstituted stone lintols which show noticeable amounts of spalling with the reinforcement bar now exposed.

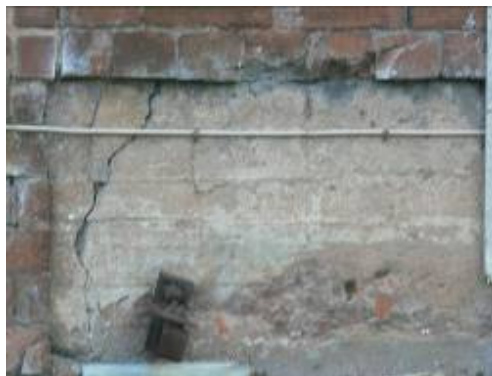
Photograph No. 57

Below these windows there is another sliding door which has been boarded over. It has a large concrete beam over the top. The brackets previously holding the rail are corroded and need to be removed, and the concrete beam needs repair as there is cracking at the western end, as shown on photograph No. 57.

The main beams over the previous opening for sliding doors need attention, including repair of the western end of the western most opening. Also on this corner, the brickwork needs repointing where it has been damaged from the leakage on the southern elevation.

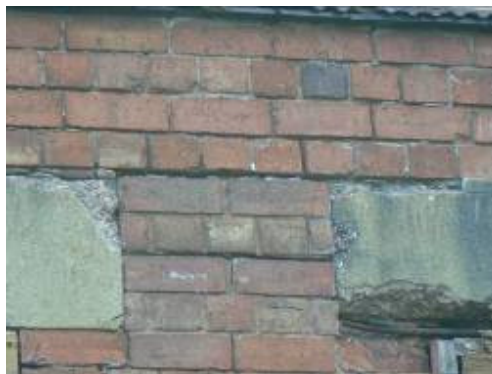
Photograph No. 58

Between the two windows above here, there are slightly open joints which require repointing, as shown on photograph No. 58.

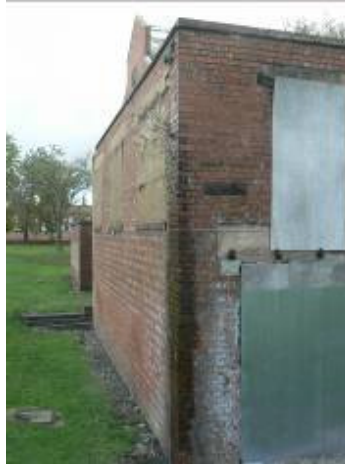
Photograph No. 59

Also in the western corner, there is a minor diagonal crack but most noticeable is the amount of damage from the water discharging from the roof above, which is on the southern corner and this is shown on photograph No. 59.

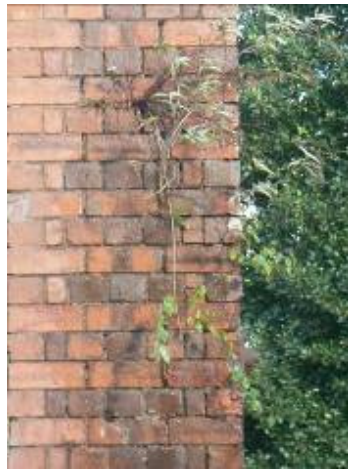
Photograph No. 61

The damage previously mentioned to this south-western corner is clearly evident and the fact that the hopper is discharging directly over the brickwork is now causing a degree of vegetative growth, as well as washing away the mortar and causing staining and this can be identified on photograph No. 61.

To the southern section of the building, the displaced brickwork at the top left hand corner, where the northern outlet has been damaged, need to be made good and the rainwater pipe needs to be re-introduced to the southern brickwork, the vegetation removed, the brickwork allowed to dry out and then repointed.

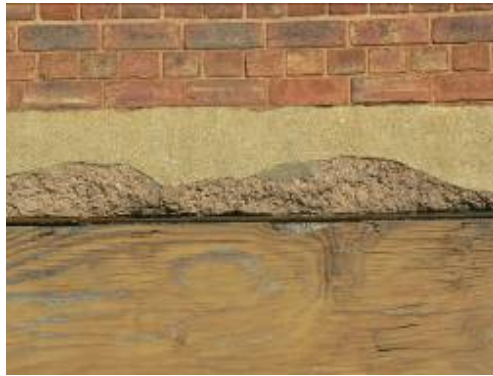
Photograph No. 62

Starting from the southern end, the lintol over the first window is in a poor condition with exposed reinforcing steel at the bottom, as shown on photograph No. 62.

At both the northern and southern ends, the lintols are showing signs of failure with either areas of cracking due to corroding reinforcement or in fact the reinforcement is already showing and due to the nature of the reconstituted stone, it is probably more appropriate that these are cut out and replaced.

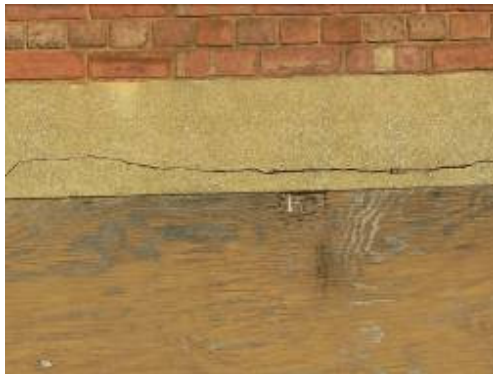
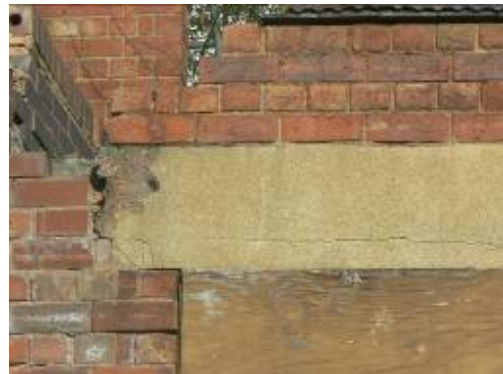
The bottom section of the central window is on the verge of spalling away and the northern most is in a similar condition with the disturbance at the top left hand corner, adjacent to where the brickwork has been removed from the parapet, all as shown on photographs numbered 63 and 64.

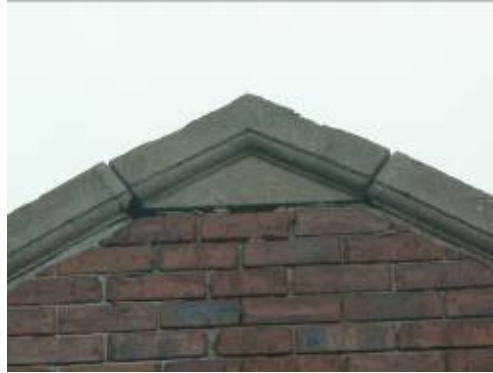
Photograph No. 66

The apex stone is quite open and needs to be re-set, as shown on photograph No. 66 and the kneeler at the northern side also requires re-setting.

The main end elevation of the swimming pool is in a more reasonable condition. There is minor making good required to the copings, in re-setting the northern kneeler and the apex stone and an allowance made for repointing the remainder.

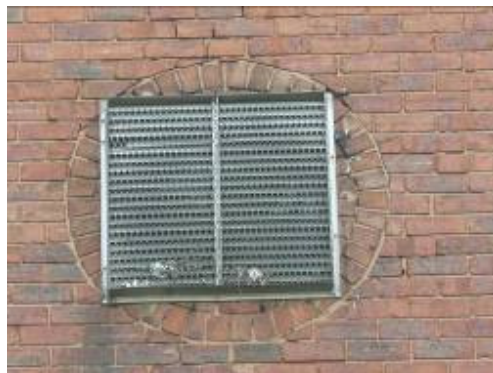
Photograph No. 67

To the centre of this upstand, there is a bulls-eye window which has had a grill quite crudely installed through the brickwork, as shown on photograph No. 67.

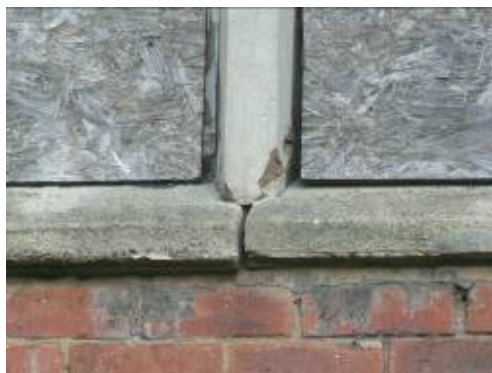
Photograph No. 68

Over the main window opening, the lintol is a three course deep row of headers and this requires repointing, although shows no sign of structural failure. There are some slightly open joints to the window cill and minor damage to the bottom of the mullion, as shown on photograph No. 68, but there are no signs of any major spalling.

The main window has minor open joints which need to be made good, but the remainder is in satisfactory structural condition.

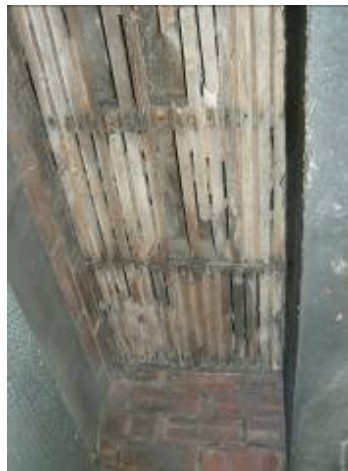
Photograph No. 69

The northern panel of brickwork with door DB01 and also windows WB05 and WU08, the surrounds etc., are in a reasonable condition with no sign of any significant defect, apart from minor paint spillage to the wall. To the ceiling to the underside of the door, this requires replacement as the plaster has come away from the laths, as shown on photograph No. 69.

To the door openings at the northern and southern sides, the lath and plaster ceilings need to be replaced and there is one window where localised making good is required in re-setting the brick lintol. The single storey extension has fallen into a slight state of disrepair and as with the remainder of the building, requires the rainwater goods to be made good.

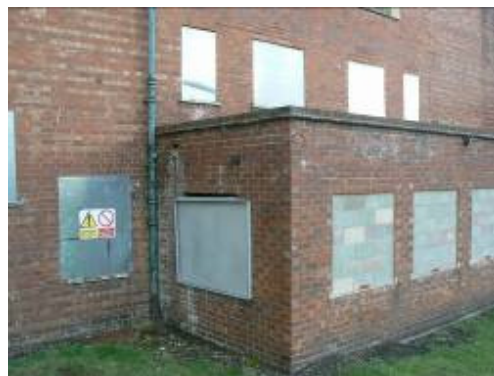
Photograph No. 70

In front of the middle section of the elevation, there is a single storey building and it can be seen that the gutter outlet has failed, causing noticeable staining to the brickwork and also the window is not present. This is all shown on photograph No. 70.

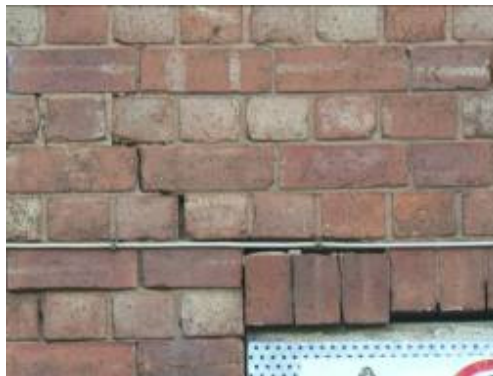
Photograph No. 72

To the southern side of the ground floor area of the main elevation, the lintol is displaced to window WB12 and this needs re-setting and the minor crack to the top left hand corner repointed, as shown on photograph No. 72.

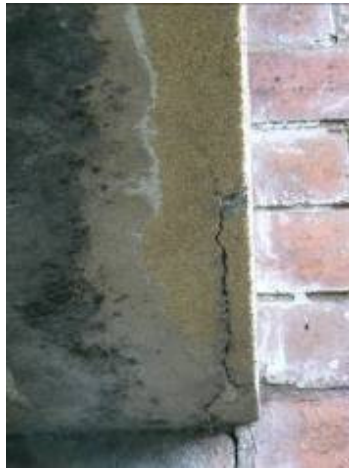
Photograph No. 73

To the southern doorway DB2, there is cracking to the underside of the lintol, as shown on photograph No. 73 and the concern here is that there is corroded reinforcement behind here and this will need replacement.

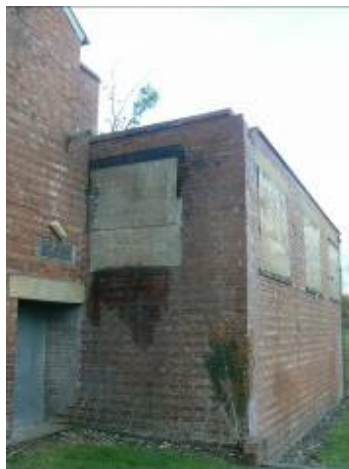
Photograph No. 74

On the short northern return, as shown on photograph No. 74, the water is not discharging properly from the window and this is causing noticeable staining and also to the upper section there is an area of repointing required.

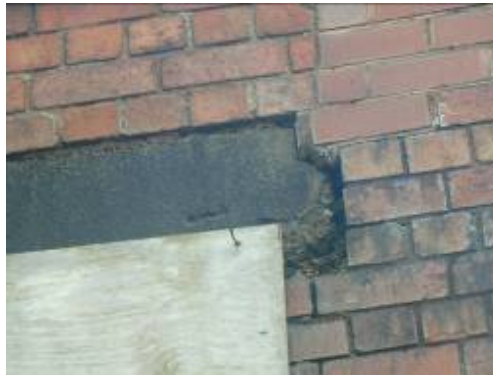
Photograph No. 75

The lintol over the window is showing signs of failure, as shown on photograph No. 75.

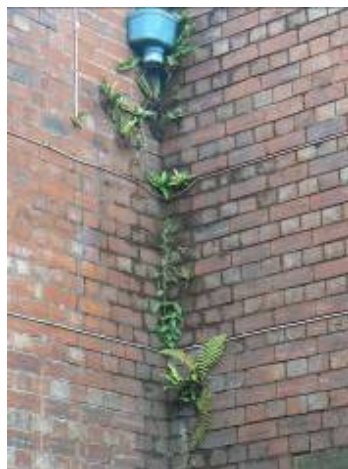
Photograph No. 77

At the southern junction, there is only a hopper and no downpipe and this is causing damage to the brickwork and vegetative growth, and this is shown on photograph No. 77.

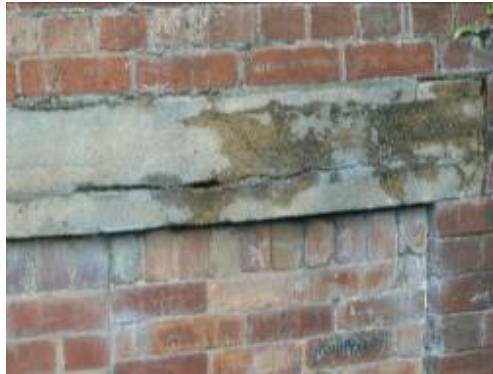
Photograph No. 78

At the lower level there are three openings which have been bricked in and starting at the southern end, the lintol has failed, as shown on photograph No. 78.

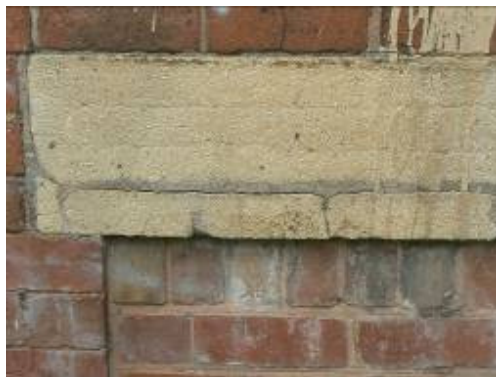
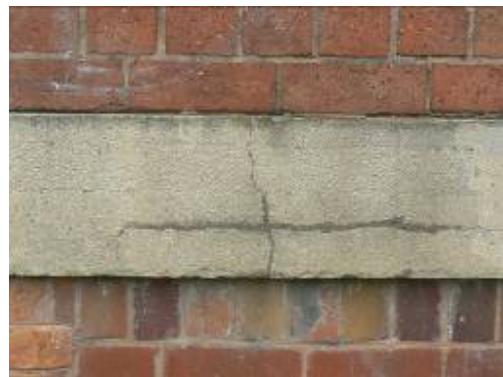
The lintol to the central opening is on the verge of failure and the northern one has a similar crack which has been pointed, but this is an indication that it has previously failed, as shown on photographs numbered 79 and 80 respectively.

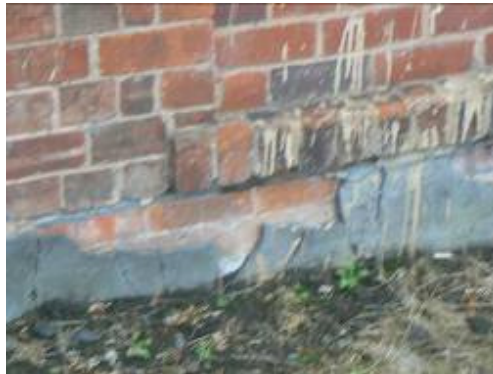
Photograph No. 81

At ground level there is an asphalt tanking system which is now coming away, as shown on photograph No. 81.

Due to the ground level rising from south to north, there is an asphalt tanking introduced on the northern section of the building. However, the effectiveness of this is not known as it can be seen that at ground level it is quite noticeably damaged, as shown on photograph No. 81 above. It would therefore, be recommended that an allowance is made for this tanking to be repaired or replaced.

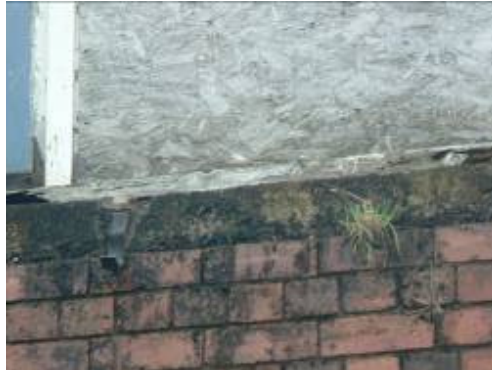
Photograph No. 83

At the bottom of the eaves level glazing, the guttering is missing and this generally has led to vegetative growth and the upper brickwork being damaged, as shown on photograph No. 83.

The lack of guttering to the western part of the building is causing damage to the brickwork, with noticeable staining and an allowance should be made for this area to be repointed and the for the concrete eaves detail at the junction with the windows to be repaired.

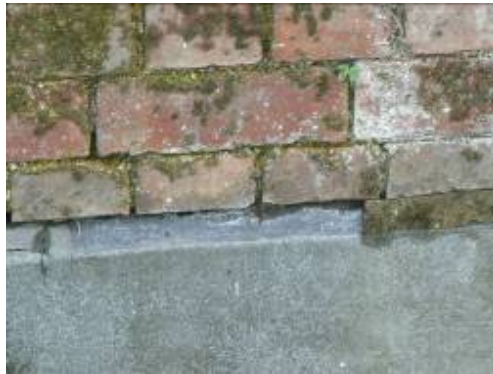
Photograph No. 84

At ground level there is evidence of an asphalt tanking system but where this is pointed against the brickwork, it is in a poor condition and water is likely to track back behind, as shown on photograph No. 84.

At the asphalt junction at ground level, this is showing signs of damage and has quite open joints, and as with the western elevation, an allowance should be made for repair or up-grading this tanking.

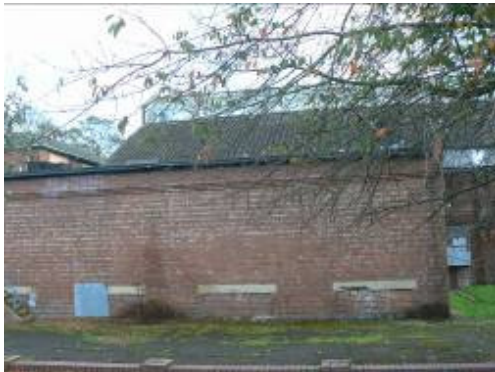
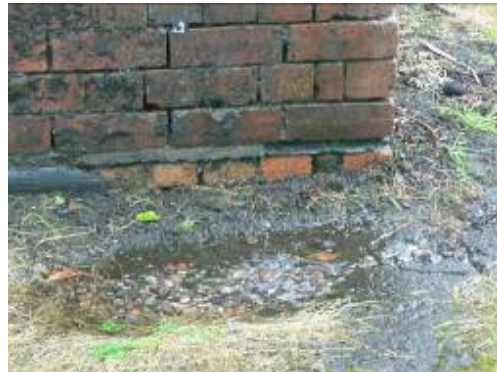
To the central single storey flat roofed area, as shown on photograph No. 85, there is no downpipe at the western end and therefore, water is discharging down the brickwork and there is a large amount of staining and collection of water at this corner, as shown on photograph No. 86.

To the main single storey elevation, again there are failures to the guttering which needs to be replaced, the downpipes re-installed and making good of the brickwork.

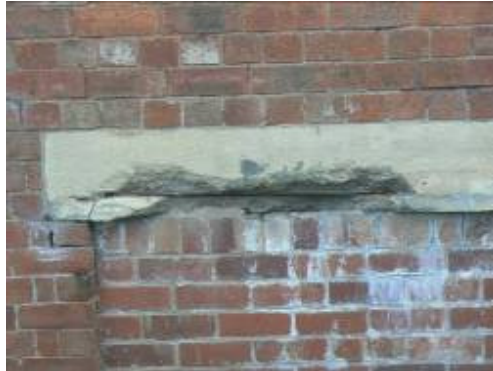
Photograph No. 88

To the lower brickwork there are three openings which have been bricked in, the lintol to the western most of which has failed, as shown on photograph No. 88.

There is damage noted to the lintols and these should be replaced.

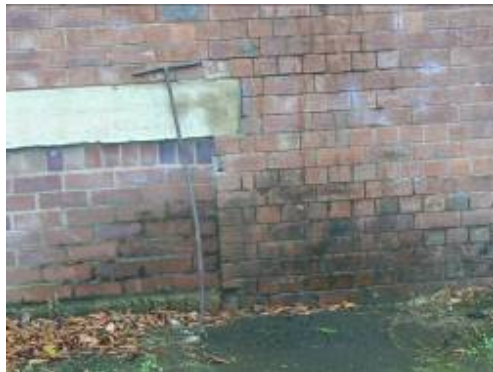
Photograph No. 89

The lintol to the central opening is in a reasonable condition and the eastern one has damp staining where again the gutter is failing, causing a staining of the lower brickwork, and this is all shown on photograph No. 89.

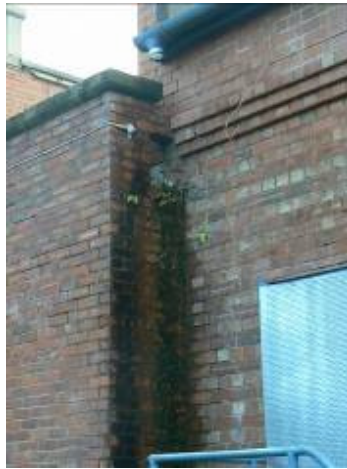
Photograph No. 90

At the eastern end there is a set of steps which are in a reasonable condition. To the front section of the building, being the children's bath entrance, the hopper outlet discharges directly onto the brickwork with no downpipe and there is noticeable staining and damp which is causing vegetative growth, as shown on photograph No. 90.

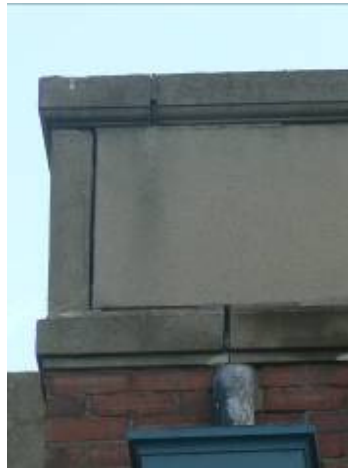
Photograph No. 92

To the eastern corner of the parapet there is slight displacement, as shown on photograph No. 92, and this will need to be re-set.

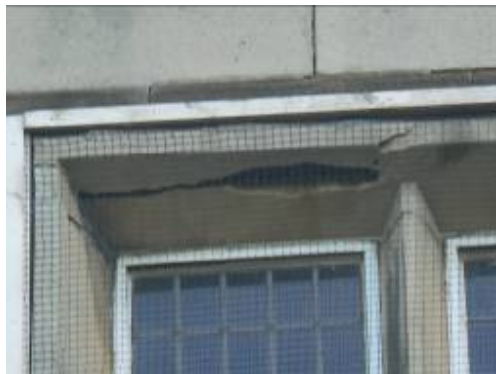
Photograph No. 93

To the main window WF11, the lintel has fractured at the eastern corner with corroding reinforcement and also to the western reveal. The cill is also in a poor condition, and this is all shown on photographs numbered 93 and 94.

The front section of the library building has similar structural defects, as noted on the front elevation, in that the main first floor window is in a poor state of repair with significant spalling of the reconstituted stone lintols and surrounds, which is likely to result in the dismantling of the window and new sections inserted.

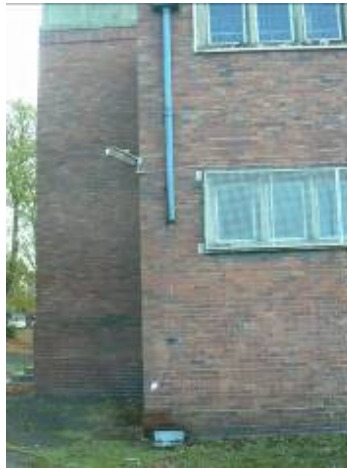
Photograph No. 95

On the eastern corner of the downpipe, the lower section is now missing, as shown on photograph No. 95, which will result in water discharging directly onto the brickwork.

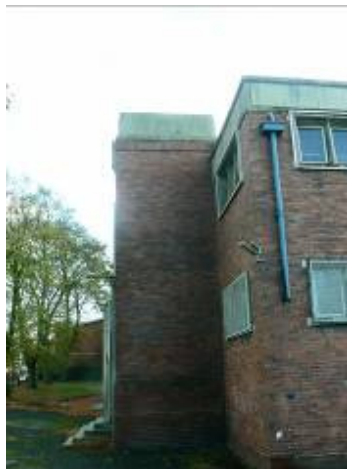
Photograph No. 96

To the front entrance tower, the northern elevation is shown on photograph No. 96.

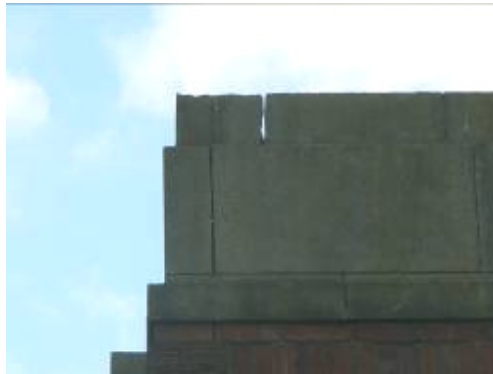
Photograph No. 97

There is displacement to the front corner of the parapet, as shown on photograph No. 97.

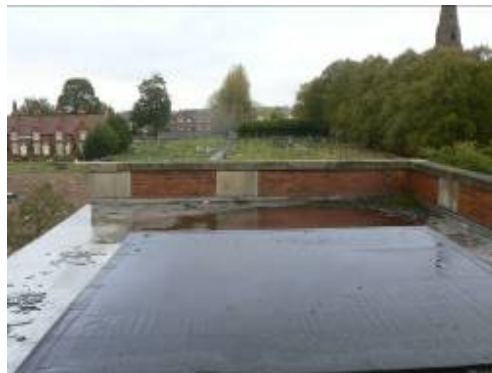
Photograph No. 98

Parapet – Starting on the northern return of the parapet wall, as shown on photograph No. 98, this is six courses of brickwork with a coping on the top.

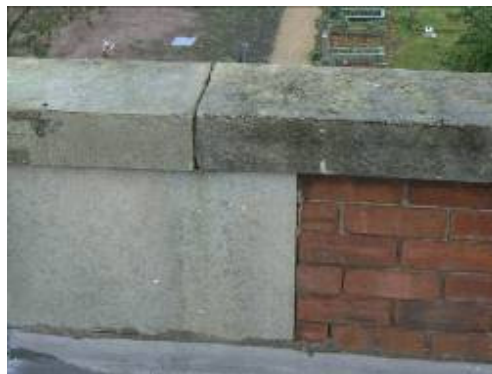
Photograph No. 99

There is no sign of major structural movement to this section of wall, but it is quite open jointed to the side of the inset stone feature panels and also the coping, as typically shown on photograph No. 99.

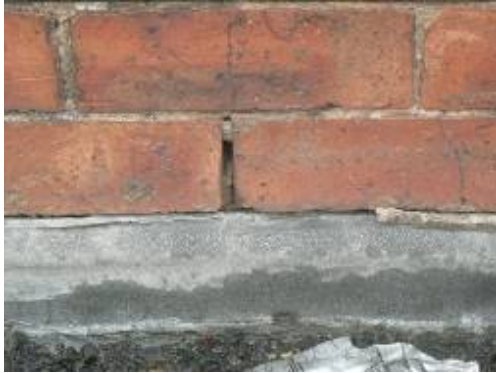
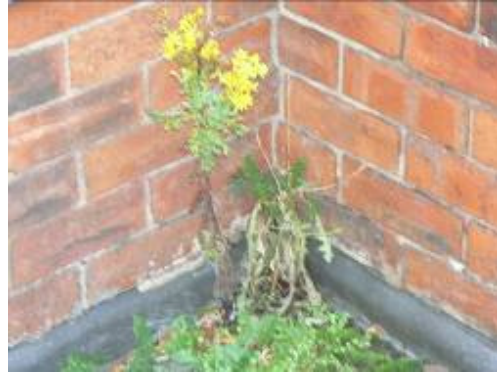
The flashing from the roof is only turned up the wall 75mm and the pointing is coming away. It is also noted that in the north-eastern corner, there is vegetation growing out of this junction, and this is all shown on photographs numbered 100 and 101.

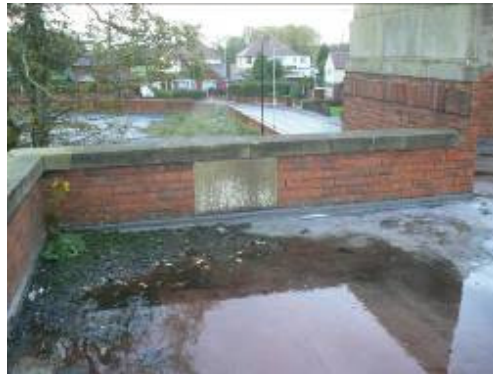
Photograph No. 102

The north-eastern section of the parapet is shown on photograph No. 102, and this is in a similar condition to that noted above with no major movement, but pointing required, especially at the junction with the flashing.

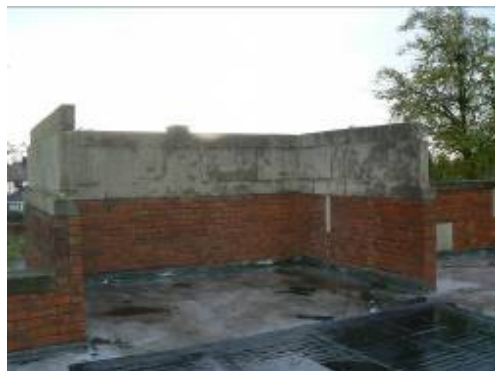
Photograph No. 103

The parapet then steps up in height around the library entrance tower, as shown on photograph No. 103.

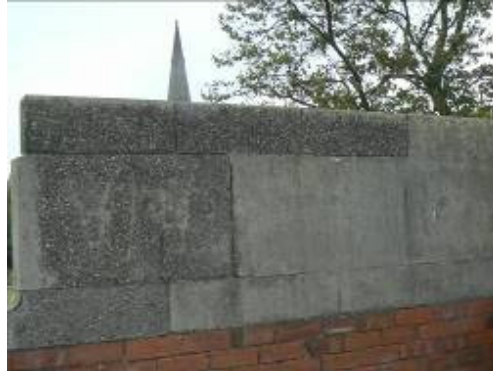
Photograph No. 104

The sections of parapet stone are quite slender and it is noticeable that on the northern face there is a large section of exposed aggregate now showing, as shown on photograph No. 104.

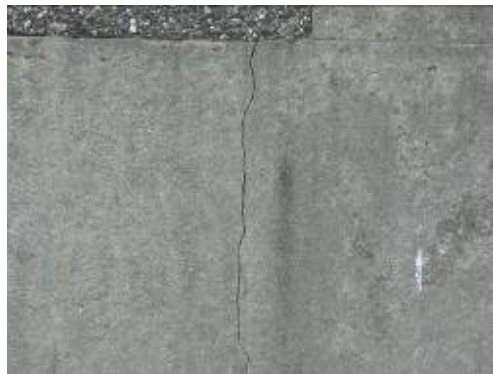
Photograph No. 105

This area is quite open jointed and to the large central block, there is now a vertical crack, as shown on photograph No. 105.

The reconstituted stonework around the towers to the library entrance, does show displacement on the corner and it is felt that this is likely to be due to thermal movements, due to a lack of cramping of the stones and the fact that they are generally quite slender in nature and therefore, more prone to movement. It would therefore, be recommended that these are taken off and re-set and clamped together to ensure that they are stable in the future. When this work has been carried out, the vertical fractures which are present can be dowelled and these cracks are considered to be due to thermal movements.

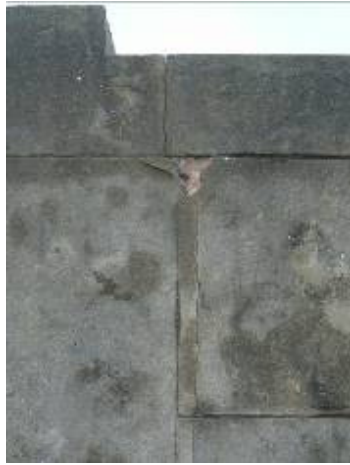
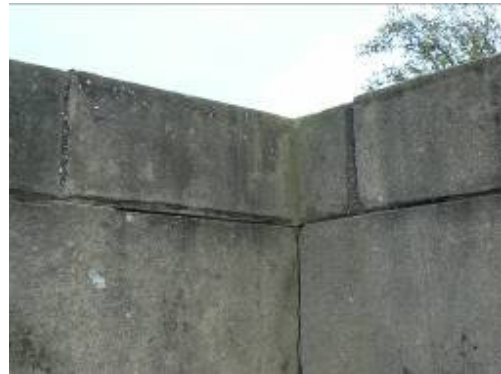
On the eastern section there is again a series of vertical cracks, a small section of spalling stone and also displacement of the top course and this is all shown on photographs numbered 107 and 108.

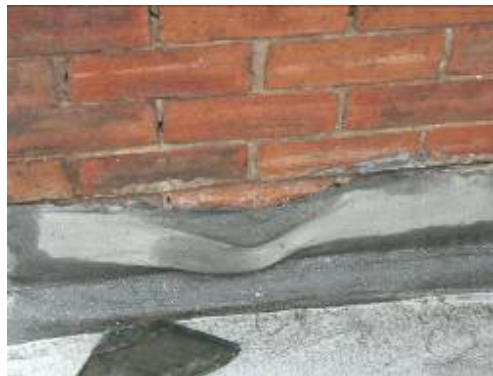
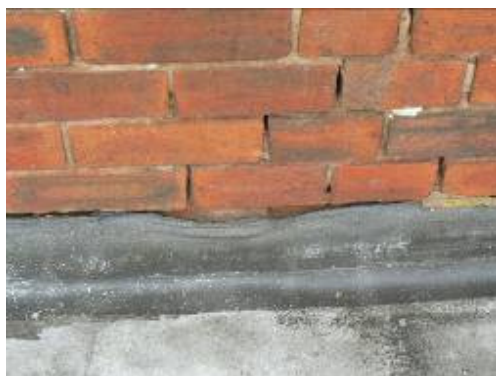
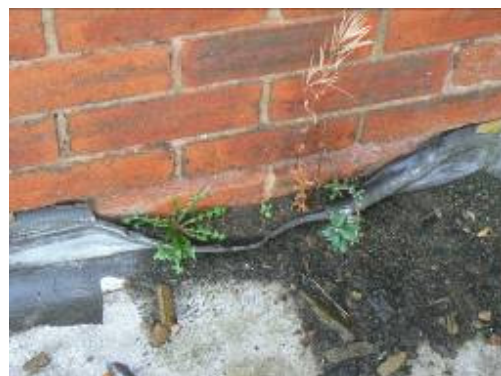
The most noticeable item is that the asphalt flashing junction has now failed in numerous places, as shown on photographs numbered 109 to 111 inclusive.

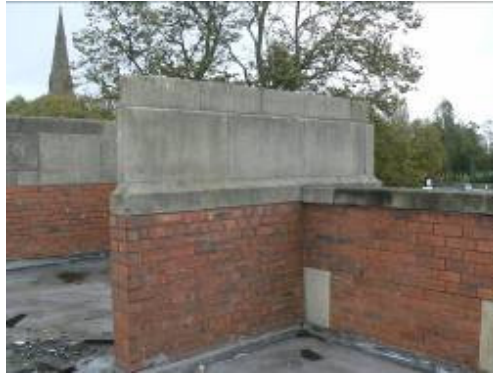
Photograph No. 112

When viewing this section from the south, the displacement to the front corners can also be seen on this side. The brickwork however, is in a reasonable condition and displays no sign of any major movement, as shown on photograph No. 112.

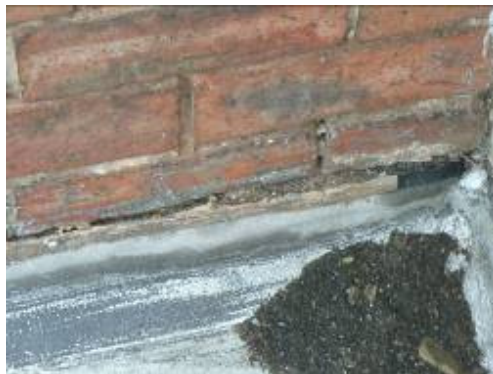
Photograph No. 113

The flashing at the base of the wall is again coming away and this is shown on photograph No. 113.

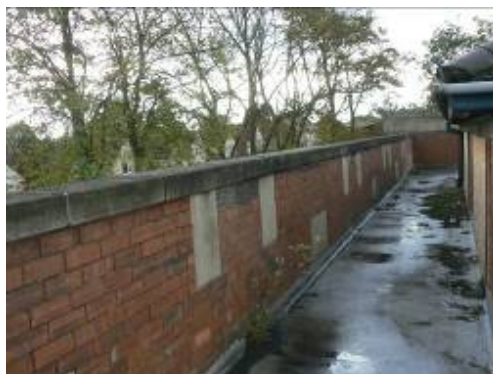
Photograph No. 114

The main eastern run of the parapet wall is shown on photograph No. 114.

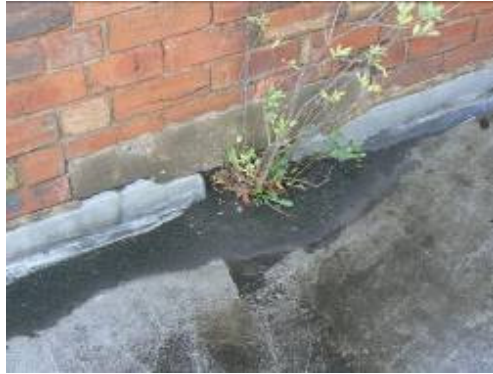
Photograph No. 115

This generally shows no sign of major structural cracking, although the coping is slightly open jointed and needs repointing and at the gutter outlet, this seems to be quite blocked and now has a small self-seeded tree growing out of the outlet, as shown on photograph No. 115.

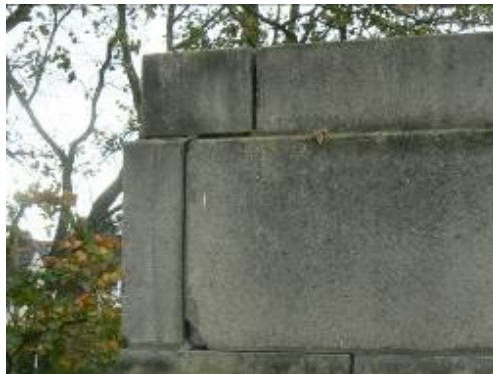
Photograph No. 116

At the raised section to the southern library tower, the north-eastern corner shows displacement, as shown on photograph No. 116. The brickwork panel below however, is in a reasonable condition.

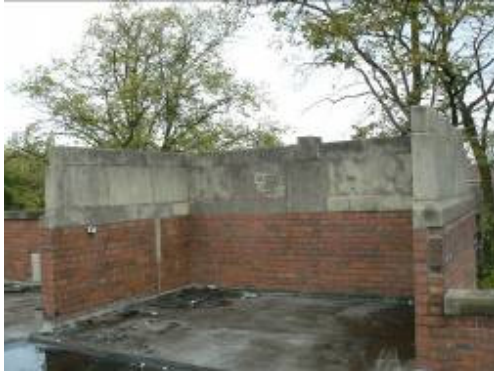
Photograph No. 117

On the inner section, as shown on photograph No. 117, there is slight displacement to the centre on the northern side and the displacement to the north-eastern corner can also be seen, as shown on photograph No. 118.

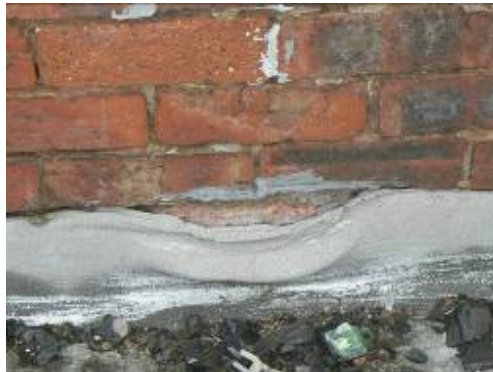
Photograph No. 119

On the last section of parapet wall along the front, the masonry is in a reasonable condition but the flashing is quite poor, as shown on photograph No. 119.
