Heath Town Baths and Library

HEATH TOWN BATHS & LIBRARY Structural Condition Survey

November 2011

This report forms part of a Feasibility Study for the adaptive re-use of Heath Town Baths & Library to a Sports Academy on behalf of the Tessa Sanderson Foundation Academy.

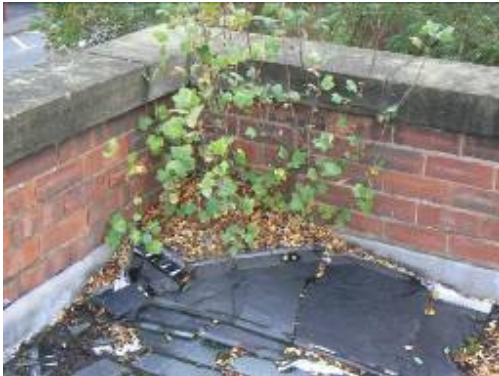
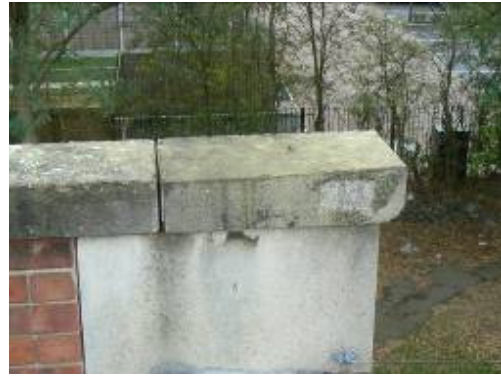
The southern wall has a large amount of vegetation in the corner and the coping joints are quite open, especially the end stone which needs to be re-set, and this is all shown on photographs numbered 120 and 121.

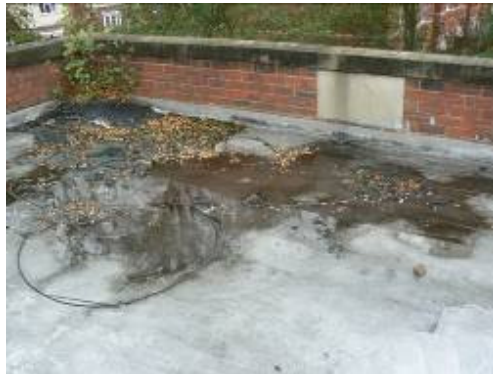
Photograph No. 122

Roof – The roof is covered in asphalt and starting at the southern flat roof, the water does pond to the centre on the southern side, as shown on photograph No. 122.

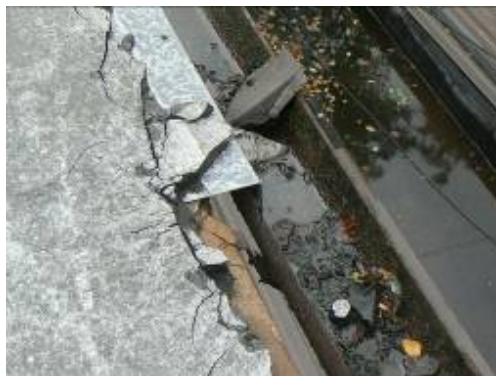
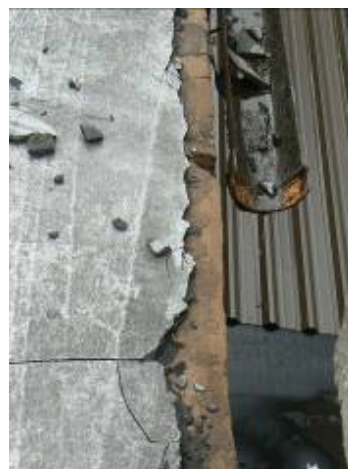
To the western edge the gutter is full and does not drain properly, and it can also be seen that the asphalt is damaged and the tin strip used to join the guttering to the roof is also missing in section and this is shown on photographs numbered 123 and 124.

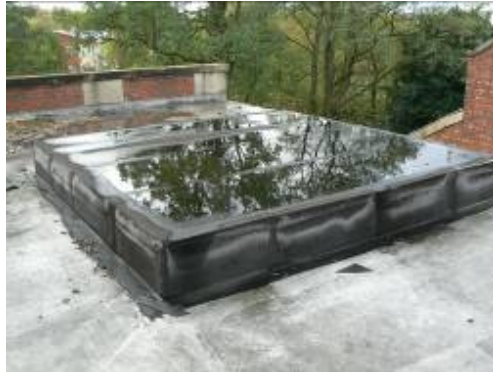
Photograph No. 125

The original central lantern has now been covered with felt and the original structure is now not present, as shown on photograph No. 125.

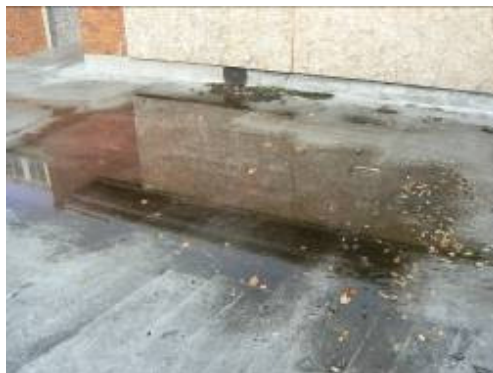
Photograph No. 126

Moving to the north, again the roof ponds quite noticeably, as shown on photograph No. 126.

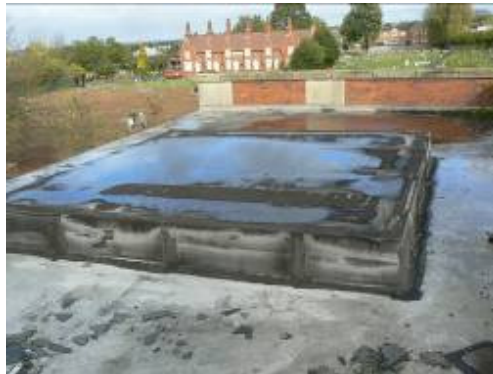
Photograph No. 127

At the northern end of the roof, this mirrors the southern side in that the roof light has been removed and has felt over it and it ponds quite noticeably, all as can be seen on photograph No. 127.

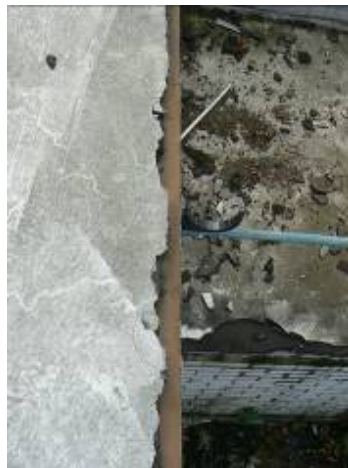
Photograph No. 128

On the western edge the asphalt is starting to break up and is damaged and the tin strip is now missing, along with the guttering, as shown on photograph No. 128.

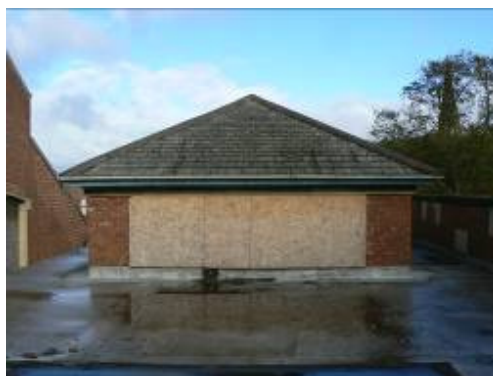
Photograph No. 129

On the raised section over the library building, the southern elevation is shown on photograph No. 129.

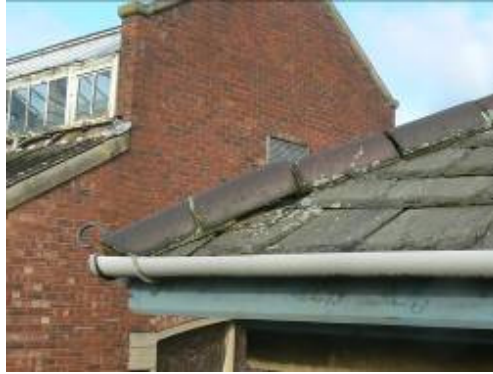
Photograph No. 130

The eastern hip is reasonable with hip irons and the slates are in a reasonable condition with just an occasional one which is chipped. The western hip however, needs to be re-set, as shown on photograph No. 130.

The raised slated roof section is actually in quite a reasonable condition. It would be recommended that the hips are re-set and a check is made on the ridge tiles. At present the windows cannot be seen, but what is noted is that the brickwork is in a reasonable condition and there are no major works required to this section.

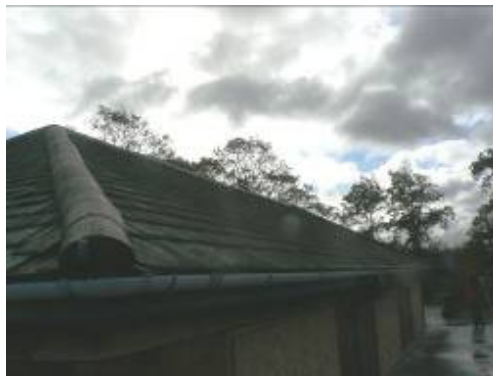
Photograph No. 131

The western roof appears to be in a reasonable condition, as shown on photograph No. 131.

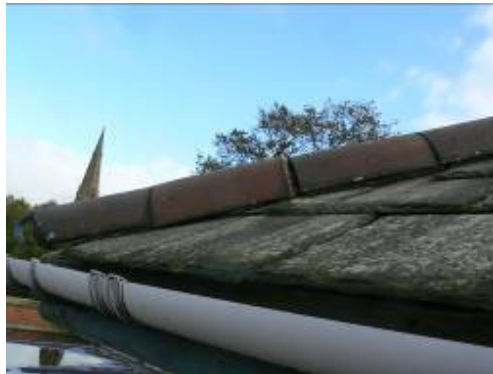
Photograph No. 132

At the northern end the bottom hip tiles are coming away and need to be re-set, as shown on photograph No. 132.

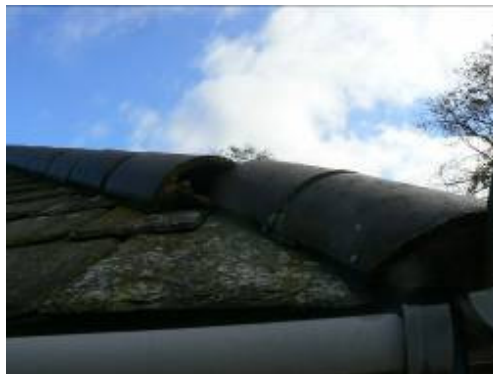
Photograph No. 133

As noted on the southern elevation, the western most hip is displaced, and this is shown on photograph No. 133.

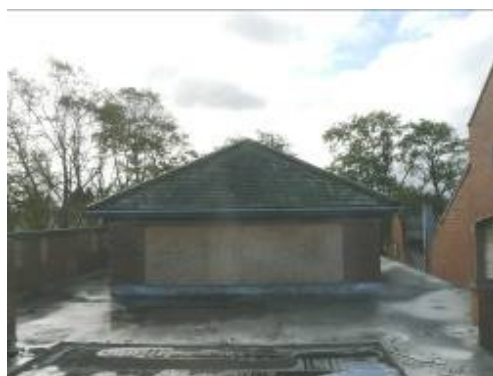
Photograph No. 134

The northern elevation of this section is shown on photograph No. 134.

The hipped roof is in a reasonable condition with only minor displacement of the slates and the hips at the lower western corner. The slates however, all appear to be present and are working quite adequately.

To the wall itself, the windows are boarded over but there was no sign of major structural movement.

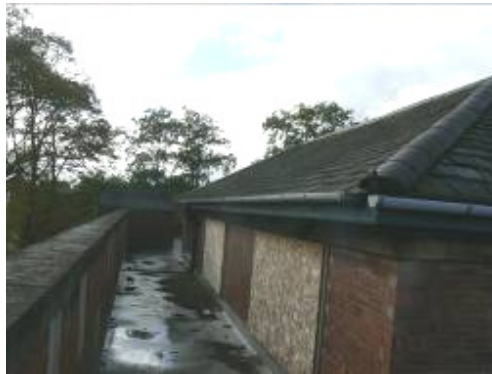
Photograph No. 135

On the eastern elevation of the roof, this is shown on photograph No. 135.

The roof lines are quite reasonable and the majority of the slates are present. In the longer term it is likely that the ridge will need to be re-set. However, generally this all appeared to be in a reasonable condition.

To the wall, the first windows are visible as they are boarded from the inside and these are metal frames without any glazing present. The reconstituted stone surrounds have an occasional hairline crack. The two windows to the northern side are boarded and therefore, could not be viewed.

The eaves course needs an occasional joint repointing and the brickwork is in a reasonable condition.

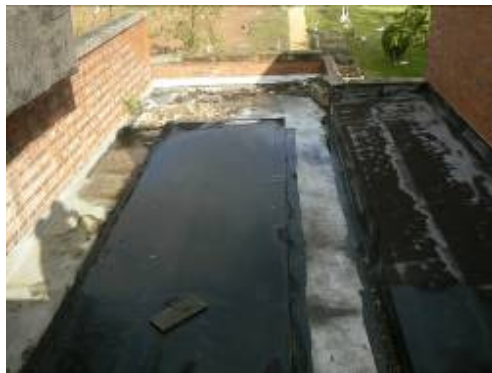
Photograph No. 136

Starting at the northern side, this originally had a large glazed lantern and also patent glazing to the eastern side, both of which have now been infilled and covered over with felt, as shown on photograph No. 136.

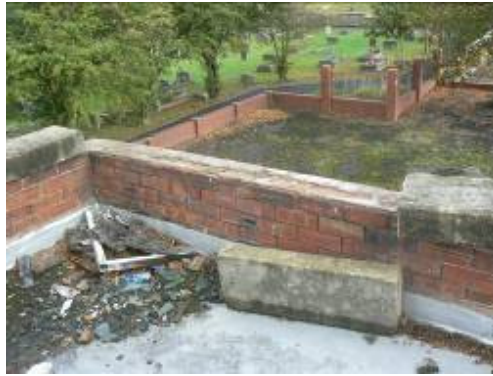
Photograph No. 137

To the northern side there is a small parapet wall and to the eastern return, the coping is now missing or has become displaced, as shown on photograph No. 137, and this needs to be re-set.

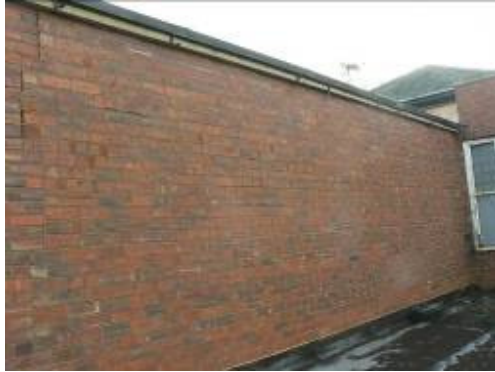
Photograph No. 139

From this lower wall, the western wall of the library building can be seen, as shown on photograph No. 139 and the brick changes at the northern end where it has been toothed-in, as shown on photograph No. 140.

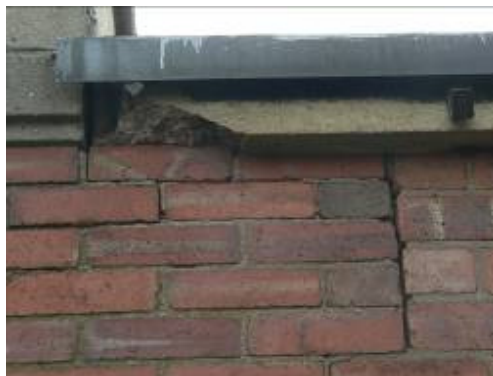
Photograph No. 141

The upper section of brickwork needs to be repointed and the eaves band also requires repair at the end, all as shown on photograph No. 141.

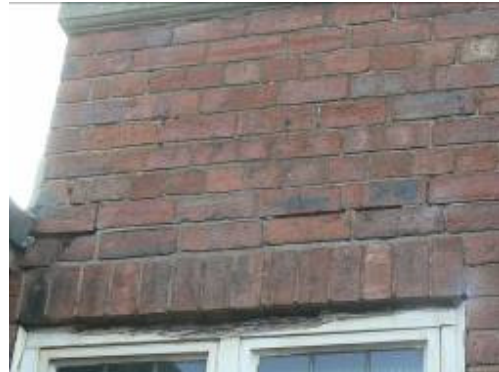
Photograph No. 143

On the southern return, the parapet wall is leaning to the south and this has fractured at its base, and it would be recommended that the top eight courses are re-set. This area and the failure lines are shown on photographs numbered 142 and 143.

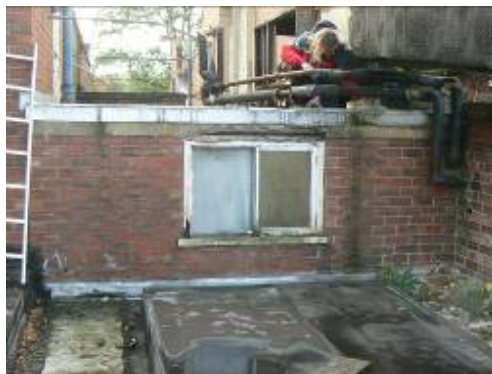
Photograph No. 144

Moving to the west there is a lower level section, as shown on photograph No. 144.

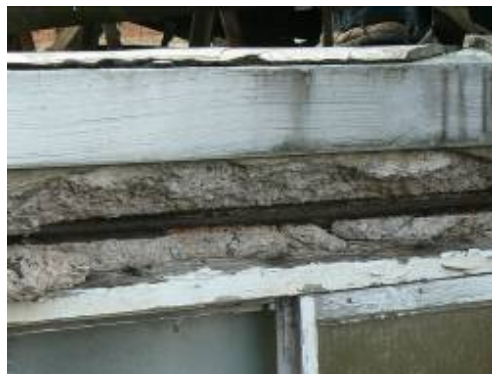
Photograph No. 145

The edge beam is in a poor condition over the window and this requires repair and the window replaced, as shown on photograph No. 145.

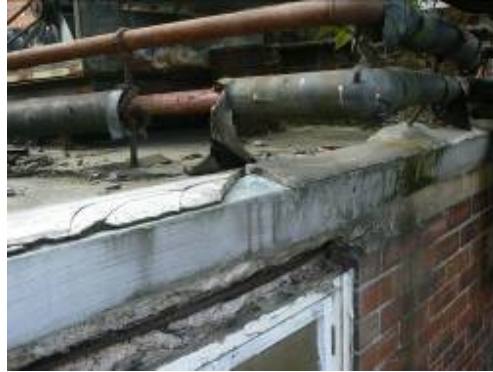
Photograph No. 146

To the remainder there is a small amount of water staining where the edge detail to the roof is not working adequately with the asphalt having come away from the end cover strip, as shown on photograph No. 146.

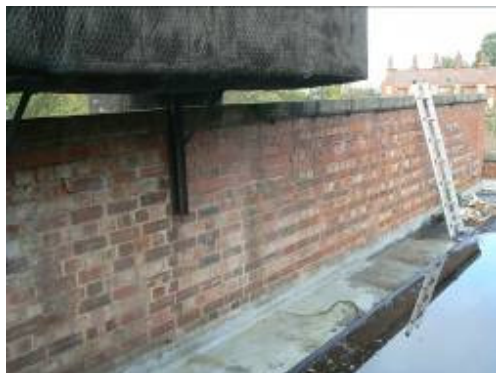
Photograph No. 147

To the western side of this first area, there is an upstand wall, as shown on photograph No. 147, and it can be seen that to the right hand end, this has previously been rebuilt, as shown on photograph No. 148.

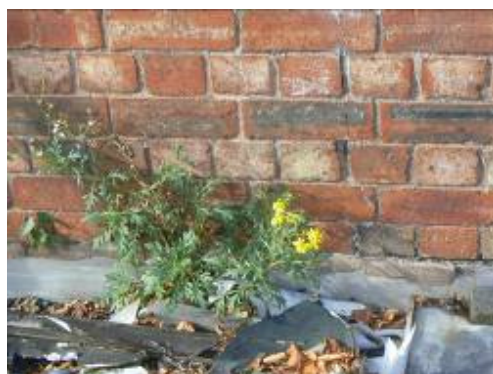
Photograph No. 149

Generally, the wall is in a reasonable condition with only an occasional amount of repointing being required. However, at the flashing junction at the base, this is quite poor with the pointing coming away and also sections of vegetative growth, as shown on photograph No. 149.

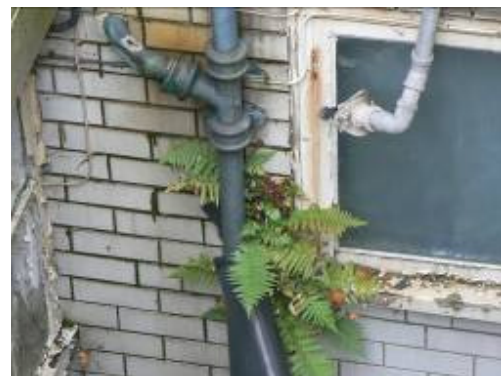
Photograph No. 54

To the lightwell, this is faced with a glazed white brick and it can be seen that the condition of the windows is quite poor. There is a lower flat roof and the front edge again is damaged, and there is also a large amount of vegetative growth, especially around the soil and vent pipe, and this is all shown as a general view on photograph No. 153 and the vegetative growth on photograph No. 154.

From what could be seen, there are no signs of major structural movements, but the area did require quite extensive work in removing the vegetation, making good the roofs and repairing the windows.

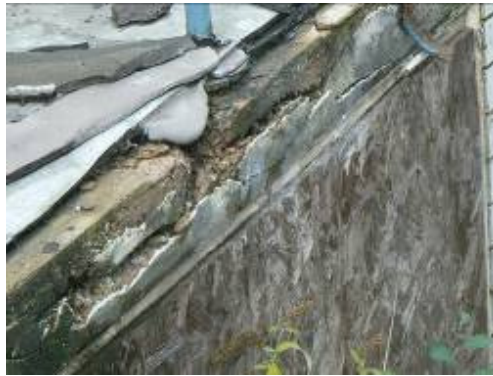
Photograph No. 155

To the eastern edge of the roof area, there is spalling to the concrete slab, as shown on photograph No. 155.

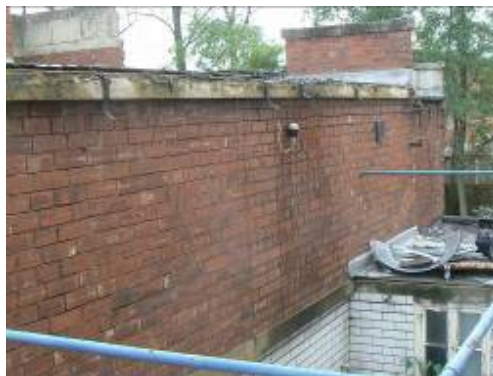
Photograph No. 156

The brickwork in the area past the southern lightwell to the library building shows localised areas of staining, but no major cracking and this is shown on photograph No. 156.

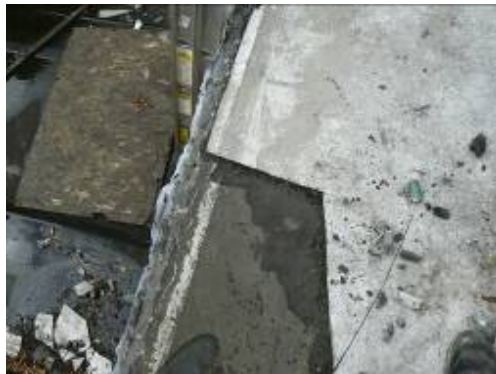
Photograph No. 160

From this roof, it can be seen that the original covering has been over-laid with a second layer of asphalt, part of which is coming away and this can be depicted on photographs numbered 160 and 161.

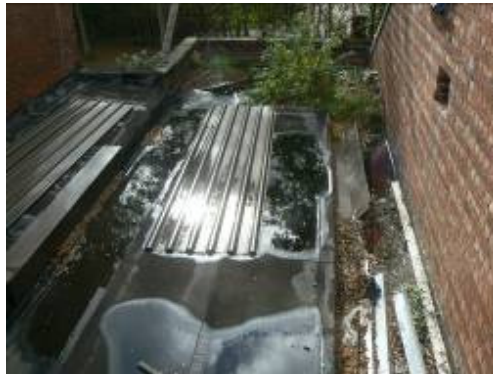
Photograph No. 162

Moving to the southern area, this mirrors the northern side in that the lightwell and glazed patent glazing area have been covered in with felt, and a general view is shown on photograph No. 162.

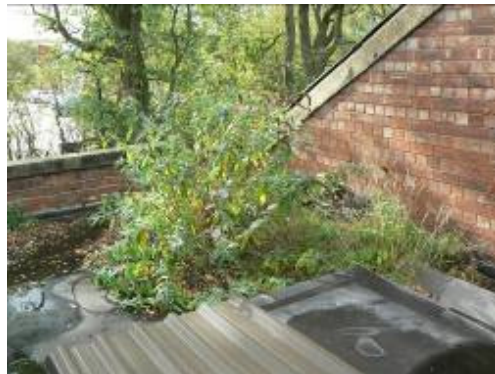
Photograph No. 163

There is a large amount of debris and also vegetative growth, as typically shown on photograph No. 163, and this will all need to be removed.

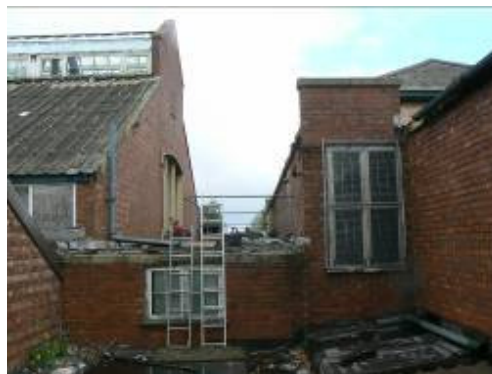
Photograph No. 164

From this area, the remaining walls to the central area can be seen and photograph No. 164 shows a view looking to the north.

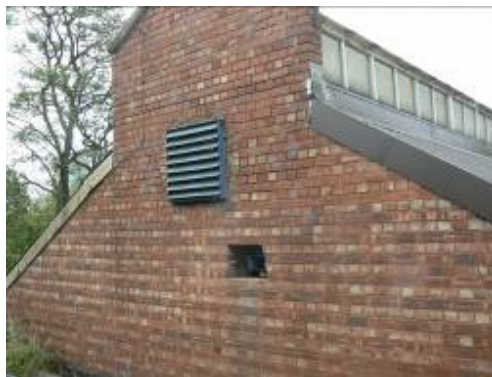
Photograph No. 165

The gable to the southern most building is shown on photograph No. 165.

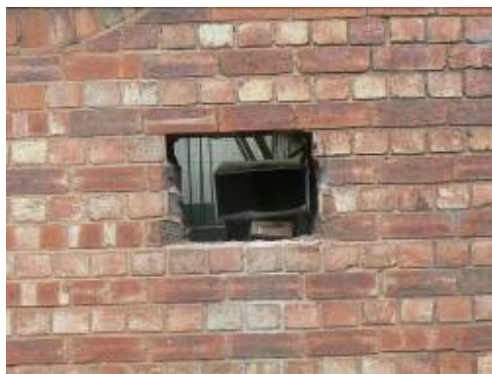
Photograph No. 166

It is noted that at the junction with the flat roof, the flashing junction needs to be repointed and apart from a large metal grill put through the bullseye window, there is also another crude opening which has been put through for an extract duct, as shown on photograph No. 166.

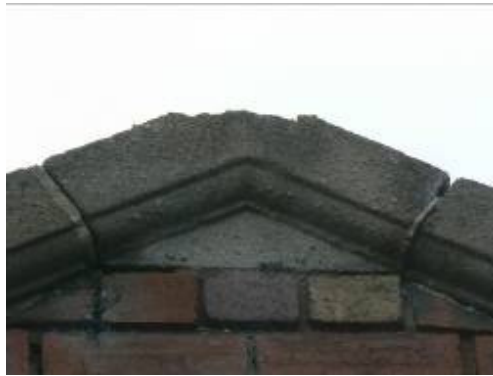
Photograph No. 167

The remainder appears to be in a reasonable condition, although there is localised making good required to the apex stone, as shown on photograph No. 167.

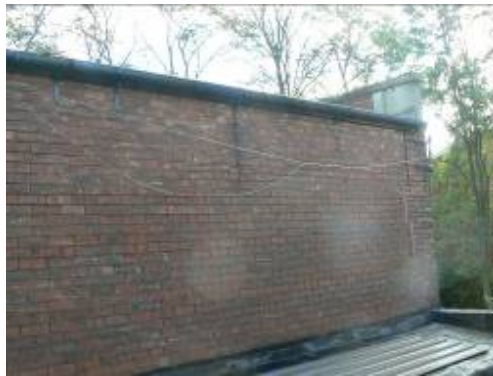
Photograph No. 168

To the western wall of the library at this southern end, a general view of this part of the wall is shown on photograph No. 168.

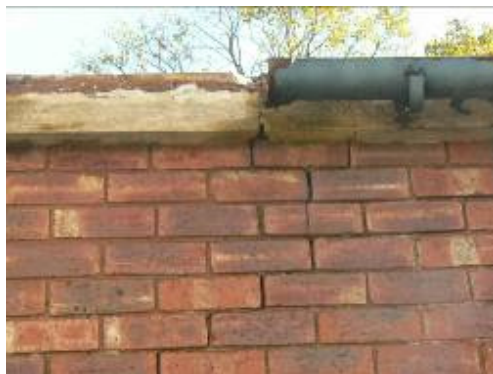
Photograph No. 169

Where the wall returns there is a minor diagonal crack which requires repointing. It can be seen that the gutter is now not present and the edge of the eaves strip requires repair, and this is all shown on photograph No. 169.

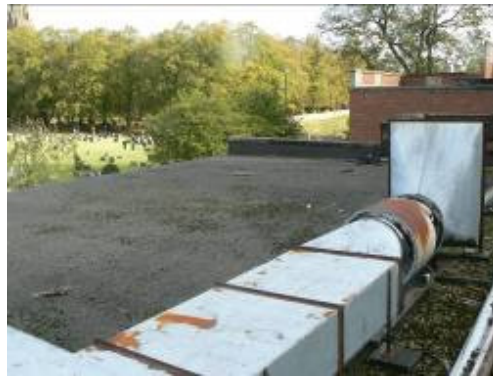
Photograph No. 171

This would originally have had a pitched roof with a lantern on top, similar to the southern side, but this has been removed and a new timber boarded roof with mineral felt and chippings installed, and a general view is shown on photograph No. 171.

The roof itself is considered to be nearing the end of its serviceable life, where it is accepted that flat felt roofs have a lifespan of between 10 and 15 years.

It is considered that the mineral felt is past its serviceable life and it would be recommended that the roof is completely stripped and if, within any of the option schemes, it is to be retained then it will require re-covering.

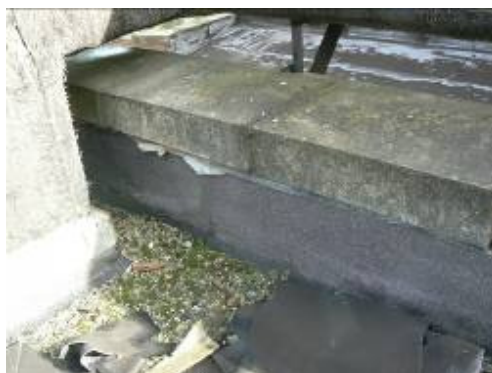
Photograph No. 172

Starting on the eastern side, where there is an upstand with a coping, the felt was taken up to the underside of the coping and then a lead cover flashing dressed over the top. However, this has now been crudely cut off and removed, as shown on photograph No. 172.

To the western side, there is again a coping and upstand and the lead has been removed, as noted on photograph No. 172 above.

The junction with the swimming pool building to the southern side requires the asphalt detail to be removed and a suitable flashing designed and installed. The small parapet wall is generally in a reasonable condition and will just require new flashings and in small areas, the coping repointed.

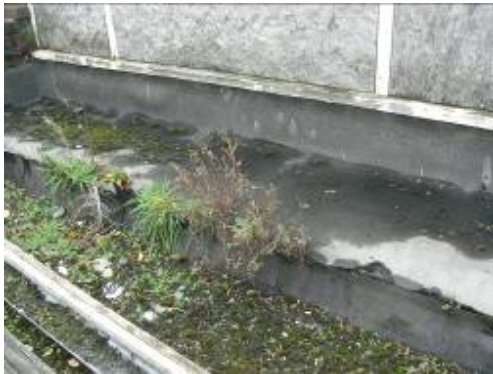
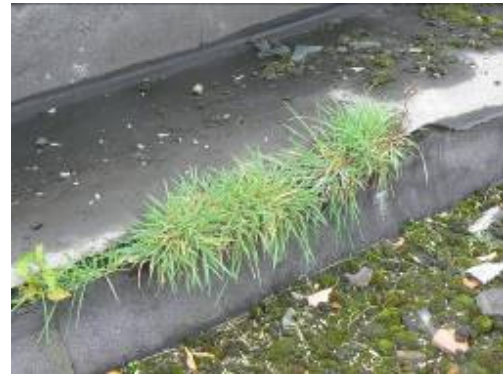
On the southern side, with the detail against the main swimming pool building, the felt is lapped up to the underside of the asphalt and this general detail is in a poor condition with large amounts of vegetation growing between the asphalt and the mineral felt, examples of which are typically shown on photographs numbered 173 and 174.

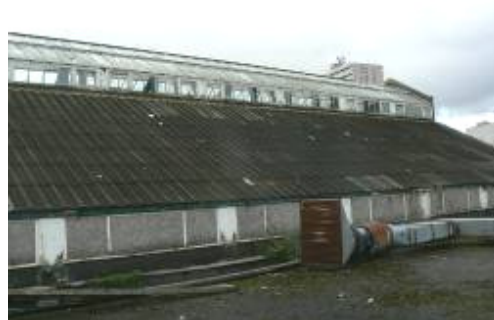
Photograph No. 176

It can be classified as a monitor roof which is a pitched roof with a glazed lantern on the top, and a general view is shown on photograph No. 176.

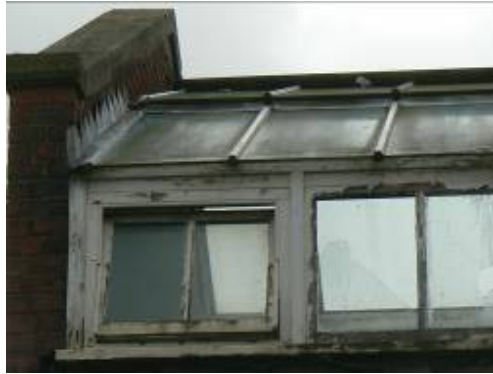
Photograph No. 177

The roof is split into a series of panels, delineated by the internal concrete frames to the Swimming Pool. Starting at the eastern end, there is a 225mm brickwork parapet and the glazing and framework are showing distinct signs of age and disrepair, and this is all shown on photograph No. 177.

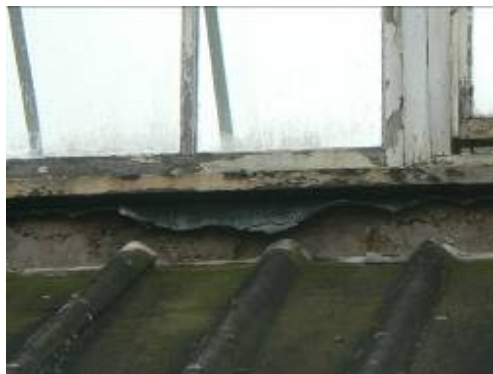
Photograph No. 178

At the underside of the lantern, there is an exposed concrete ring beam and the lead which formerly lapped underneath the upper frame and then over the sheeting, has been crudely cut off and removed exposing the concrete, as shown on photograph No. 178.

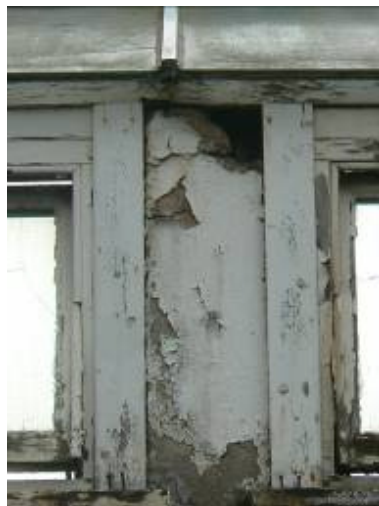
Photograph No. 180

There is then a similar situation with the second and third frames, as shown on photographs numbered 180 and 181.

The damaged concrete will all need to be cut out and a suitable concrete repair material introduced to re-establish their structural integrity.

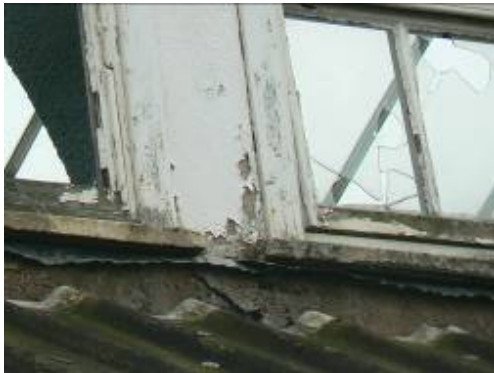
Photograph No. 182

The 4th, 5th and 6th frames do appear to be in a slightly better condition, but there is still evidence of spalling concrete at the lower areas, as shown on photographs numbered 182 and 183.

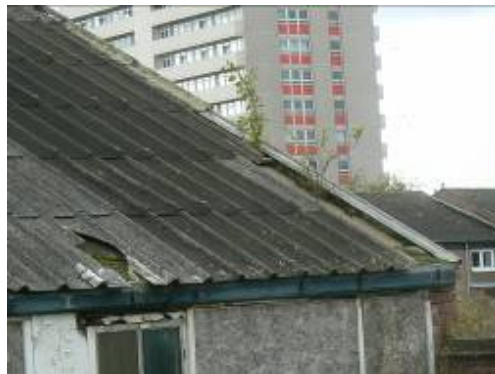
Photograph No. 184

At the western end the sheeting is missing and there is vegetation growing out of the end flashing detail, as shown on photograph No. 184.

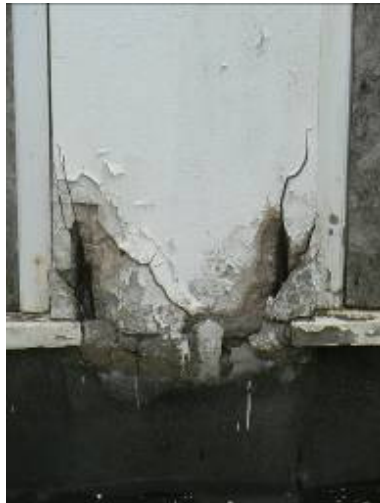
Photograph No. 186

To the lower level upstand and again starting at the eastern side, the first frame has exposed and spalling concrete, as shown on photograph No. 185 and there is a similar situation to the remainder of the frames and a photograph of each is shown on photographs numbered 186 to 190 inclusive.

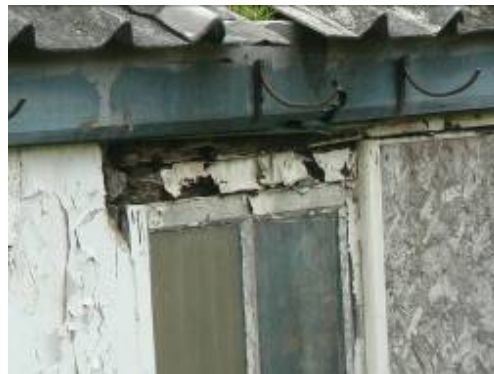
Photograph No. 191

The majority of the windows are boarded over, but from the one window which can be seen, this appears to be in a very poor condition, as shown on photograph No. 191.

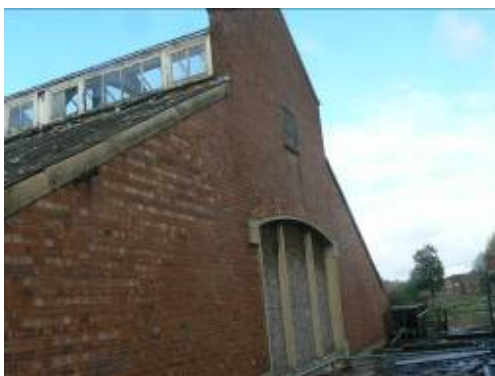
Photograph No. 192

The main eastern end elevation of the Swimming Pool section is brickwork with a window set just above Area 2, and a general view is shown on photograph No. 192. It is noticeable that there is a change in the style of the brickwork to the outer edges, as can be depicted on photograph No. 193.

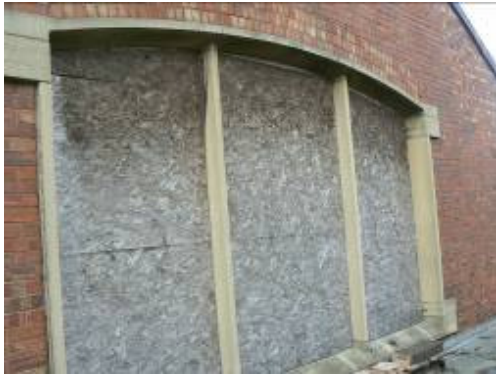
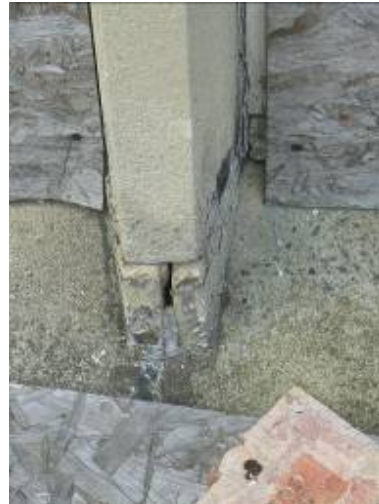
The main window surround is in a reasonable structural condition with no sign of major spalling and just a slight opening where the separate sections of cill were jointed, and this is all shown on photographs numbered 194 and 195.

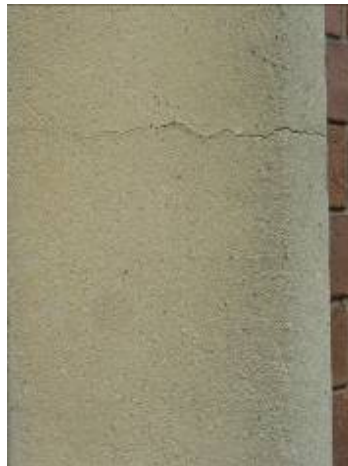
Photograph No. 196

To the northern reveal there is a series of horizontal cracks which will require repair, as shown on photograph No. 196.

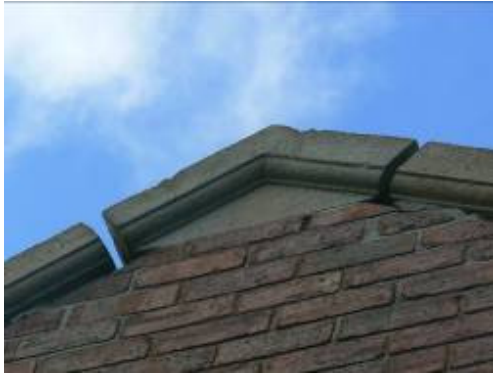
Photograph No. 197

To the reconstituted stone copings, the apex stone is quite open jointed, as shown on photograph No. 197, and it can be seen that the kneeler has slipped slightly, probably due to its inadequate size, as shown on photograph No. 198. An allowance should be made for re-setting this coping.

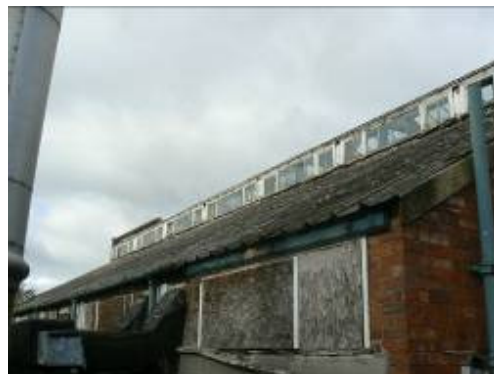
Photograph No. 199

The southern elevation of the main Swimming Pool roof is shown on photograph No. 199.

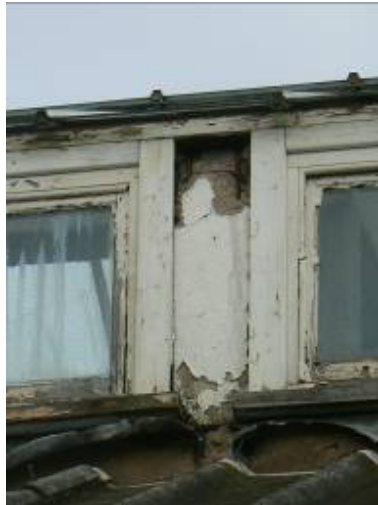
Photograph No. 200

From what could be seen, the upper lantern is in a similar condition to that noted on the northern side, in that the timber framework to the glazing is in a poor condition. To the main concrete frames, there is again noticeable damage with exposed sections of reinforcement and starting at the eastern side, the first frame has exposed reinforcement bar at both the top and the bottom, as shown on photograph No. 200. The remaining five are in a similar condition, as typically shown on photographs numbered 201, 202 and 203.

It is considered that the main Swimming Pool roof is in need of significant repair. The exposed surfaces of the main concrete frame supporting the roof show noticeable spalling to both the northern and southern sides. It is therefore, considered that the glazing and upper lantern frame will all have to be removed, not only due to the condition of the timber, but also to allow access to the frames so that these can be repaired, and this will require access to all four sides of the columns.

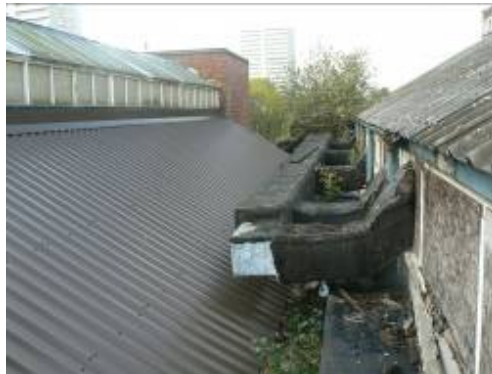
Photograph No. 204

Viewing of the lower area was restricted due to the amount of boarding and also the amount of ventilation ducting present, as shown on photograph No. 204. However, it should be accepted that this is in a similar condition to that noted on the northern side.

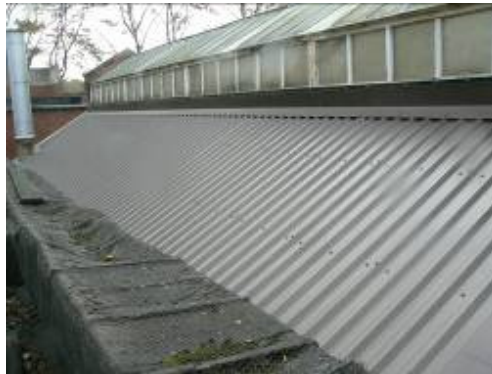
Photograph No. 205

The northern face has been re-covered in profiled metal sheeting and a general view is shown on photograph No. 205.

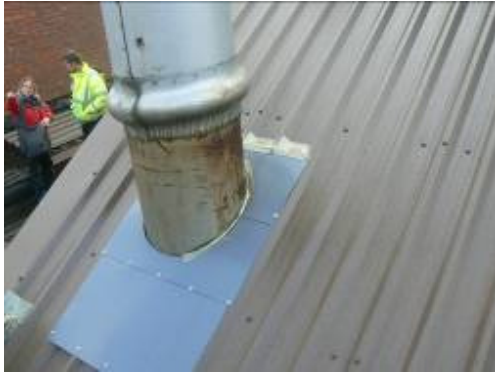
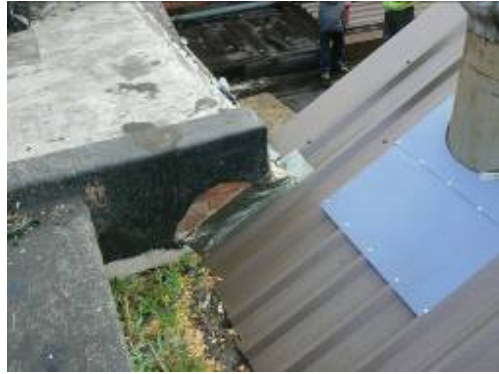
The roof sheeting is in a reasonable condition, but the flashing details around pipe entries and also at the eastern end were poorly executed with the use of Flashband which is a temporary material, and this is typically shown on photographs numbered 207 and 208.

The northern slope to this roof has already been replaced in a profiled metal sheeting, although it should be noted that the flashing details are poor around service entry positions, and these need to be up-graded to provide a watertight junction.

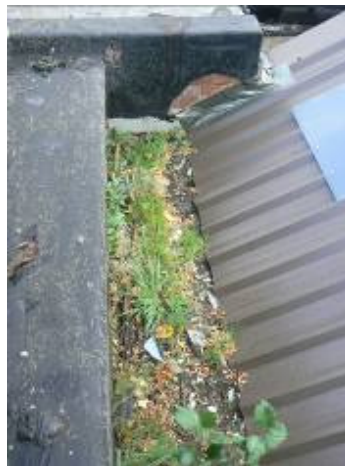
Photograph No. 209

The valley between Areas 4 and 5 is full of vegetation and is likely to be in a poor condition, as shown on photograph No. 209.

The valley between roof Area 4 and 5 is considered to be in need of replacement, and this will involve the removal of all the extract ducting.

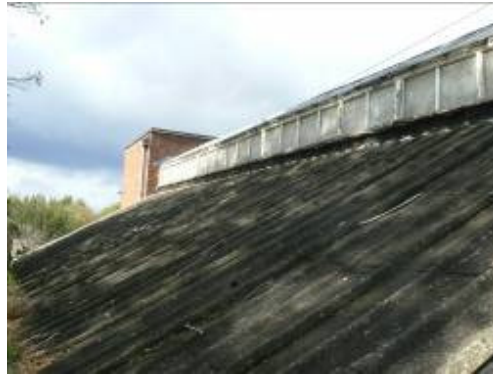
Photograph No. 210

On the southern elevation, the roof sheeting is asbestos cement, matching that on the Swimming Pool building, and a general view is shown on photograph No. 210.

The southern roof slope is asbestos cement sheets which should be removed and replaced, and this should include for clearing out all the guttering which should be either overhauled or replaced and reinstated. There are however, no sign of any major structural defect with this area of the building.

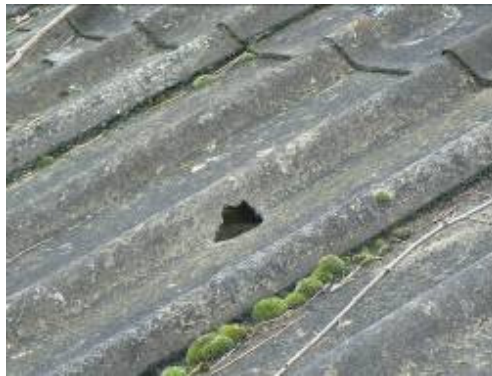
Photograph No. 211

The roof sheets are showing distinct signs of age and do have occasional holes within them, as typically shown on photograph No. 211.

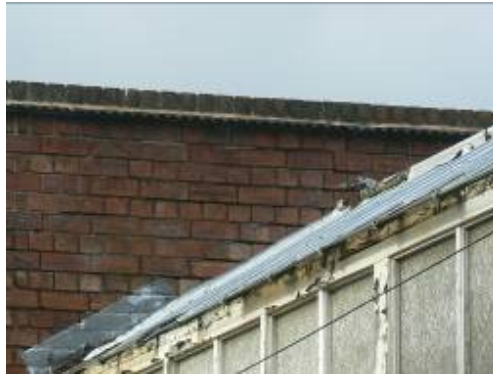
Photograph No. 213

To the lantern itself, the timber work is in need of decorative attention and a general view of all the above is shown on photograph No. 213.

The lantern area is of a slightly different form to that over the Swimming Pool, in that this roof is supported by steel angle trusses with the timber frame sat on top rather than the use of reinforced concrete. However, the timber work does require repair and redecoration.

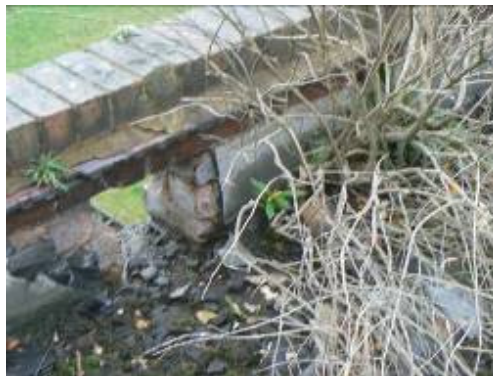
Photograph No. 214

Starting with the parapet on the southern side, this has a brick on edge acting as a coping and then a tile creasing underneath, and then the asphalt roof flashed underneath. There is a lot of vegetative growth at the outlet position and the asphalt is in a poor condition, as shown on photograph No. 214.

The asphalt roof is considered to be past its serviceable life with a large amount of cracks present. It is recommended that the plant and ducting is all removed and the roof stripped and re-formed. At this time, a new flashing will need to be let into the parapet wall and repairs can also be carried out to this, including making good the tile creasing course, repointing fractures in the brickwork and making good localised areas of damage.

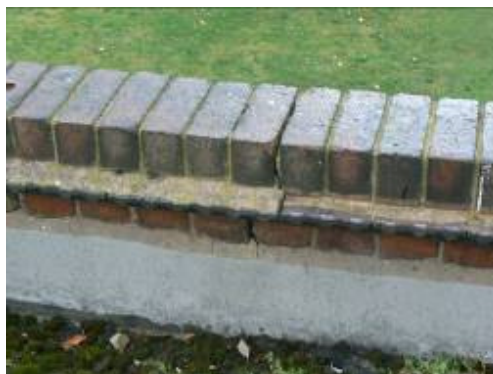
Photograph No. 215

The tile creasing course is often broken and also the mortar fillet on top coming away, and there is often an occasional minor crack in the brickwork and this is all generally shown on photograph No. 215.

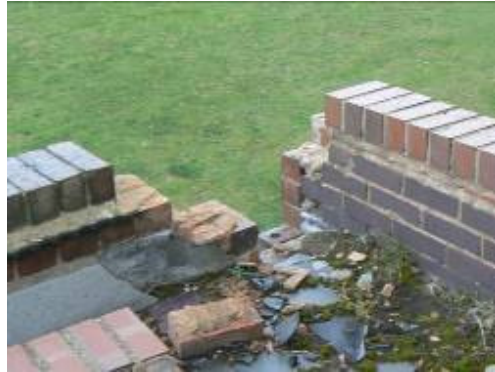
Photograph No. 216

In the north-western corner the brickwork is now damaged and missing, as shown on photograph No. 216.

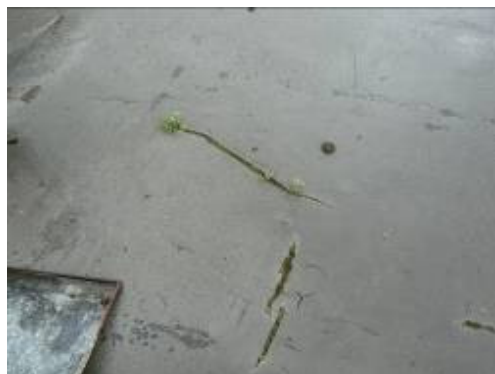
Photograph No. 218

To the asphalt roof itself, this is often cracked which is inducing vegetative growth, as shown on photograph No. 218.

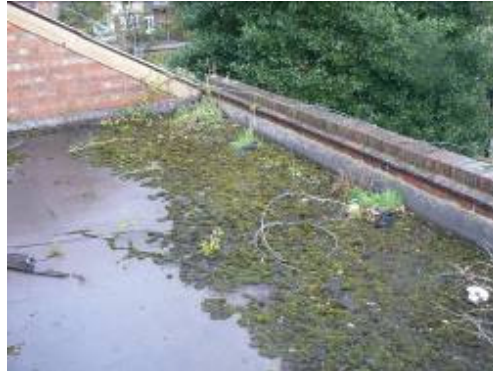
Photograph No. 219

On the southern side it is assumed that the roof ponds as there is now a lot of moss and vegetative growth at the junction with the parapet wall, as shown on photograph No. 219.

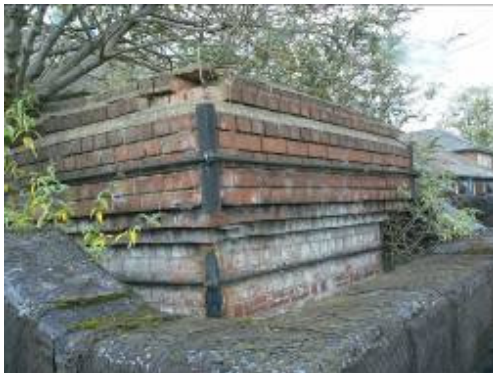
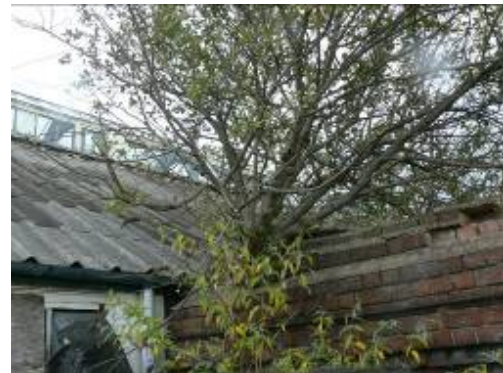
Set within this area there is a large service tower and also a chimney. The chimney has metal banding around the edge and also a large tree growing at the junction with the swimming pool building, all as shown on photographs numbered 220 and 221, and this will require all these top courses to be removed, the tree taken out and then the chimney rebuilt.

The chimney shaft adjacent to the Swimming Pool building needs the tree growth removed and the top courses rebuilt. The service duct however, is in a better condition. The condition of the roof is not known, but the brickwork does not show any sign of major movement, and there are only general areas of repointing required.

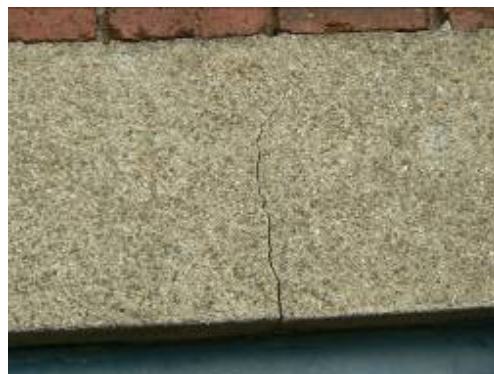
Photograph No. 223

To the main lintol there is one central crack which requires repair, and this is shown on photograph No. 223.

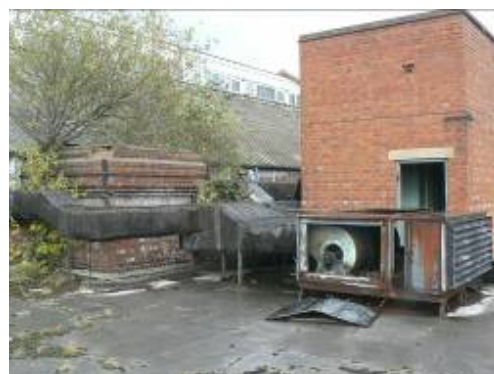
Photograph No. 224

The roof generally has a large amount of plant, a lot of which is corroding and it would be recommended that this is removed when the roof is re-covered. A general view of this area is shown on photograph No. 224.

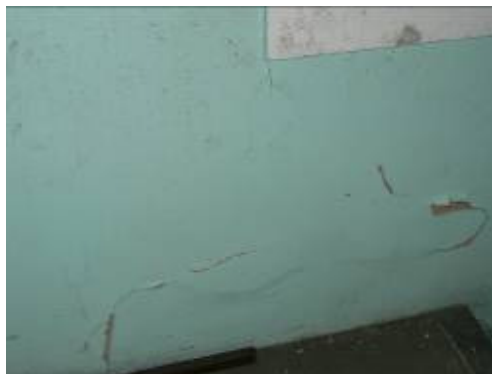
Photograph No. 225

Room F1 – This is the staircase area with the southern lobby with the cantilevered stair. The stair appears to be working quite adequately and the main issues are with penetrative damp through the walls which is causing a disturbance to the plaster, as shown on photograph No. 225.

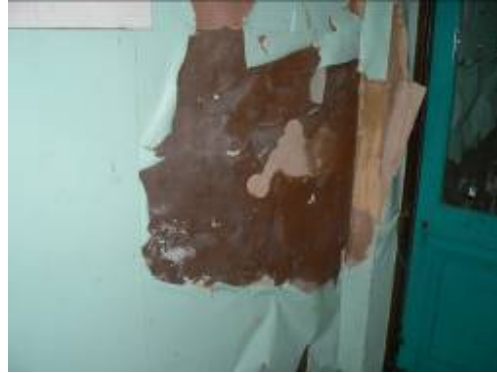
Photograph No. 227

Room F3 – This is the main eastern corridor and the eastern wall is in a poor state of repair with both the northern and southern ends having large areas of plaster delaminated, finishes coming away and damp penetration. This is all shown on photographs numbered 226 and 227 respectively.

These positions correspond with the external rainwater pipes which have already been noted as leaking. The walls show no sign of major structural cracking, the main issues being the damp penetration. What is noticeable is that in the large areas of damp, there is a significant amount of spores from the rot, which will need to be further investigated to ascertain whether this is dry or wet rot, and typical examples are shown on photographs numbered 228 to 230.

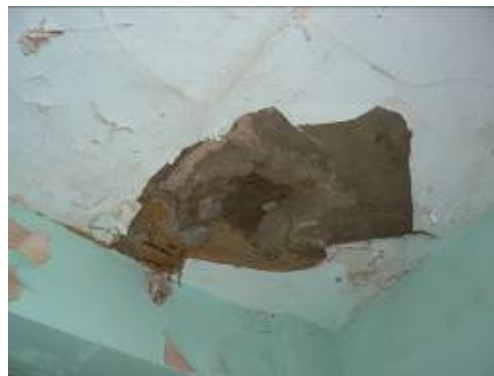
Photograph No. 232

To the ceiling there are areas of damp penetration and a small amount of reinforcing bar present at the end of the corridor, as shown on photograph No. 232.

There are localised areas of spalling concrete to the flat roofed areas to the northern and southern sides, which will all need localised repairs. At present however, they still considered capable of repair.

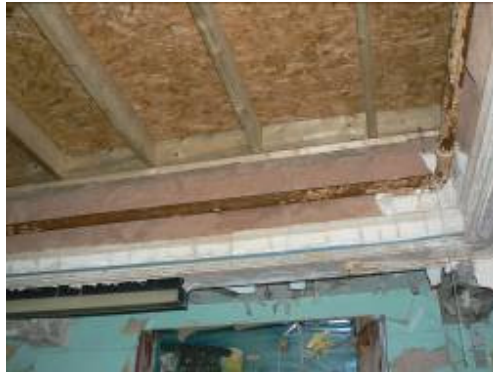
Photograph No. 233

Room F6 – This is the northern end of the Library building and at the position of the original lantern, this is now supported with softwood joists with chipboard over. The original lantern was trimmed with downstand beams and these generally have hairline cracking to them and historically, there has been water ingress through the lantern. A general view of all the above is shown on photograph No. 233.

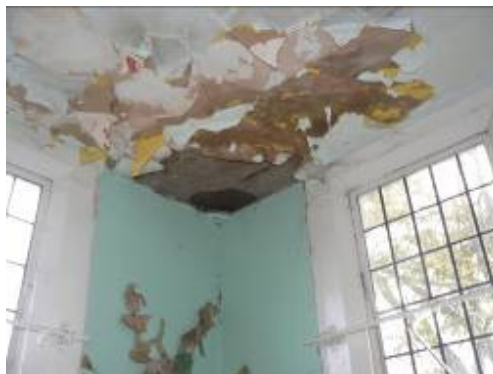
Photograph No. 234

To the northern section of the ceiling, this has a large amount of damp in the north-eastern corner and the reinforcing bars are now showing, and this area is shown on photograph No. 234.

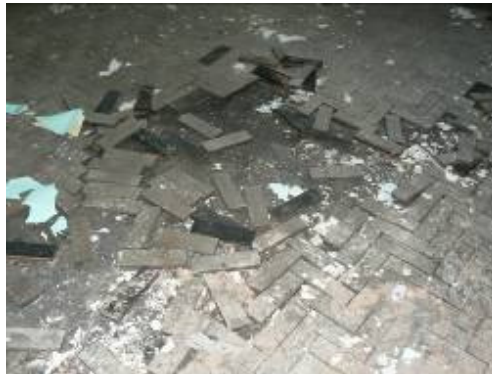
Photograph No. 235

The floor is wood block laid in a Herringbone style and a large percentage of these blocks are now coming away, as typically shown on photograph No. 235.

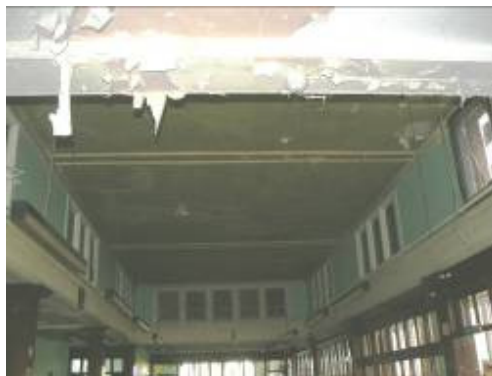
Photograph No. 236

Room F9 – This is the main central area of the Library which has the raised section with the slated hipped roof. A general view of the central section is shown on photograph No. 236 and either side, there is a lower ceiling area which is to the underside of the flat roof above.

Starting in the northern section, the finishes are coming off the walls, but generally it appeared to be in a reasonable structural condition.

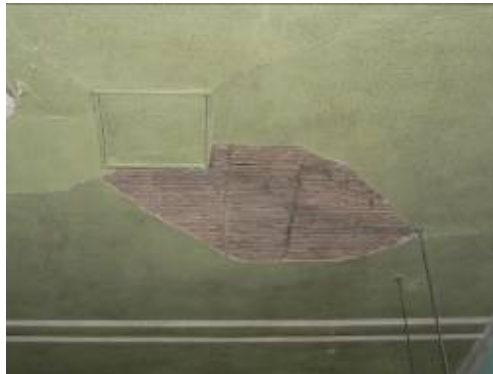
Photograph No. 237

To the central area the plaster is coming away from the ceiling, which is noted to be lath and plaster, as shown on photograph No. 237.

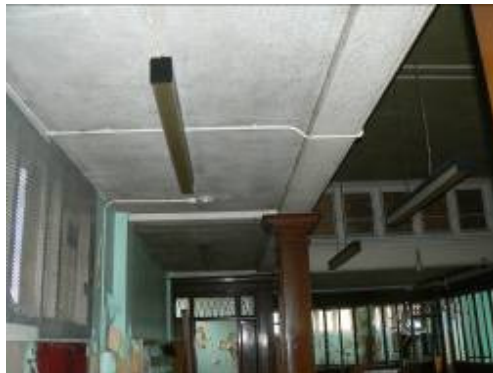
Photograph No. 238

To the western side, the area has the lower section of ceiling and the beam supporting the raised section is supported by columns, and a general view is shown on photograph No. 238.

There were no signs of any major structural failure but the main problems are due to damp ingress and poor decorative condition.

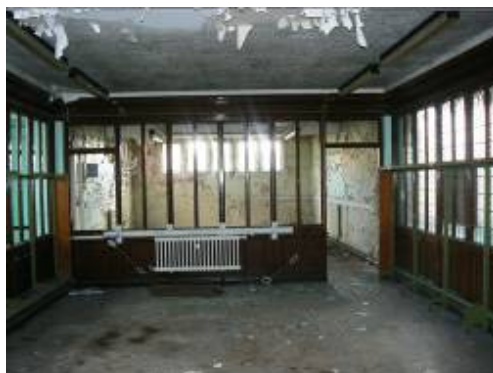
Photograph No. 239

Moving back out into the main area and the southern flat roofed section, this is shown on photograph No. 239. This also shows the timber panelling which is present, but the majority which was originally glazed is now missing and has generally been vandalised, the remnants of which are on the floor.

The ceiling has a lot of flaking paintwork, but there were no signs of any major structural distress.

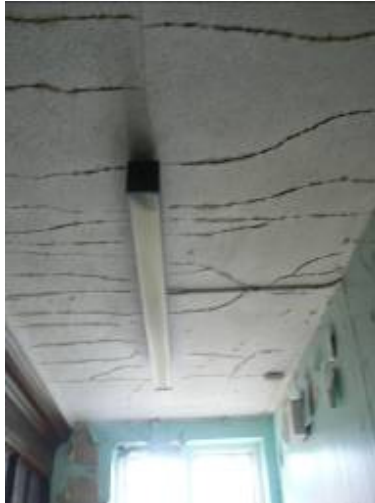
Photograph No. 240

Room F10 – This is a small librarian’s office in the south-western corner and it can be seen that there is significant damp coming through the roof, indicated by the amount of staining to the cracks in the ceiling, as shown on photograph No. 240.

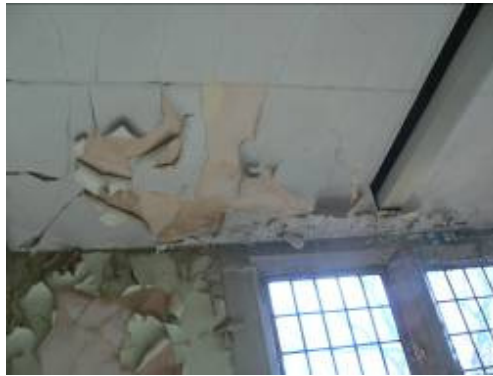
Photograph No. 242

On the eastern side there is a large amount of flaking paint which is indicative of damp ingress around the window, as shown on photograph No. 242.

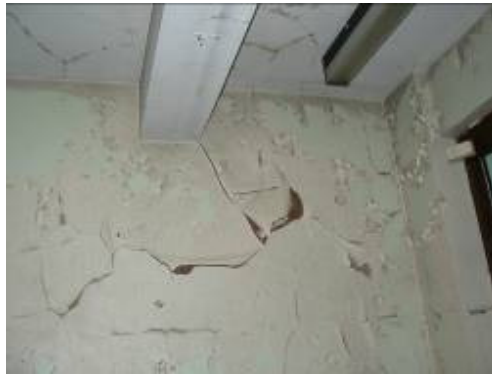
Photograph No. 244

On the western wall there is a lot of crazed cracking to the plaster work and around the edge of the downstand beam which supports the lantern, the plaster is saturated, as can be depicted on photograph No. 244.
