Heath Town Baths and Library

HEATH TOWN BATHS & LIBRARY Structural Condition Survey

November 2011

This report forms part of a Feasibility Study for the adaptive re-use of Heath Town Baths & Library to a Sports Academy on behalf of the Tessa Sanderson Foundation Academy.

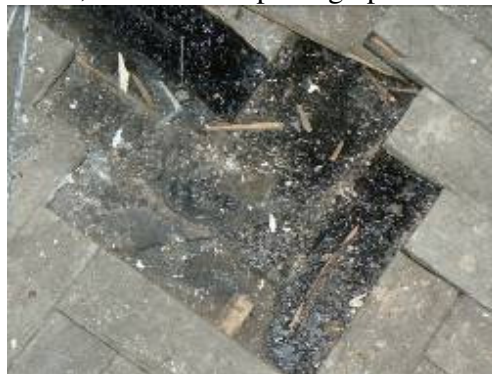
Photograph No. 245

The floor is similar to the northern end and there are areas which have lifted and minor hairline cracks through the floor finishes, as shown on photograph No. 245.

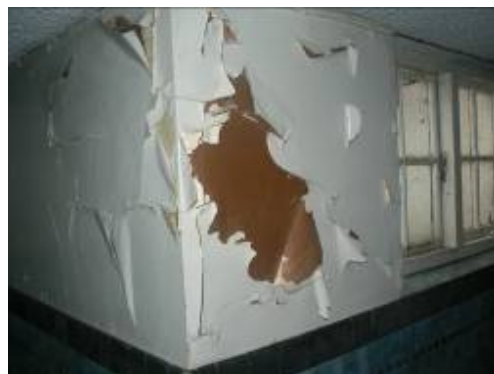
Photograph No. 247

Next to the staircase, there is damp ingress coming through the plasterwork, as can be seen on photograph No. 247, but no major cracking. However, an allowance should be made for making good the plaster work and decorations.

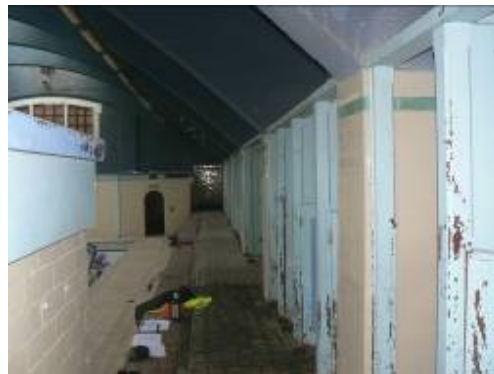
Photograph No. 249

Room UG 5 – This is the upper deck which housed the men's changing boxes and a general view is shown on photograph No. 249.

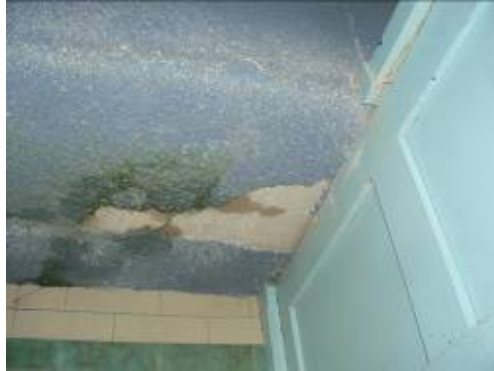
Photograph No. 250

Starting at the eastern end, there is the sprayed concrete finish to the main support frame and downstand beams and the stalls are all tiled. Generally in the first boxes, there is occasional hairline cracking, but in the 4th stall, to the underside of the downstand beam, the concrete finish is coming away and there is water ingress, as shown on photograph No. 250.

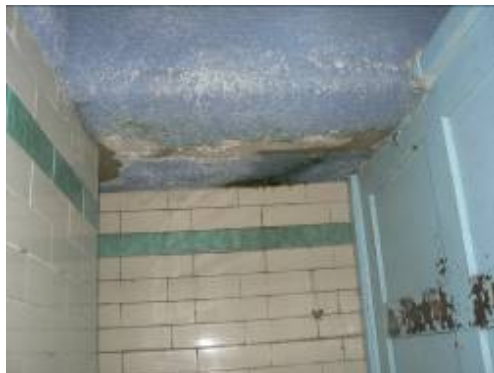
Photograph No. 251

Generally the windows are boarded up, as noted externally, although it is noticeable that there is a large amount of water penetrating through the concrete and staining the downstand beams, as can be seen on photograph No. 251.

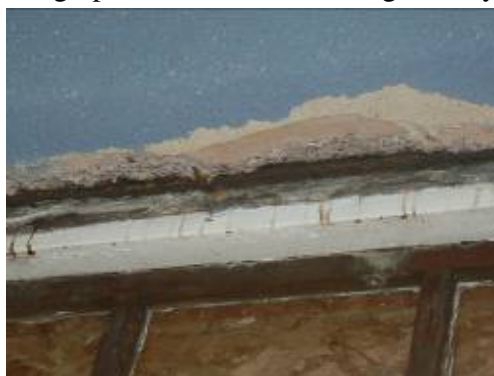
Photograph No. 252

Between the second and third cross frames, the downstand beam has exposed reinforcement showing, as shown on photograph No. 252, and this is generally in a poor state of repair.

The visual assessment leads us to consider that the frames can be fully retained with only localised areas of traditional concrete repair. However, prior to a major scheme being implemented, a further full concrete analysis would be recommended, similar to the form previously carried out in 2003.

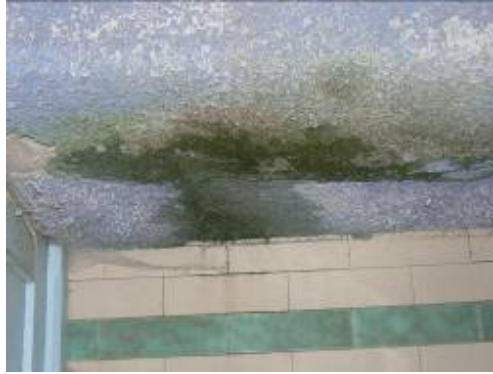
Photograph No. 253

Between the main 4th and 5th frames, the amount of water penetration is now starting to form mould on the underside of the sprayed concrete finish, which is also coming away in places, as shown on photograph No. 253.

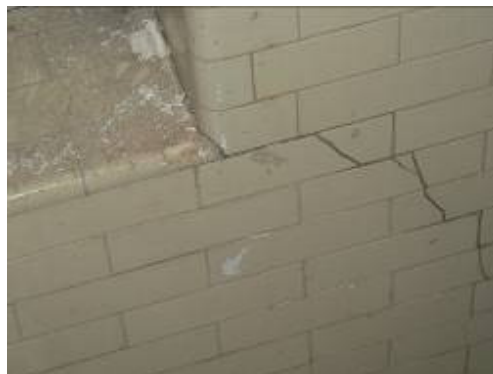
Photograph No. 256

Moving down the stairs there is also a fracture to the bottom right hand corner of window WG08 at the quarter landing position, as shown on photograph No. 256, and this cracking is also present on the wall above the quarter landing position.

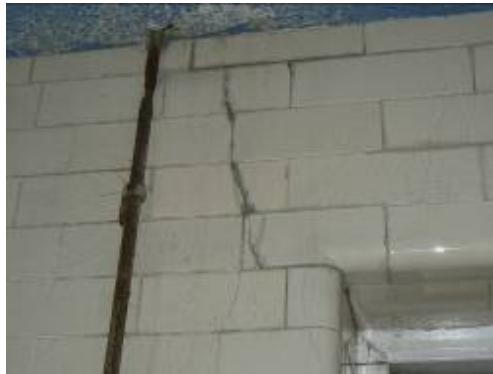
Photograph No. 259

Room UG9 – This is the main sink area and there is slight cracking to the top corner of the window, as shown on photograph No. 259, and based on the damage to WU10, this raises concerns that there is corroding concrete behind this area.

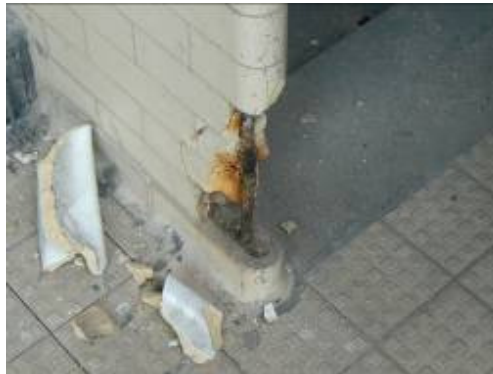
Photograph No. 261

The main area of defect is at the entrance door where it can be seen that the ceramic bricks are 60mm wide and the end ones are hollow with a reinforcing bar down the edge which has corroded and split the bricks, as shown on photograph No. 261, and this needs to be re-formed.

To the ceramic brick partitions forming the opening into UG10, there is again damage at this position and it is felt that this will likely need to have the end section carefully dismantled and if this is to be retained, new ceramic bricks made to match the existing.

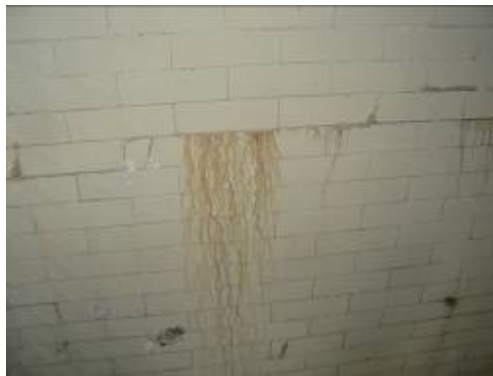
Photograph No. 262

Room UG11 – This is the stairwell area leading down to the basement and it can be seen that there is damp ingress through the wall half way up, as shown on photograph No. 262.

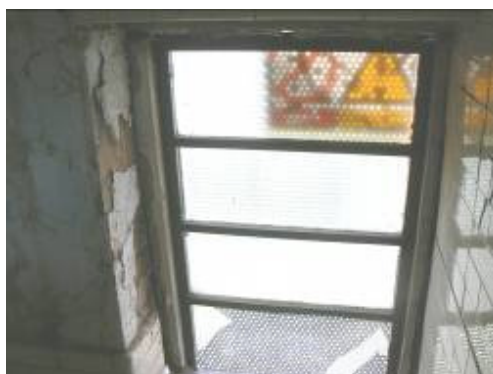
Photograph No. 263

To the bottom of the stairs the window is in a poor state of repair, as shown on photograph No. 263. Similarly, the plaster work needs attention as there appears to have been some damp ingress.

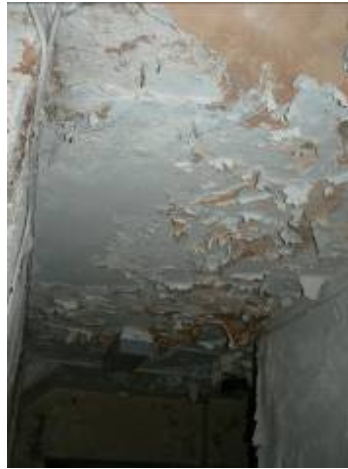
Photograph No. 264

At the bottom of the stairs is the basement area, where the ceiling is in a poor condition with most of the paint coming away through damp ingress, as shown on photograph No. 264.

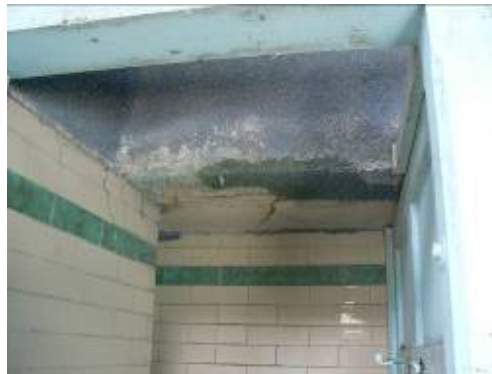
Photograph No. 265

To the soffit to the underside of the ring beam area, again there are signs of leakage and subsequent damage, as shown on photograph No. 265.

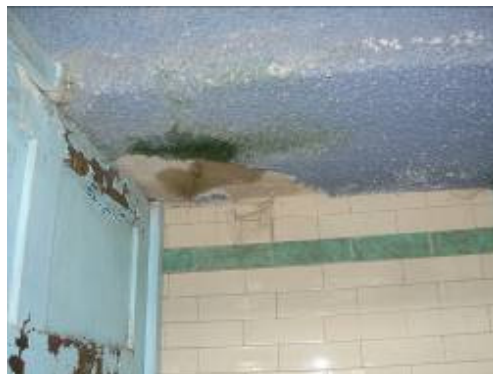
Photograph No. 266

The majority of this finish is suffering from damp ingress and a typical example of the damage that is occurring, is shown on photograph No. 266.

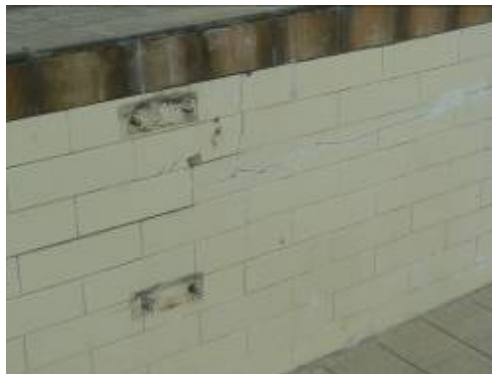
Photograph No. 267

To the pool walkway there is a drainage channel set within the tiling and the covers to this are quite loose. The remainder of the upstand walls showed no major damage, just localised areas of cracking where previous fixings were present, as typically shown on photograph No. 267.

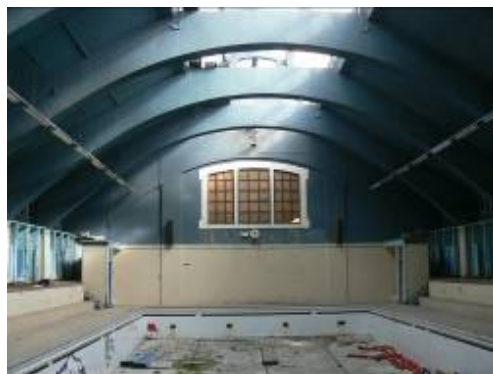
Photograph No. 268

To the main concrete cross frames and the main end walls, starting at the eastern end, a general view is shown on photograph No. 268.

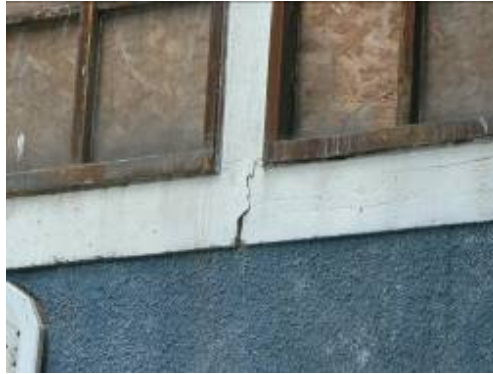
Photograph No. 269

The upper part of the wall has been sprayed with the same concrete finish as the underside of the ceiling, and generally this was in a reasonable condition, showing no sign of major cracking. To the main window the open cill joints noted externally can be seen internally, as shown on photograph No. 269.

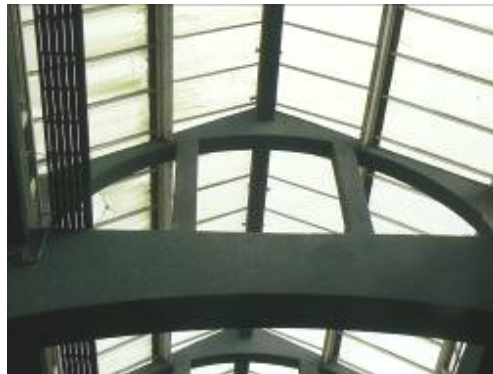
Photograph No. 270

To the main frames there was no cracking through the finishes to indicate any areas of major structural failure and the significant areas of spalling are actually at the upper levels, supporting the lantern roof, and the area in question is shown on photograph No. 270.

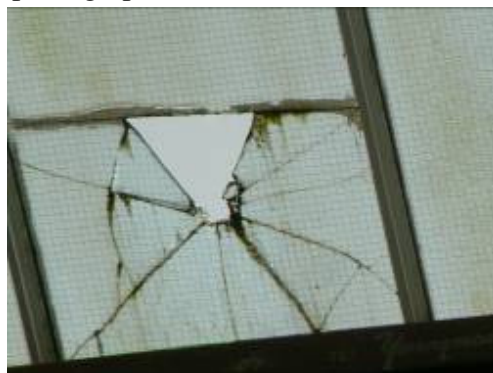
Photograph No. 271

What is apparent is the amount of leakage coming through the roof and typical damage to some of the roof vents is shown on photograph No. 271.

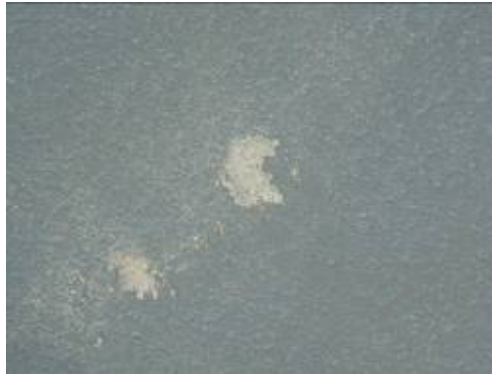
Photograph No. 272

To the ceiling slab there are occasional areas where the finish is slightly discoloured which is an indication that water may be penetrating, as shown on photograph No. 272.

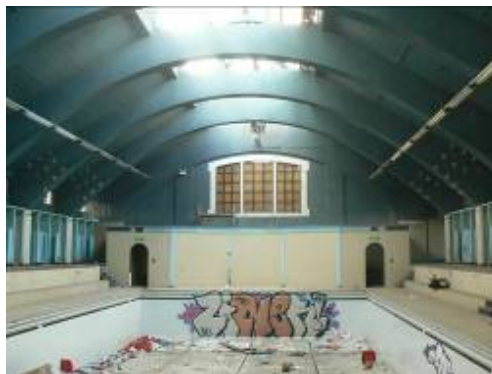
Photograph No. 273

The main western wall is shown on photograph No. 273.

This has slight staining underneath the main window cill, but overall, from what could be seen, there were no signs of any major cracking or failure of this end wall.

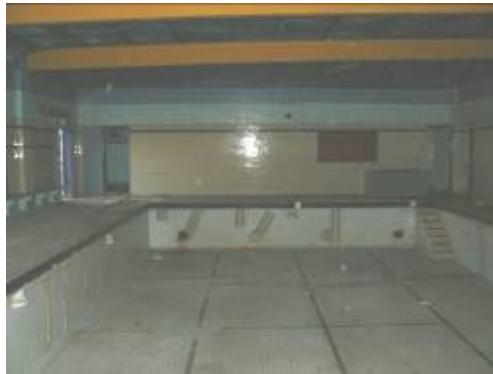
Photograph No. 274

Room G1 – This is the original Children’s Pool and a general view is shown on photograph No. 274.

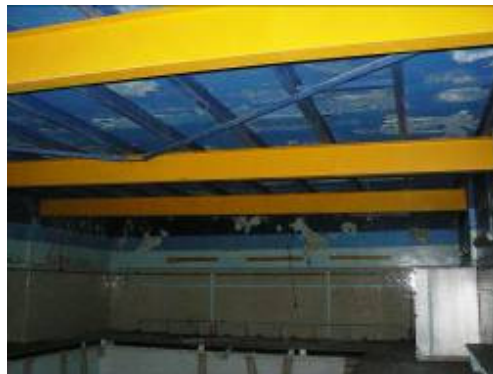
Photograph No. 275

The roof over here is a replacement where the original lantern roof has been removed and it is now supported by a series of three main steel beams spanning north-south and then smaller steels acting as joists supporting a Woodwool type slab with the felt over, as shown on photograph No. 275.

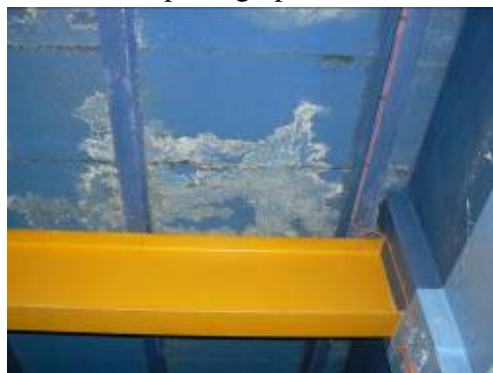
Photograph No. 276

The lighting was poor but from what could be seen, there are damp patches indicating water ingress in localised areas, as shown on photograph No. 276.

The steels all appear in a reasonable condition, although the secondary steels, where they bear into the wall, do show slight signs of damp and it would be recommended that a further check is carried out to the end of these.

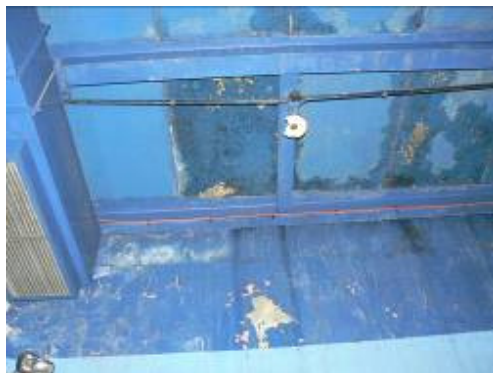
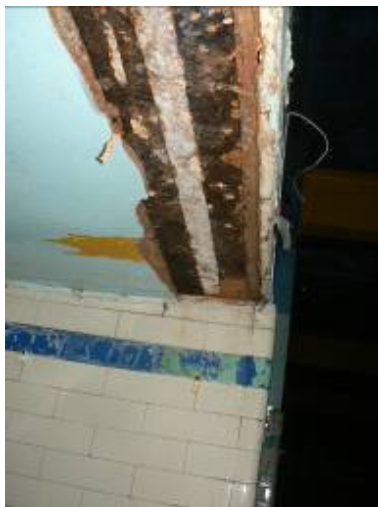
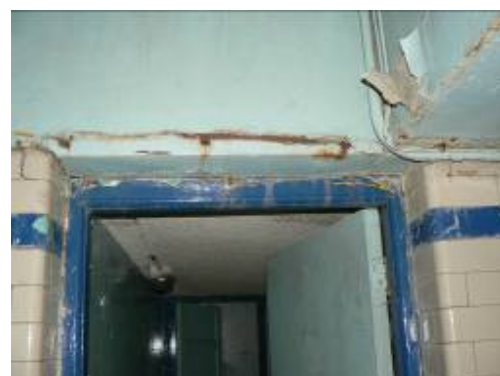
On the southern wall, there is significant water ingress over the doorway DG15 and DG13 in the south-eastern corner. To the former, the lintol has now heavily corroded and there is also staining to the latter. The leakage and the doorways are shown on photographs numbered 277 to 279 inclusive.

It is noticeable that due to this heavy water ingress, the plaster is becoming saturated.

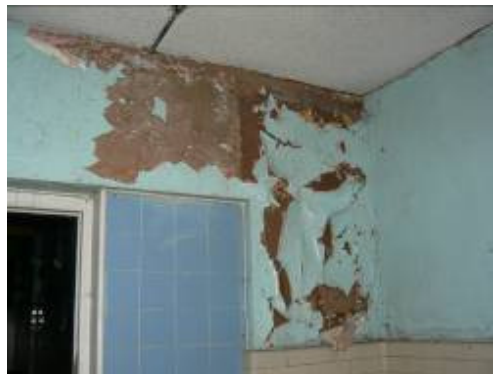
Photograph No. 281

Room G4 – This is in the north-eastern corner and there is a noticeable amount of damp penetration on the western wall, as shown on photograph No. 281.

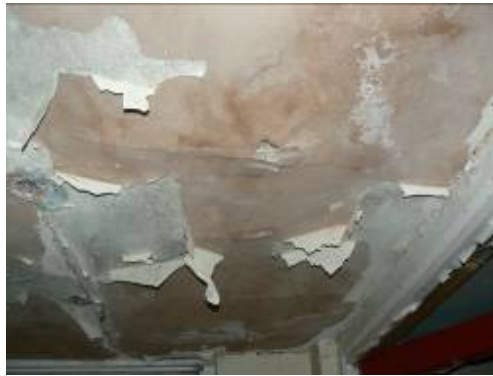
Photograph No. 283

To the southern section of the corridor there was localised damage to the plaster and also areas where there is paint peeling from the walls, indicating damp ingress. There is also blown plaster to the ceiling and this is shown on photograph No. 283.

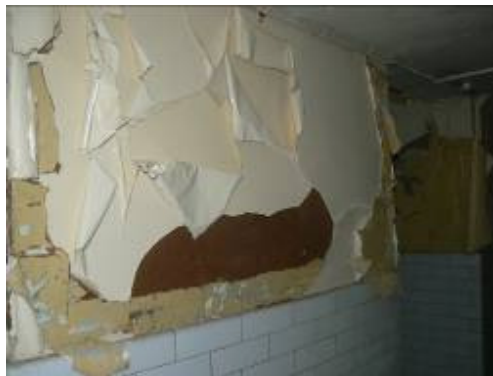
Photograph No. 284

The door to the eastern wall which gives access to the lightwell is boarded up, but it can be seen that there is a large amount of damp coming in through this area, as can be seen by the darkened plaster areas on photograph No. 284.

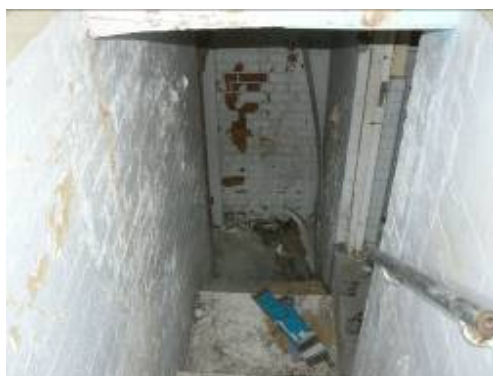
Photograph No. 285

Room G7 – This is the access stair up to the main pools and a view from the upper ground floor level looking down, is shown on photograph No. 285.

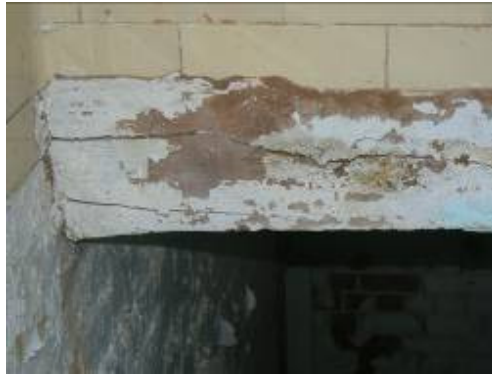
Photograph No. 286

The walls have superficial damage and the lintol is quite poor, indicating a large amount of corrosion, as shown on photograph No. 286.

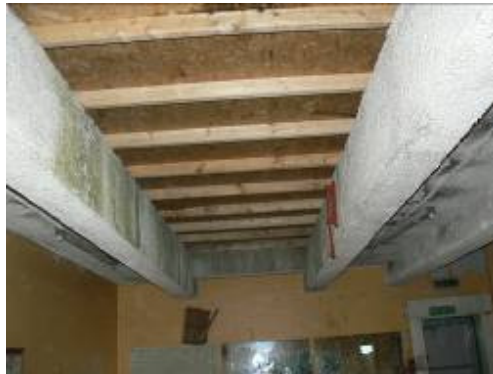
Photograph No. 287

Room G14 – This is a large open room which has main beams spanning north-south which trim the large lantern, as shown on photograph No. 287.

This is now decked over with softwood joists and chipboard. The beams have been covered with a sprayed concrete finish and from the darkening of the plaster to the western side, this would indicate damp ingress. From what could be seen however, there were no signs of major structural failure.

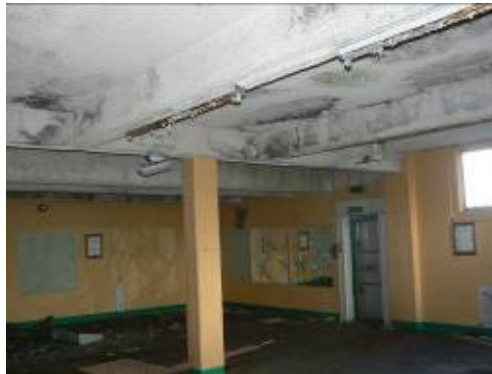
Photograph No. 289

Room G15 – This is the eastern area of the same room and the dividing wall between the two has been removed and supplemented with a downstand beam and post, as shown on photograph No. 289.

The downstand beams are sprayed with concrete and show no sign of any major failing or cracking. The light fittings are all corroding, and this would indicate a damp atmosphere.

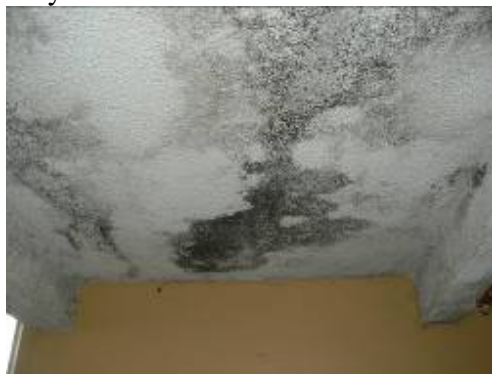
Photograph No. 290

To the panels between the downstand beams, there is a large amount of darker staining, indicating water ingress, as shown on photograph No. 290. However, it should be stated that there was no major cracking to indicate any failure.

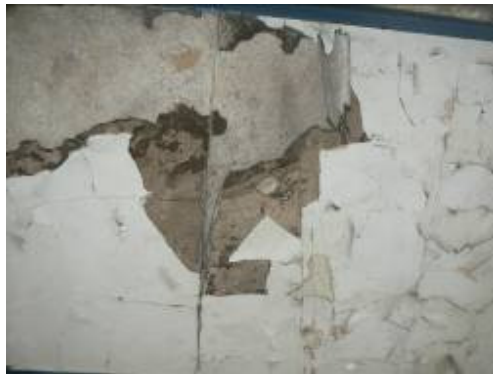
Photograph No. 292

Room G21 – This is accessed externally and is between the two arches to the northern side of the front elevation. There is repointing work required to the brickwork and making good to the window. However, it is noticeable that the plaster is coming away from the ceiling. However the concrete underneath the plaster is in a reasonable condition, as shown on photograph No. 292.

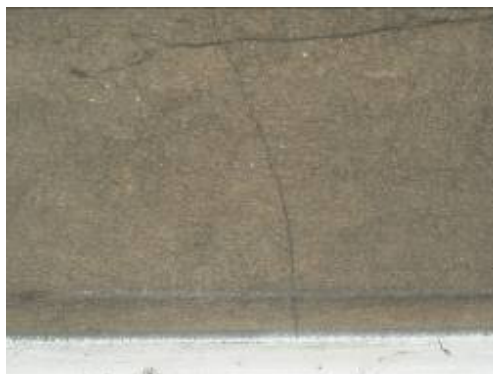
Photograph No. 293

Room G23 – This is the southern area underneath the arches on the front elevation, which includes a ramp access. There are concerns that this may induce damp into the building. The ceiling is in need of decoration, but the brickwork is in a reasonable condition. The lintol over the ground floor window has an occasional vertical hairline crack, as shown on photograph No. 293.

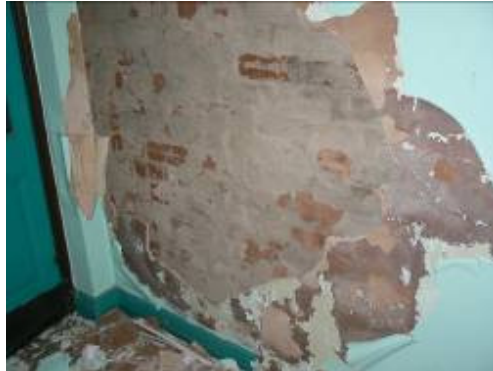
Photograph No. 294

Room G24 – This is the southern entrance lobby to the Library stair tower. On the southern wall there is a large amount of damp ingress and the plaster is coming away from the wall, as shown on photograph No. 294.

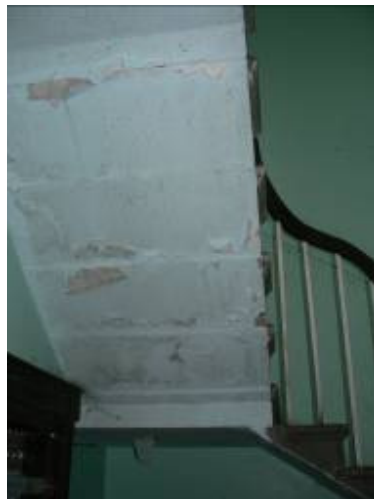
Photograph No. 295

To the remainder there is paint coming away from the underside of the soffit of the stair, as shown on photograph No. 295, although it should be noted that the cantilevered stair itself is working quite adequately. A typical example of the profile of the balustrading is shown on photograph No. 296.

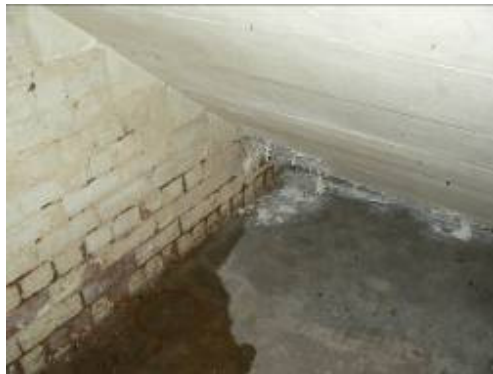
Photograph No. 297

Room G27 – This is a small storage area under the staircase. However, it is noticeable that there is a large amount of damp ingress on the floor, as shown on photograph No. 297.

It can also be seen that the paint is flaking off the walls, but apart from the damp issues there were no signs of any significant structural defect.

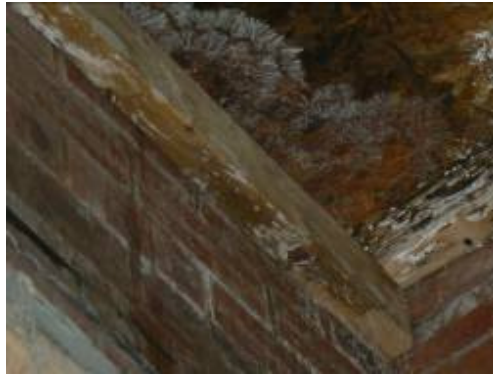
Photograph No.299

The plaster to the eastern wall has a large amount of crazed cracking and it can be seen that where the wall was extended, the boarding is rotted, as shown on photograph No. 299.

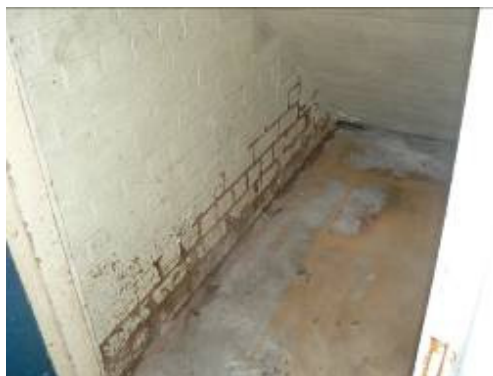
Photograph No. 300

Room G30 – This is a storage cupboard under the stairs. There are again signs of rising damp to the bottom courses indicated by the loss of paint and damp on the floor, as shown on photograph No. 300. The soffit of the stairs appears to be in a reasonable condition and there were no signs of any structural failure.

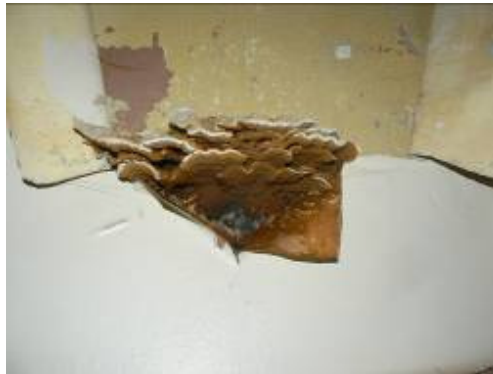
Photograph No. 301

Room G31 – This is a corridor leading to the east and the finishes are coming away. It is noted that there is a large fruiting body, as shown on photograph No. 301.

Although there are no significant structural issues, the ingress of damp does give rise for concern.

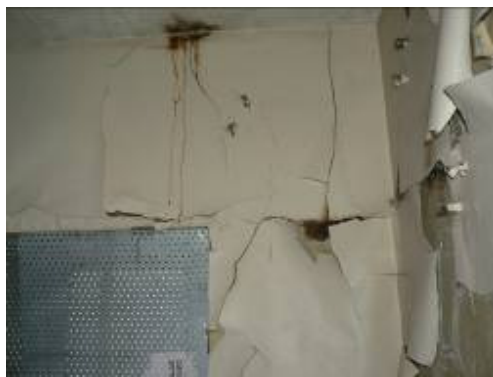
Photograph No. 302

Room G32 – This is a small toilet and the walls are saturated which is due to the relationship with the lightwell adjacent to the southern wall. The damp has caused a degree of cracking and damage to the decorations and plaster and it can also be seen that the soffit of the lintol is fractured. A general view is shown on photograph No. 302.

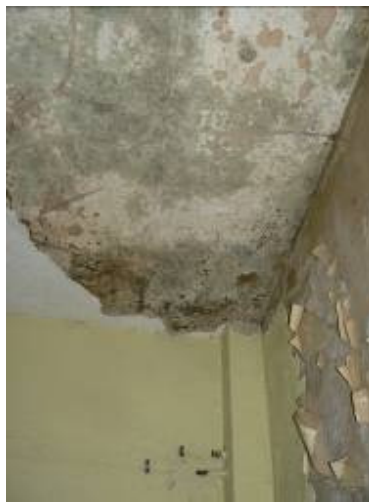
Photograph No. 303

Room G36 – This is a small toilet room which backs onto the lightwell. The ceiling has noticeable damp penetration and the damp is causing fruiting bodies and there is a heavy loss of finishes due to this damp ingress, as shown on photograph No. 303.

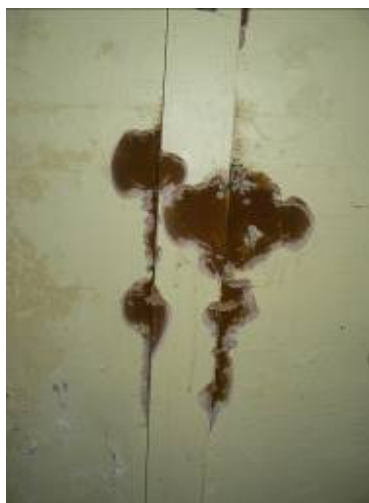
Photograph No. 304

Room G37 – This again has a large amount of damp coming through causing the start of fruiting bodies, as shown on photograph No. 304.

Structurally, there was no significant cracking, although the amount of damp entering the building is a structural concern.

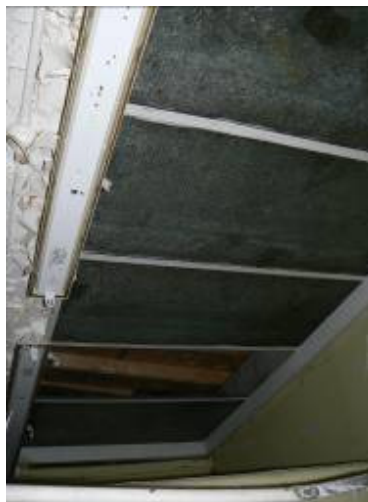
Photograph No. 305

Room G39 – This is to the west of this room and is a changing area, and there is patent glazing over the top which now has boarding over, as shown on photograph No. 305.

The walls are painted ceramic bricks and this is all coming away. However, there are no signs of any structural cracking. The downstand beams show no sign of any failure, but there are signs of damp ingress.

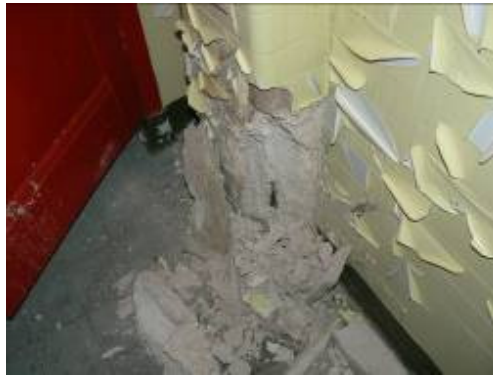
Photograph No. 306

Room G40 – This is a similar room to G39 which shares the same roof and the finishes are coming away, but there are no signs of major cracking. To the southern side there is a pier which supports the end of the downstand beam and this has disintegrated at the base, as shown on photograph No. 306.

This will need to be fully exposed and the structure made sound.

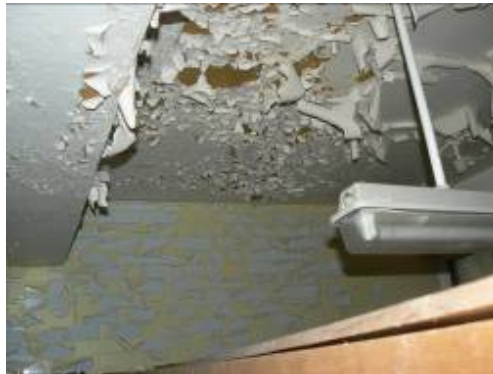
Photograph No. 307

Room G41 – This is a later inserted sauna which is a timber box set below the ceiling line. To the ceiling over the top and also to the walls, the paint is flaking quite noticeably, as shown on photograph No. 307.

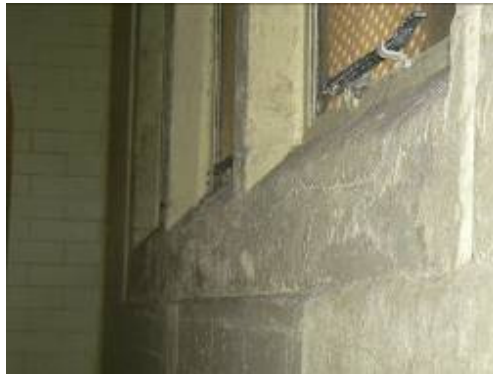
Photograph No. 308

Room G43 – This is a sauna constructed within the south-eastern room and from what could be seen, there were no signs of any significant defect. To the southern side however, there is a small gap which shows that the window cill to WG06 is noticeably cracked, as shown on photograph No. 308.

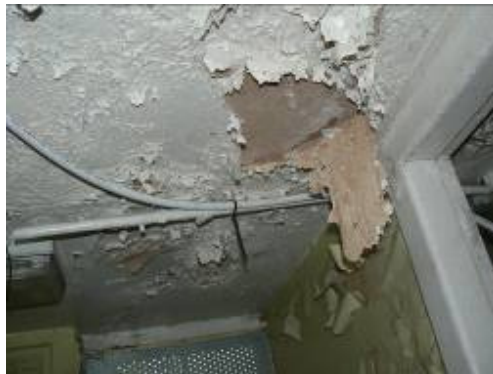
Photograph No. 310

Room G45 – This is on the northern wall of G44 and has the lightwell to the northern side. There is damage to the ceiling due to the amount of water ingress and there are also signs of rot and fungi starting to grow here. The remainder of the walls have their finishes coming away due to damp ingress, but no sign of structural failure, and this is all shown on photograph No. 310.

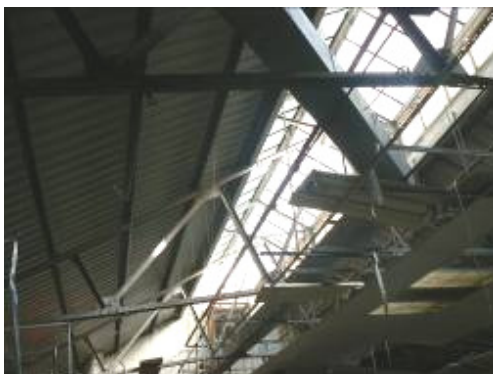
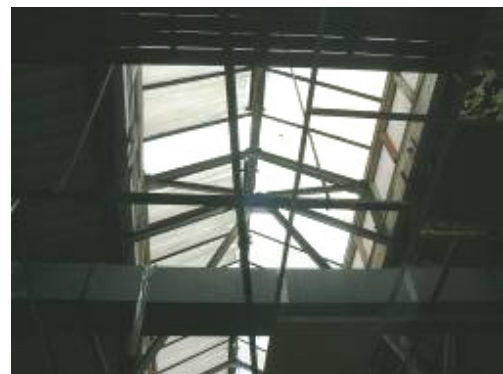
Room G49 – This is the original public wash house but has now had an internal room created. The monitor roof is supported by a series of steel angle trusses which then have an additional section bolted to the top to form the upper lantern, as shown on photographs numbered 311 and 312.

The trusses themselves actually look to be in a reasonable condition with only slight surface corrosion. The sheeting is supported by a series of four angle purlins. On the northern side with the new sheeting, the valley is in a poor condition and is clearly leaking, as shown on photograph No. 313. This is now causing considerable damage to the brickwork and also to the lintol over door DG08.

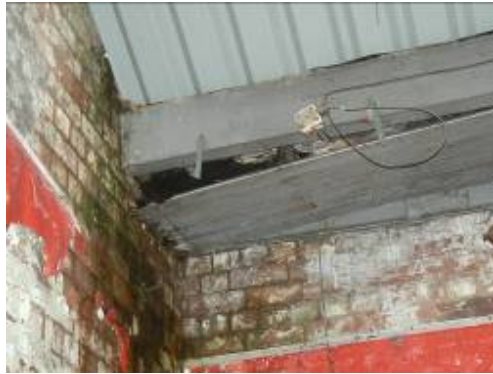
Photograph No. 313

The northern roof over the original Children's Swimming Pool is leaking where the flashings externally are noted as being poor and this is now causing damage to the Woodwool slabs and also to the lower lintols. Therefore, if this flat roof is to be kept, although the steelwork can be kept and cleaned, an allowance should be made for new boarding and roof finishes.

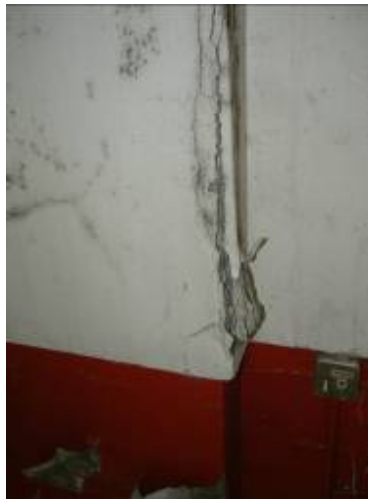
Photograph No. 314

There is minor cracking to the upper courses on this northern wall, but nothing which gives rise for significant concern. The paint finish is coming away in large sections and to the middle pier there is slight plaster damage, as can be seen on photograph No. 314.

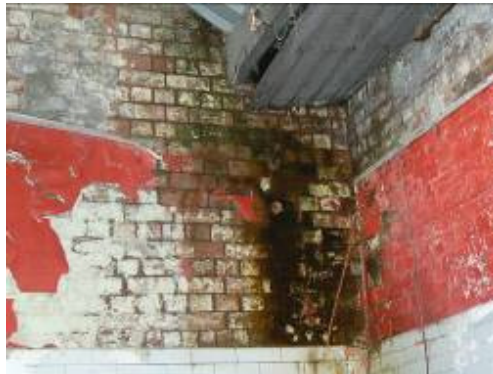
Photograph No. 315

The western wall is a plain gable, but the damage from the leaking valley gutter can be seen in the north-east corner on photograph No. 315.

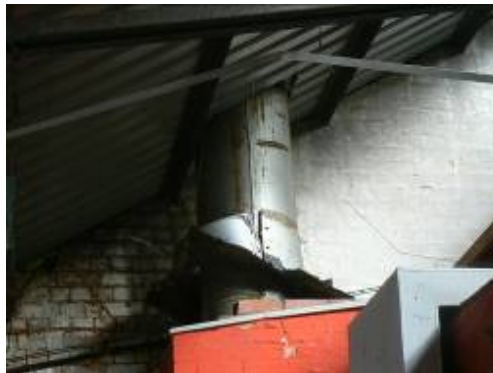
Photograph No. 318

The eastern wall is masked by Room G50, but from what could be seen the flashing to the outlet pipe is now not present and this is clearly leaking, as shown on photograph No. 318.

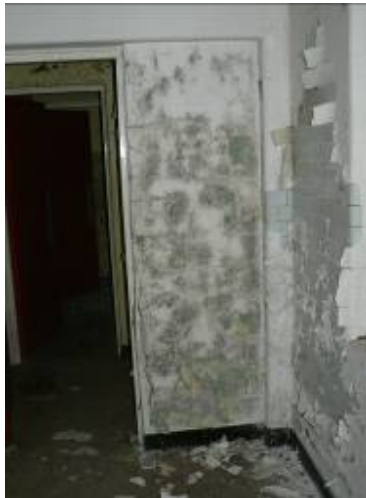
Photograph No. 319

In the south-eastern corner, at the doorway leading into G51, there is a noticeable amount of mould growth and also decorations coming off the ceramic bricks, as shown on photograph No. 319.

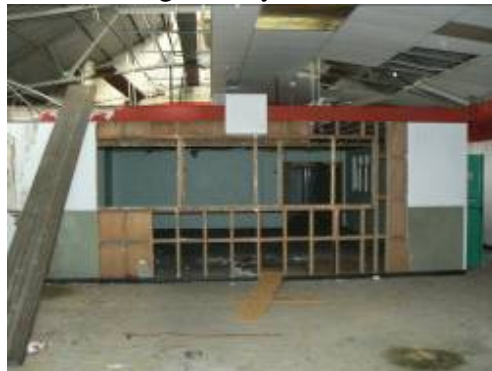
Photograph No. 320

Room G50 – This was a space created with a timber partition and suspended ceiling, as shown on photograph No. 320. This shows no sign of any structural failure.

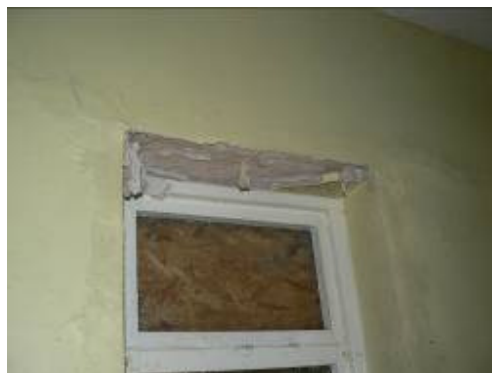
Photograph No. 321

Room G52 – This is the urinal and toilet area and the soffit to the lintol is coming away, as shown on photograph No. 321.

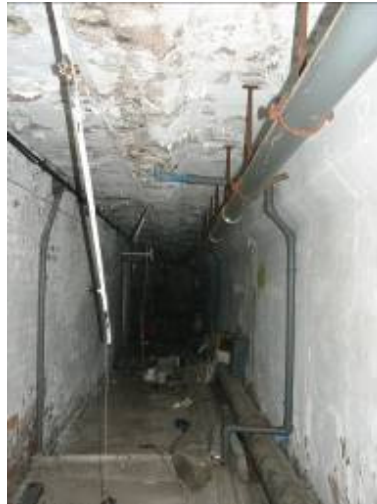
Photograph No. 322

Service Duct – This is a corridor which runs down around the side of the Swimming Pool and is typically shown on photograph No. 322.

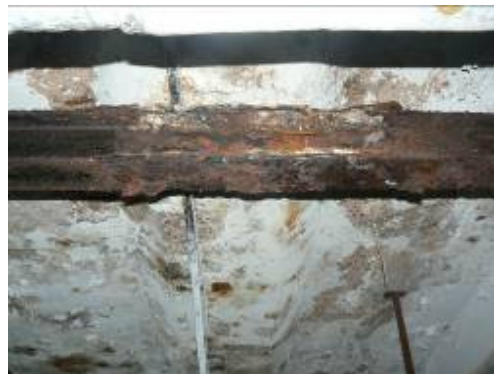
Photograph No. 323

Starting along the northern passageway, at the north-western corner there is a corroded beam supporting the walkway around the Swimming Pool, as shown on photograph No. 323.

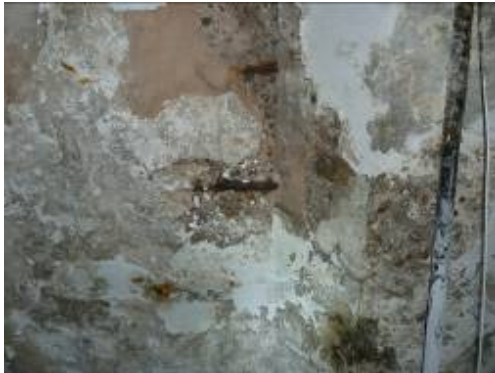
Photograph No. 324

The ceiling slab to the underside of the walkway around the pool has a central downstand which is the drainage channel. On the northern side there is one exposed reinforcement bar and then further along there is cracking to the downstand section of the drainage channel, as shown on photographs numbered 324 and 325 respectively.

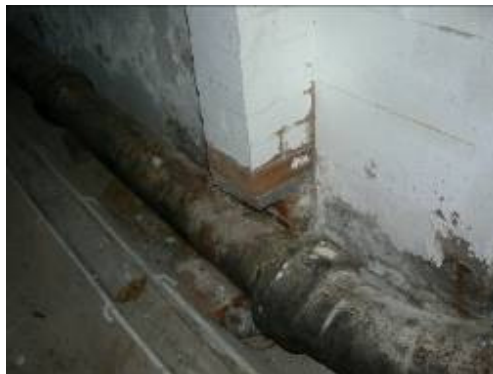
Photograph No. 326

On the pool wall there is a pier supporting the downstand beam, but this has been largely removed at the base for a service pipe, as shown on photograph No. 326.

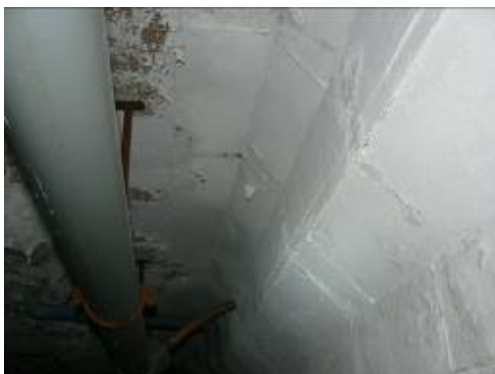
Photograph No. 327

To the pool structure itself, it would appear that this is insitu concrete with a thickening at the top of the floor slab, and to the lower areas there are sections of spalling concrete and the top pool detail and the example of spalling concrete are shown on photographs numbered 327 and 328.

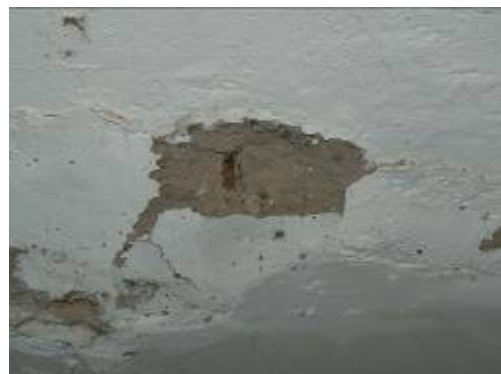
Photograph No. 328

It is apparent that the cover from the reinforcing steel to the concrete is at little as 10mm in places.

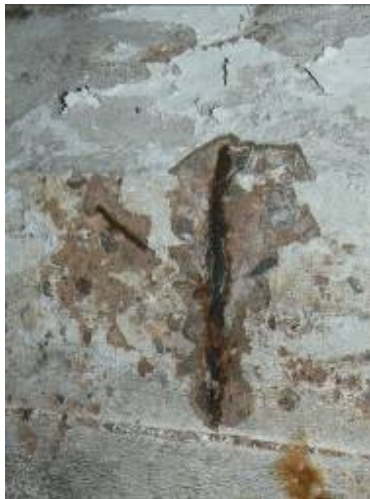
Photograph No. 329

Moving along the wall and the ceiling, there are signs of reinforcement bars showing. The majority of the spalling to the pool concrete is in the bottom 1m, as typically shown on photographs numbered 329 and 330.

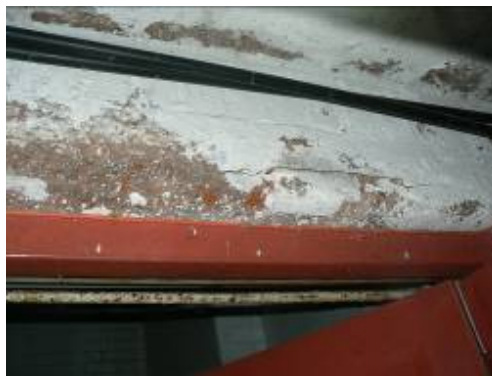
Photograph No. 331

Half way along this northern walkway there is a doorway to the northern side into B6 and the brickwork above this area is quite poor and it would appear that previously an attempt has been made for this to be rendered over, as shown on photograph No. 331.

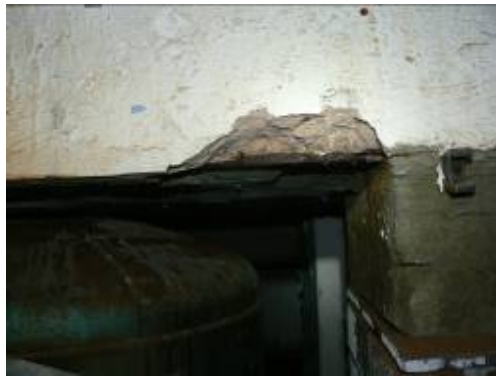
Photograph No. 332

The eastern most beam over the entrance to B4, again the concrete is spalling away, as typically shown on photograph No. 332 and also falling away from the underside of the soffit, as shown on photograph No. 333.

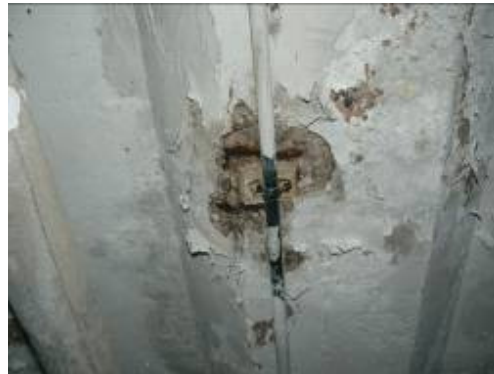
Photograph No. 334

To the ceiling in the service duct where service fixing points are in place, there is again exposed reinforcing steel, as shown on photograph No. 334 and the pool wall again has flaking paint and an indication of spalling.

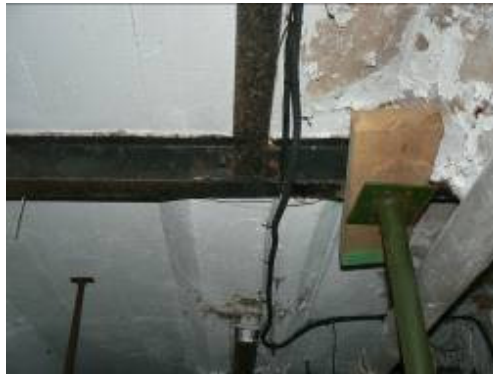
Photograph No. 335

In the eastern corner there is a downstand beam which is propped, as shown on photograph No. 335.

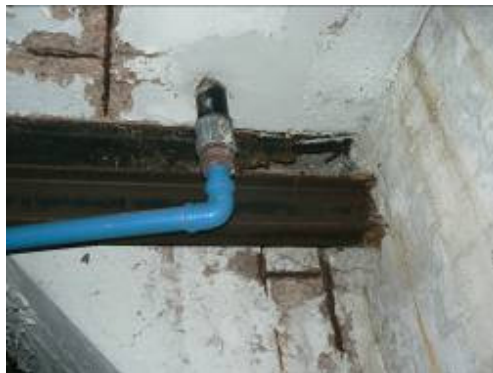
Photograph No. 336

To the northern side there is a sloping soffit which is the staircase and on the eastern face there is a large amount of reinforcing steel. The steel beam at this position would also appear to be two steels, one on top of the other with the web to the upper one having disintegrated, and this is all shown on photograph No. 336.

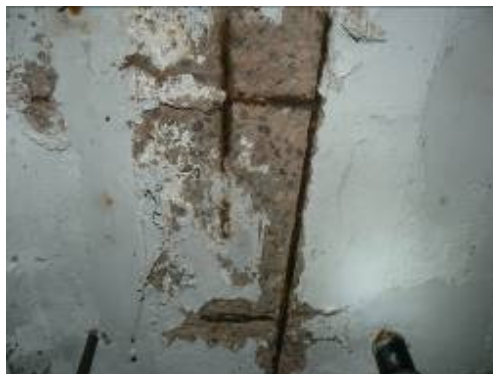
Photograph No. 337

The soffit to the underside of the drainage channel is also in a poor condition with a large amount of spalled concrete, as shown on photograph No. 337.

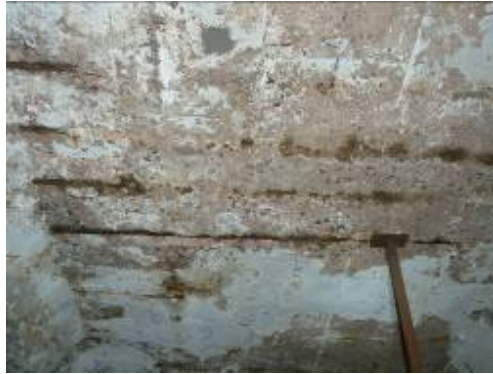
Photograph No. 338

Moving along the eastern service duct, the soffit on the underside of the walkway around the pool is in a poor condition, as can be seen on photograph No. 338.

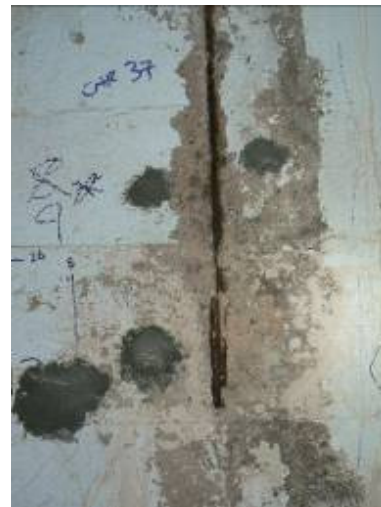
Photograph No. 340

Generally, this is in a similar condition to the northern side in that there are localised areas of exposed concrete to both the ceiling and the pool wall, and this is typically shown on photographs numbered 339 and 340.

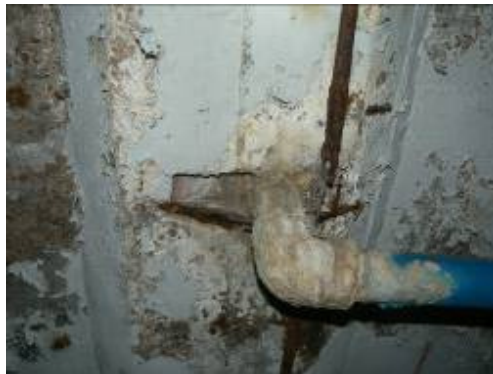
Photograph No. 342

Moving along the southern service duct, it can be seen that there is an open drainage channel and where the pipework comes out of the floor channel above, this concrete is in a poor condition, as shown on photograph No. 342.

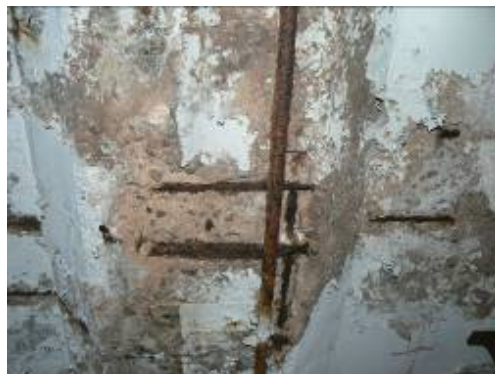
Photograph No. 343

There does appear to be a large amount of damp coming through this slab and half way along this side, the drainage downstand is heavily spalled, as shown on photograph No. 343. Moving further to the north there is a similar situation, as shown on photograph No. 344, and there are also indications that further areas are about to come away, and a typical example is shown on photograph No. 345.

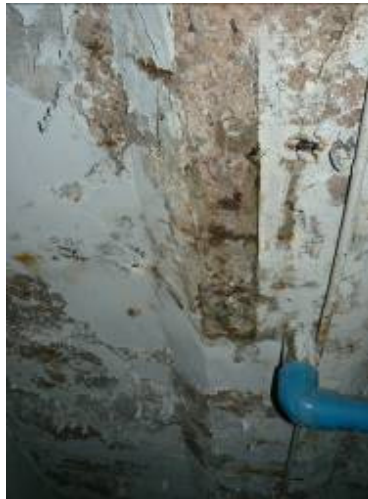
Photograph No. 346

In the south-west corner, the soffit is in a poor condition, as typically shown on photograph No. 346.

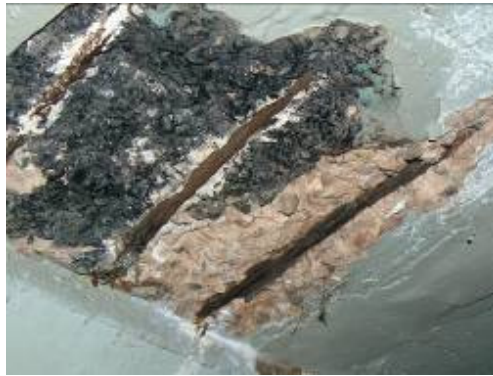
Photograph No. 347

Moving along the northern side, there is one area which is in a very poor condition, as shown on photograph No. 347, although the pool wall is in a slightly better condition.

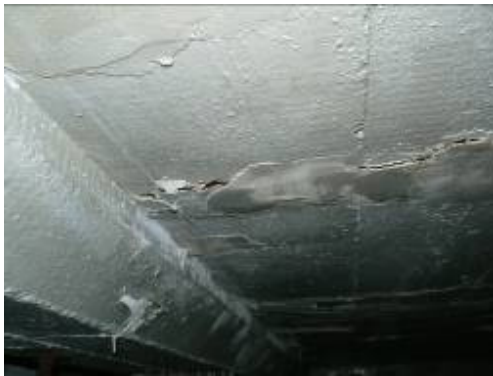
Photograph No. 348

The external wall is in a reasonable condition, although the vents are blocked in. The areas of defect are more localised to the soffit of this slab and also occasional spalling at the bottom of the pool wall, examples of which are shown on photographs numbered 348 and 349.

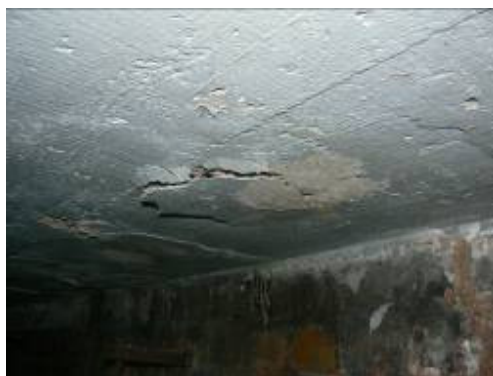
Photograph No. 350

On moving round to the western side, there are localised areas where the soffit is starting to come away, as shown on photograph No. 350. The remainder is in a more reasonable condition.

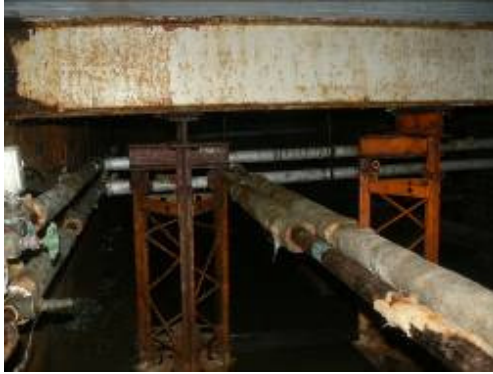
Photograph No. 351

Room B1 – This area was heavily propped and there is a large amount of chemical drums stored in the corner and due to the amount of water on the floor, access was not gained into this area. Typical examples taken from the entrance are shown on photographs numbered 351 and 352.

Room B2 – In the area leading up into the entrance to B1, the steels are supported off the mini tri-shores which can be noted on photograph No. 351 above, and the exposed steelwork leading through into this area is all showing signs of corrosion, as shown on photograph No. 353.

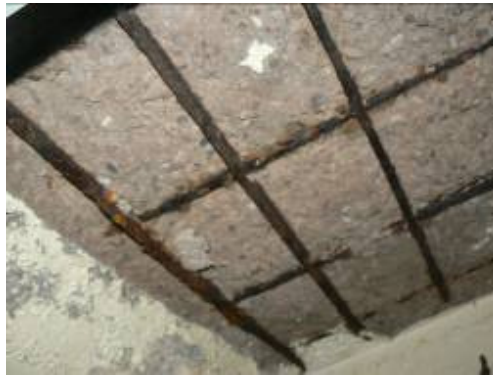
Photograph No. 354

Room B3 – This is in the area of the staircase and the brickwork has slight cracking to the cupboard under the stairs. The underside of the stair soffit is very poor with all the reinforcing steel exposed, as shown on photograph No. 354.

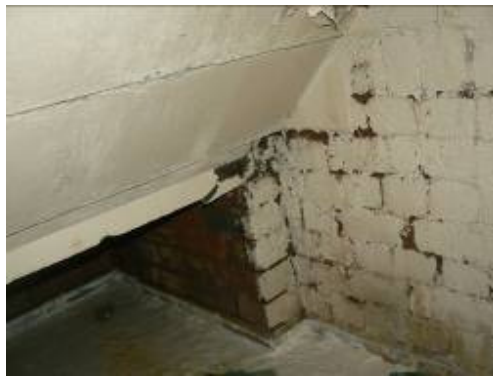
Photograph No. 355

The stair itself in the bottom corner has also fractured, as shown on photograph No. 355.

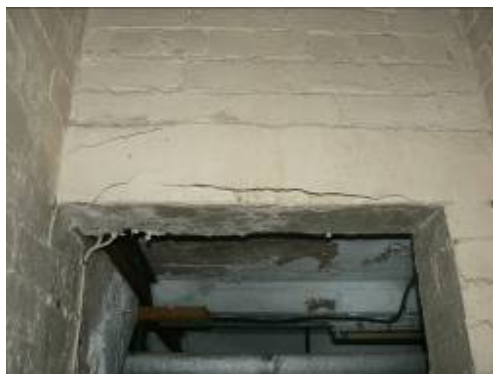
Photograph No. 356

There is a diagonal crack over the head of the cupboard under the stairs and also the lintol leading into this area shows fracturing to the bottom section, as shown on photograph No. 356.

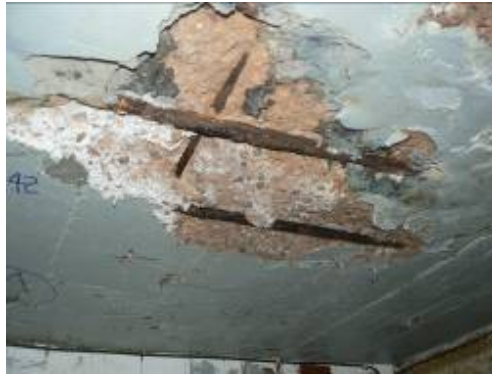
Photograph No. 357

Room B4 – This is a lower area of the service duct corridor between this and the service duct to the Children’s Pool and the underside of the floor slab is quite poor, but the main steel beam over opening DB13 is in a more reasonable condition. A typical view of the floor slab is shown on photograph No. 357.

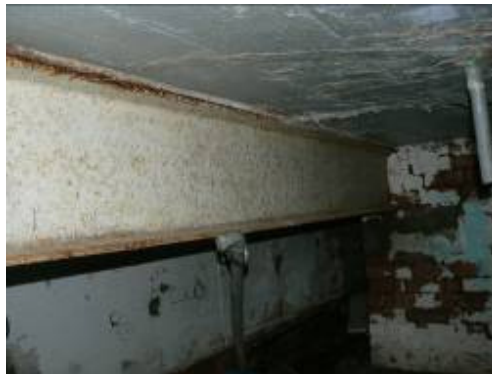
Photograph No. 358

Room B5 – The downstand beam at the northern side over DB15 has got surface corrosion, but is working satisfactorily and this is shown on photograph No. 358.
