Heath Town Baths and Library

HEATH TOWN BATHS & LIBRARY Structural Condition Survey

November 2011

This report forms part of a Feasibility Study for the adaptive re-use of Heath Town Baths & Library to a Sports Academy on behalf of the Tessa Sanderson Foundation Academy.

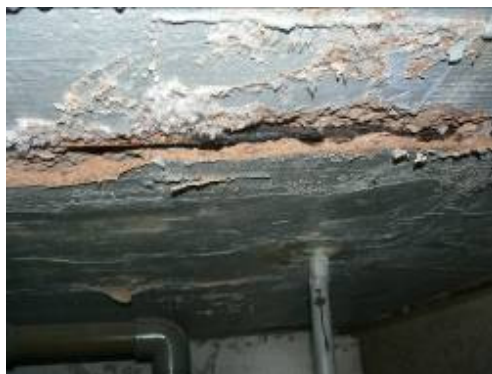
Photograph No. 359

The ceiling is showing signs of spalling, as shown on photograph No. 359.

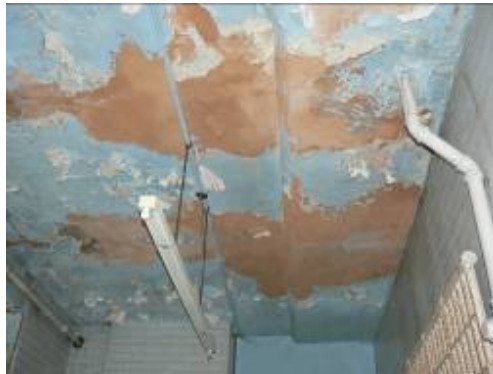
Photograph No. 360

Room B7 – These are again fully tiled areas and the ceiling shows quite a lot of damp penetration and a general view is shown on photograph No. 360.

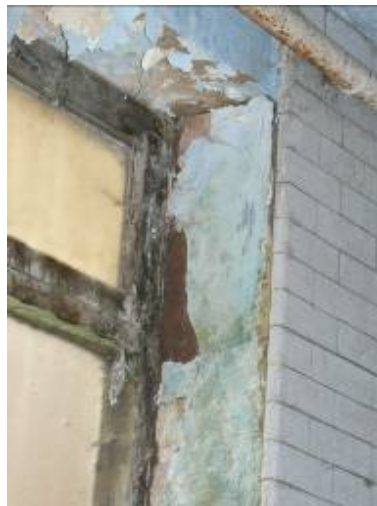
Photograph No. 361

Around window WB03 on the northern wall, this has a large amount of water coming in around the lintol and also to the reveals, as indicated on photograph No. 361.

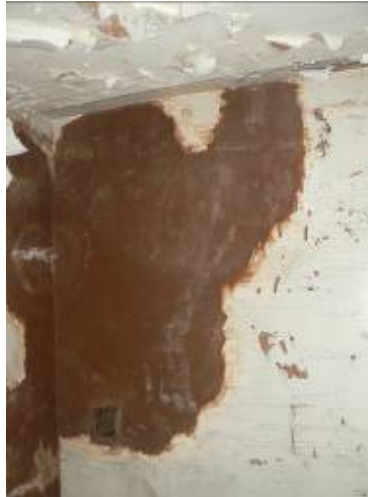
Photograph No. 362

Room B9 – Through the northern wall there is a large amount of damp penetration coming through, as can be seen on photograph No. 362 and although no major cracking, the plaster has de-bonded from the wall.

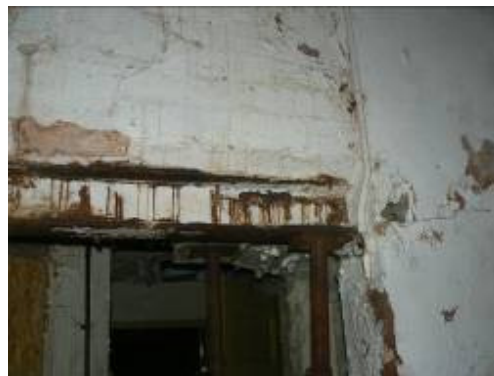
Photograph No. 363

Over the entrance door DN19, this steel is now propped and is heavily corroded, as shown on photograph No. 363 and there is a large amount of water ingress coming down the face of the wall.

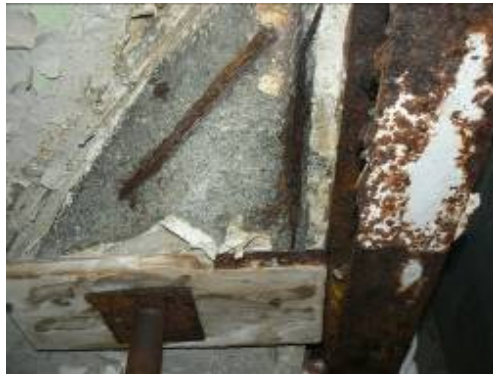
Photograph No. 364

Adjacent to entrance door DB20, there is exposed reinforcing steel across the corner and this area is also propped, and this is all shown on photograph No. 364.

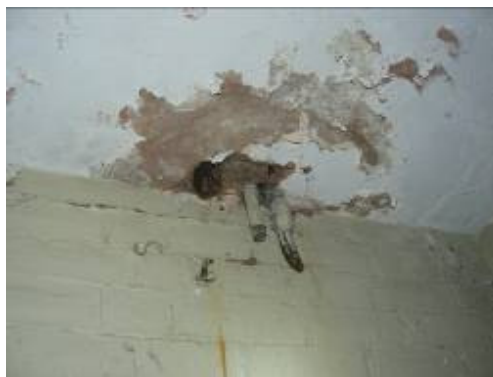
Photograph No. 365

Room B12 – This is a similar construction and it can be seen that where the pipework was put through on the southern wall, this was quite crudely carried out and there is corrosion noted here, as shown on photograph No. 365. There are also indications of damp within this room.

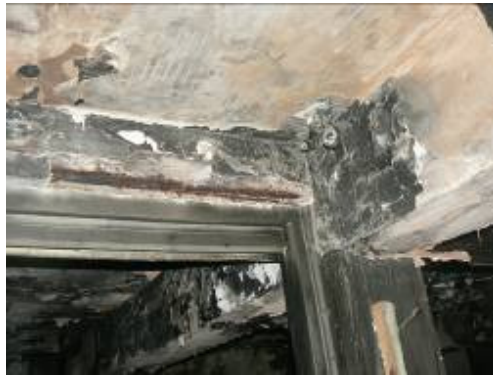
Photograph No. 366

Room B14 – This was originally classed as the Club Room, where the floor above is supported by a central column and four downstand beams. The eastern most beam at the column bearing is quite corroded, as shown on photograph No. 366.

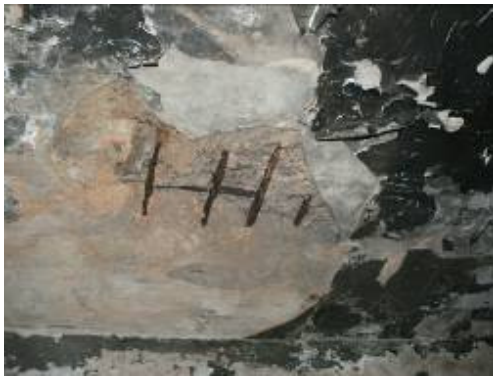
Photograph No. 367

The ceiling has a lot of paint flaking away and in the north-eastern corner there is an area of exposed reinforcing steel to the ceiling, as shown on photograph No. 367. On the south-eastern corner there is a similar situation, as shown on photograph No. 368.

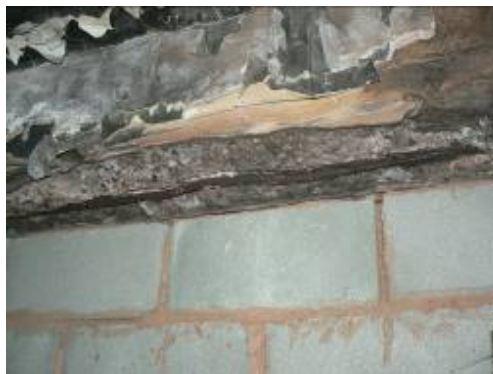
Photograph No. 369

The window to the northern wall has been quite crudely ripped out and this just has a grill in front of it. Over WB08, the lintol has failed in that the reinforcement is now showing, as shown on photograph No. 369.

To the remainder of the building there is noticeable defects with a large majority of the lintols, this relating to not only the decorative style to the Library but also the more functional ones to the boiler rooms and these often require complete replacement.

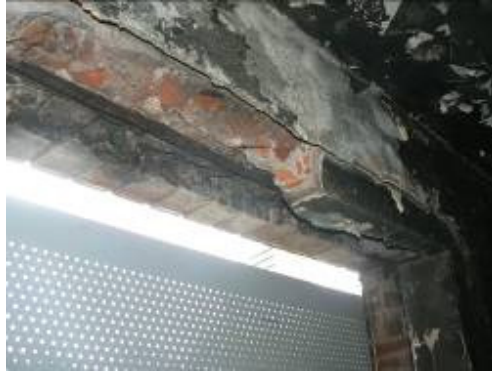
Photograph No. 370

To WB11 on the southern wall, there is a similar situation where the reinforcing steel is now present. It is also noted that this concrete was made up with crushed bricks and this is all shown on photograph No. 370.

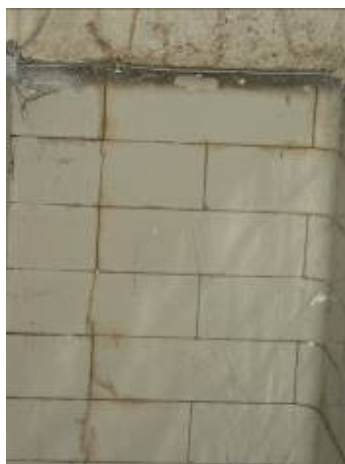
Photograph No. 371

Room B19 – Viewing is slightly restricted as this is where the ‘asbestos tent’ has been constructed. The ceiling shows a large amount of flaking paint and there are signs of water damage. The walls appear to be in quite a poor condition and to the lower area, there is a crack to the side of the column, as shown on photograph No. 371.

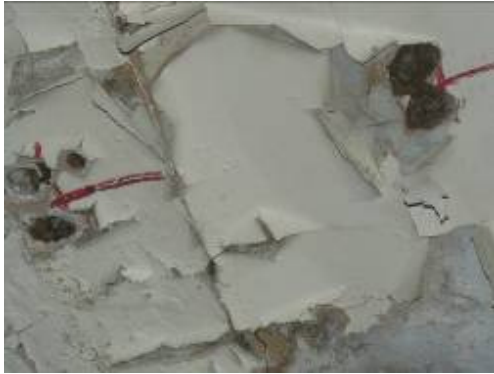
Photograph No. 372

Room B20 – The ceiling has a large amount of flaking paint and an occasional amount of spalling. Some of the holes which have been put through the wall are quite crudely formed, but structurally, apart from the ceiling, there are no major concerns. This can all be seen on photographs numbered 372 and 373.

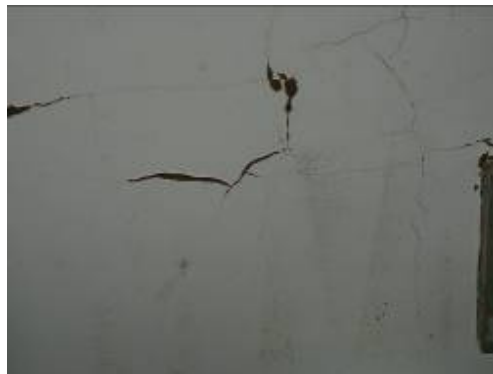
Photograph No. 374

Room B21 – The ceiling is damp and there is cracking to the finishes which are indications that sections may soon begin to spall, as shown on photograph No. 374.

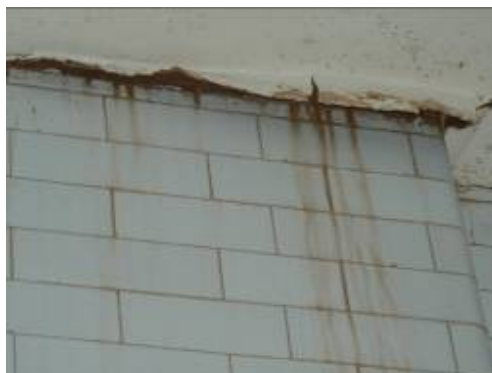
Photograph No. 375

The walls again show signs of damp ingress extending down from above, but there are no signs of major cracking. The damp ingress is shown on photograph No. 375.

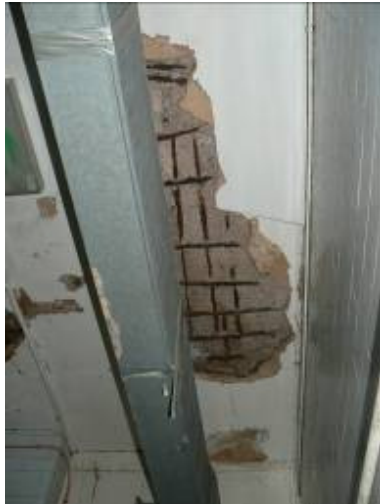
Photograph No. 376

Room B22 – The soffit is in a poor condition with both the downstand and the main ceiling having large areas of exposed concrete, and this is shown on photographs numbered 376 and 377.

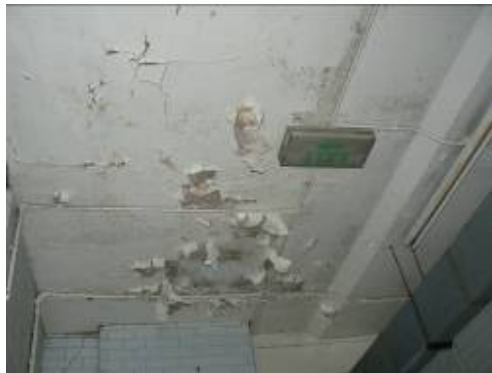
Photograph No. 378

Room B23 This has a set of steps up to the original wash house area and the soffit of the ceiling has lost a lot of paint and the concerns are that there is spalling concrete behind, as shown on photograph No. 378.

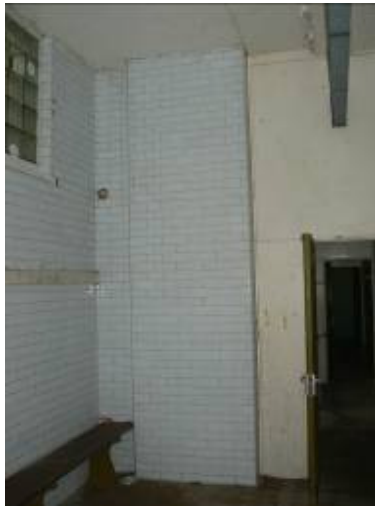
Photograph No. 379

The tiled walls are in a reasonable condition and there is no significant cracking to the main column supporting the pool hall roof which extends to this level. A typical example is shown on photograph No. 379.

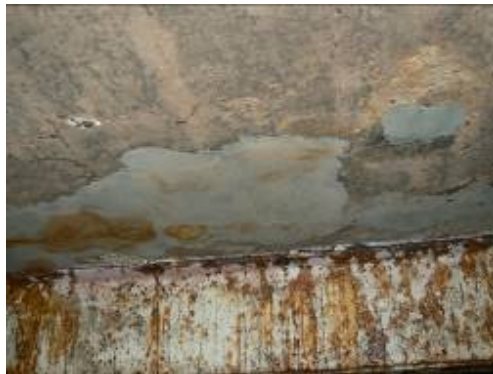
Photograph No. 381

Room B26 – This is a mirror of Room B2, however, the steel beams are in a slightly better condition, as is the soffit on the underside of the stairs. Leading into the south-east corner, before Room B27, the steel beam does show signs of corrosion and there is a slight spalling on the underside of the concrete, as shown on photograph No. 381.

Room B27 – This is equivalent to Area B1 where access was not possible. It can be seen that the slab is supported by a series of steel beams spanning onto brick piers and the most noticeable item is major damp to this section. The steelwork is showing surface corrosion and there have been attempts to patch the ceiling which can be depicted on photograph No. 381 above.

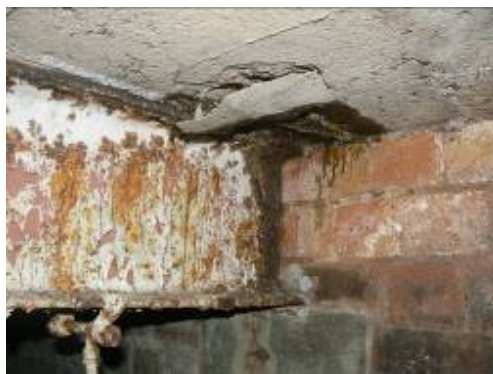
Photograph No. 382

The bearing of the steel in the south-western bay is heavily corroded and the soffit of the concrete above is also starting to spall, all as shown on photograph No. 382.

The remainder of the basement structure also need attention, in that the areas of to north-east and south-east side, namely B1 and B27, the steel beams supporting the floor above show noticeable corrosion and there are many instances where they are already propped and it is felt that these floors will need to be broken out and re-cast. Alternatively, a new structure formed making the existing system redundant. Also the majority of the other steel beams are in need of replacement in the basement.

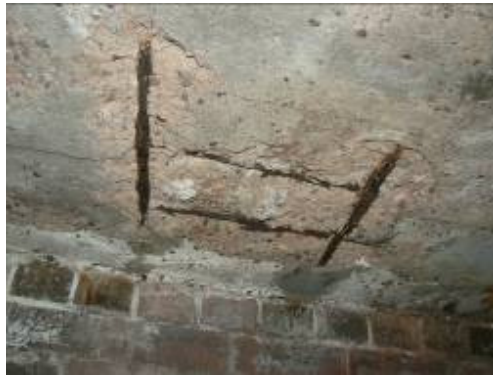
Photograph No. 383

Moving along the southern side, the underside of the slab shows exposed reinforcement, as shown on photograph No. 383.

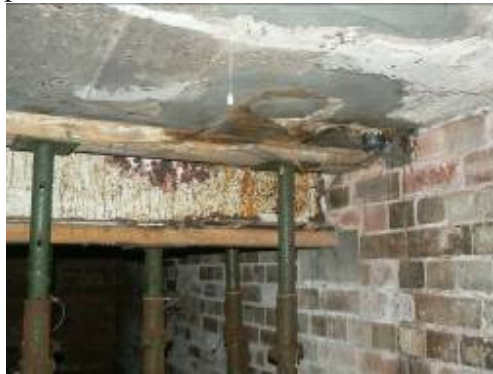
Photograph No. 384

The cross beam which runs north-south on the southern side is now propped, as is the floor, and this is shown on photograph No. 384.

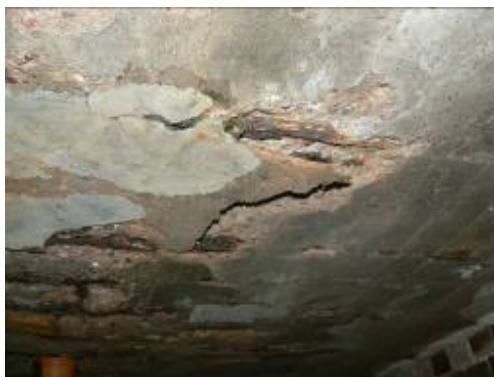
Photograph No. 385

In the south-eastern bay the condition of the floor is exceptionally poor, as shown on photograph No. 385 and the steelwork is also quite heavily propped, as shown on photograph No. 386.

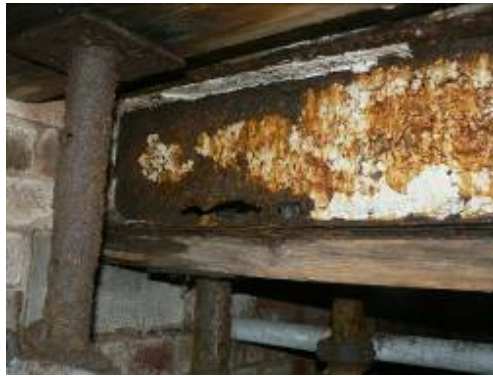
Photograph No. 387

On the eastern middle bay the steelwork shows a lot of surface corrosion and to the southern beam, the end bearing has now failed with holes in the web, as shown on photograph No. 387.

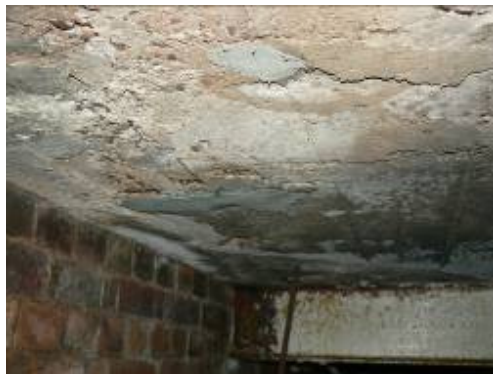
Photograph No. 388

Generally, the steelwork has noticeable corrosion and there are sections of the slab which are also in a poor condition, all as generally shown on photograph No. 388.

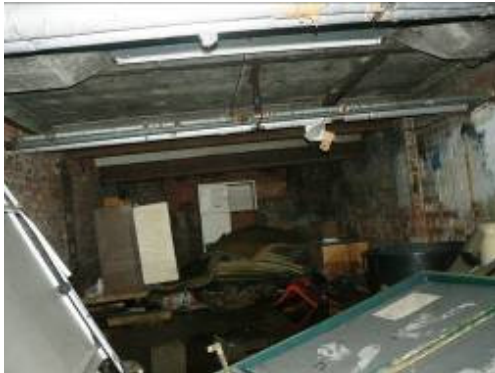
Photograph No. 389

Under the northern most steel beam the ground floor slab has become damaged and this does need repair, and a general view of the room is shown on photograph No. 389 and the floor slab damage on photograph No. 390.

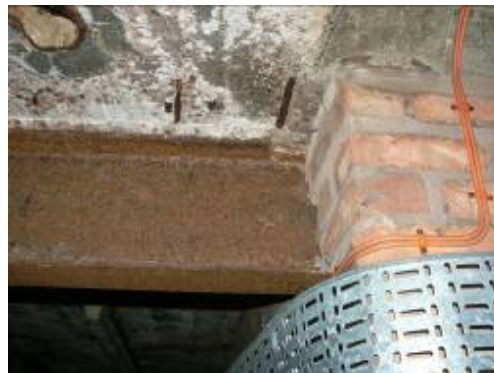
Photograph No. 391

There is then a small corridor which leads up to Room B26 and this also has a lot of water present. There are downstand beams supporting the floor over and at the western edge the steel beam does need attention as it has corroded, and the slab requires repairing where there is exposed steelwork, as shown on photograph No. 391.

The slab does require areas of localised repair, but this apart it was in a reasonable condition, as was the brickwork.

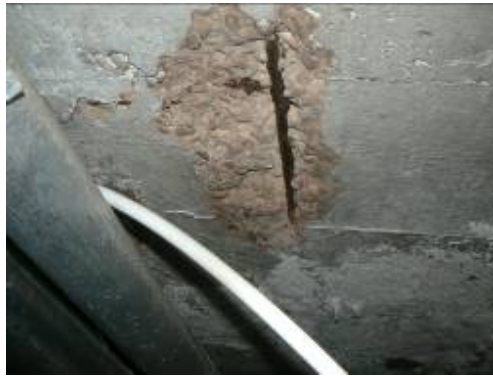
Photograph No. 392

The cross steel is corroding and the soffit is damaged with areas of exposed reinforcing steel, as shown on photograph No. 392.

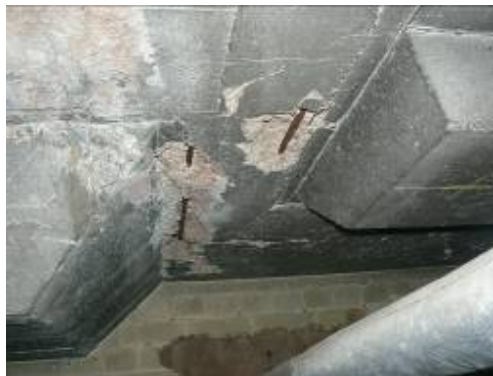
Photograph No. 393

To the middle section on the eastern side there are two downstands in the concrete and adjacent to here the reinforcing steel is all exposed, as shown on photograph No. 393.

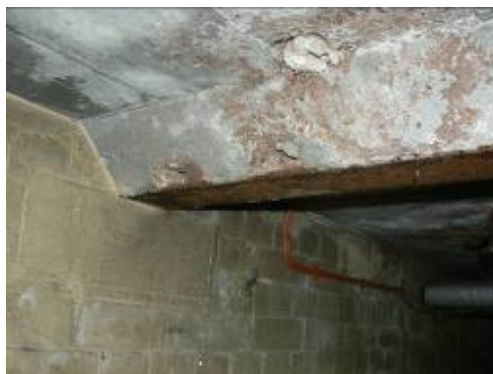
Photograph No. 394

Moving to the southern side there is another cross beam and this appears to be in a reasonable condition, although the concrete does require repair. The steel beam is partially encased and against the western wall the underside of the steel beam is corroded, as shown on photograph No. 394.

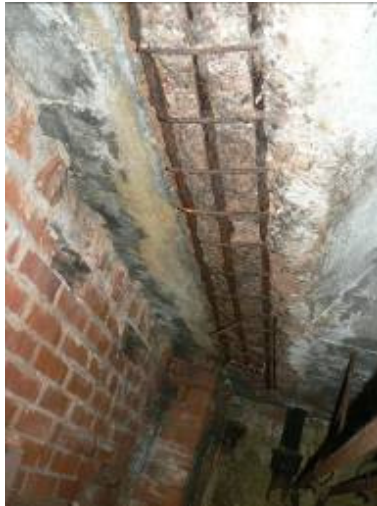
Photograph No. 395

Adjacent to the entrance there is one section of slab which is in a very poor condition, with a large amount of exposed reinforcing steel, and this is shown on photograph No. 395.

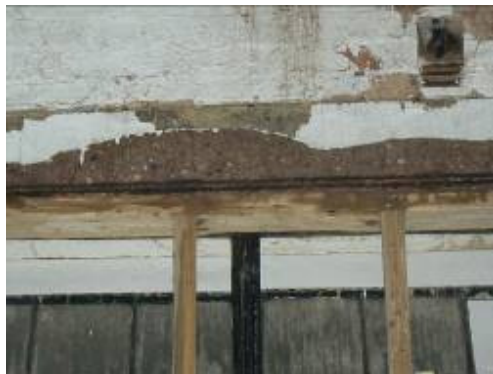
Photograph No. 396

Room B30 – The upper roof is supported by two large downstand steel beams spanning east-west with the walls all being brickwork. Starting on the northern wall which houses the stairs, this is showing significant signs of damp. To the lintol over WB13, this is badly corroded and needs to be re-formed as the reinforcing bar is visible, as shown on photograph No. 396.

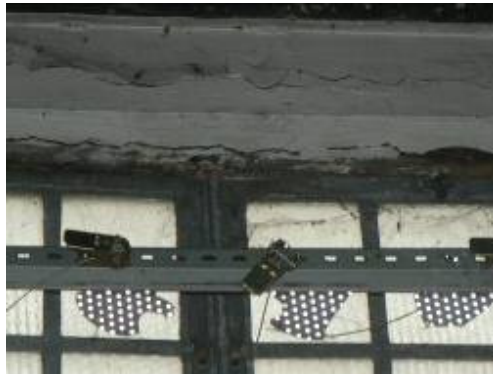
Photograph No. 397

On the southern wall there is a large area which has been blocked in and the upper windows here have cracking to the lintols, as shown on photograph No. 397.

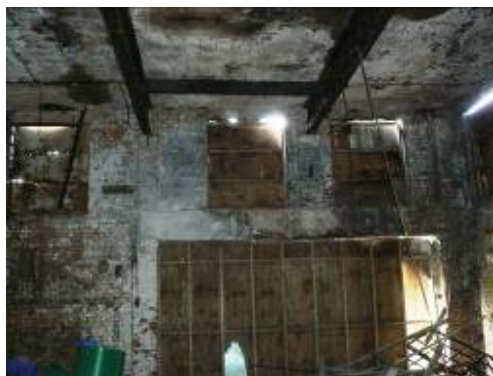
Photograph No. 398

Room B31 – This is the old Boiler House and the upper floor is supported by main steels spanning north-south and a general view is shown on photograph No. 398.

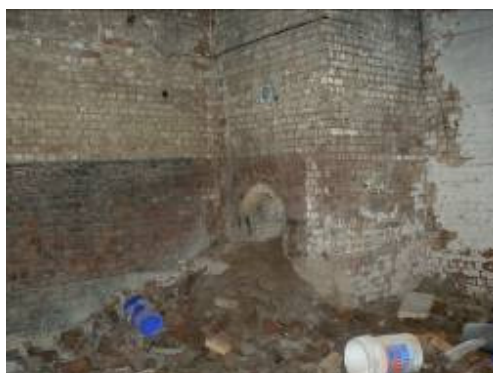
Photograph No. 399

In the north-east corner there is a large brick chimney and from the bottom of this there is now a large amount of debris, as shown on photograph No. 399.

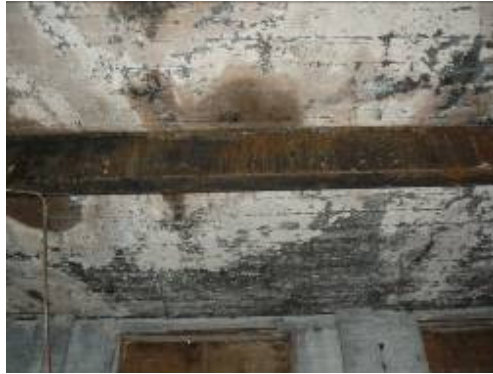
Photograph No. 400

The main steel beams show signs of surface corrosion, as typically shown on photograph No. 400.

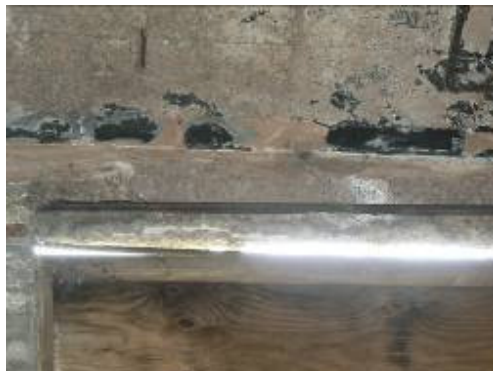
Photograph No. 401

The main area of defect is the condition of the lintols, which have all now largely failed and typical examples are shown on photographs numbered 401 to 403 inclusive.

To the boiler rooms on the southern elevation, all the lintols appear to have failed, although the main steel beam supporting the flat roof are in a more reasonable condition.

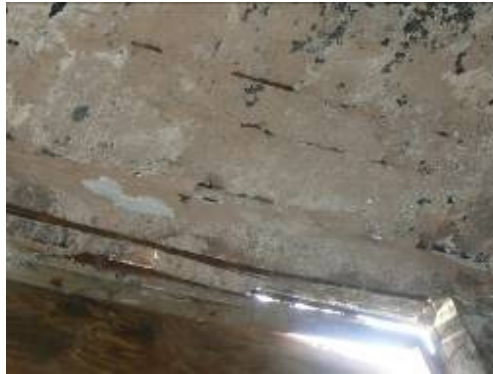
Photograph No. 404

To the main concrete beam over the original sliding door, there are areas of surface cracking to the underside and the face which do give rise for concern. Similarly on the western wall, the lintols are also in a very poor condition with large amounts of exposed reinforcement, as shown on photograph No. 404.
